Reconnaissance Report of July 16, 2007 Niigata-Ken Chuetsu-Oki, Japan, Earthquake

M.R. Ghayamghamian¹, Tetsuo Tobita², Susumu Iai², and Gi-Cheon Kang²

ABSTRACT: *The damage survey of the Niigata-ken Chuetsu-Oki, Japan earthquake ($M_{JMA} = 6.8$) of July 16, 2007 was conducted by the reconnaissance team of Disaster Prevention Research Institute (DPRI), Kyoto university. The area with dimension of 24 km x 19 km is investigated by the reconnaissance team. This paper reports the seismological aspects and observed geotechnical and structural damage during the damage survey in the area. The landslides, liquefaction and ground settlements were the most important geotechnical features that caused serious damage to the lifelines and buildings. Especially, landslides caused major damage to the railways and roads. The building damage survey was conducted around Kashiwazaki city hall where the K-net strong motion station was located. The damage to the buildings was classified as D2 or D3 within 100m around the city hall. Meanwhile, the collapsed wooden houses (D6 Grade) were mostly concentrated in Higashi Honmachi street situated in 280 m south of city hall. Most of the wooden house, concre

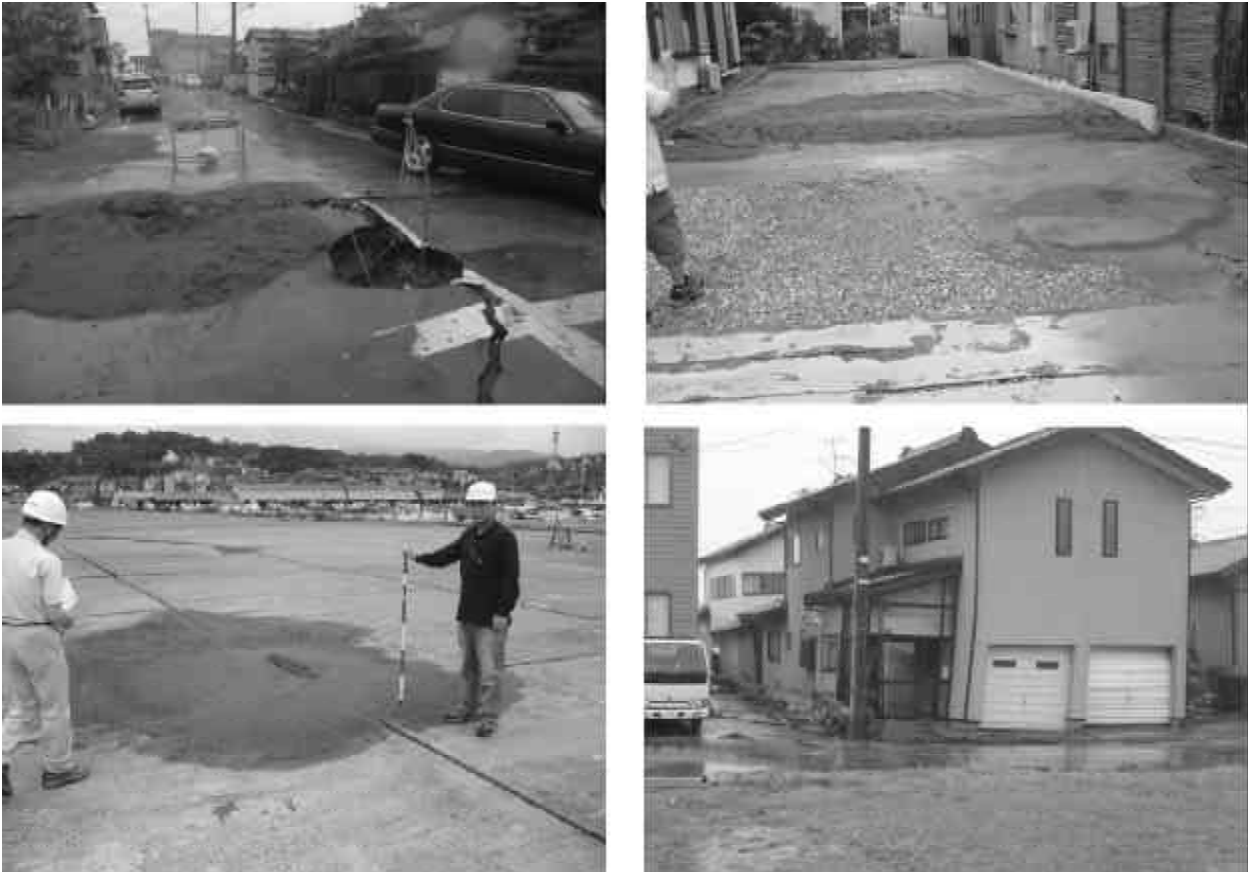
land suffered heavy damage due to liquefaction. The occurrence of liquefaction after the large shaking with an eruption of muddy water at 2m height is described by eye witnesses, see Figure (10). Settlement of a railway embankment due to the loss of the bearing capacity of its base ground was found in Doh-Ai with no evidence for liquefaction, see Figure (11). Cross-sectional dimension of the

Figure 10. The liquefaction observed at Matsunami 2 in Kashiwazaki city that cause damage to utility poles, asphalt roads and foundation of houses.

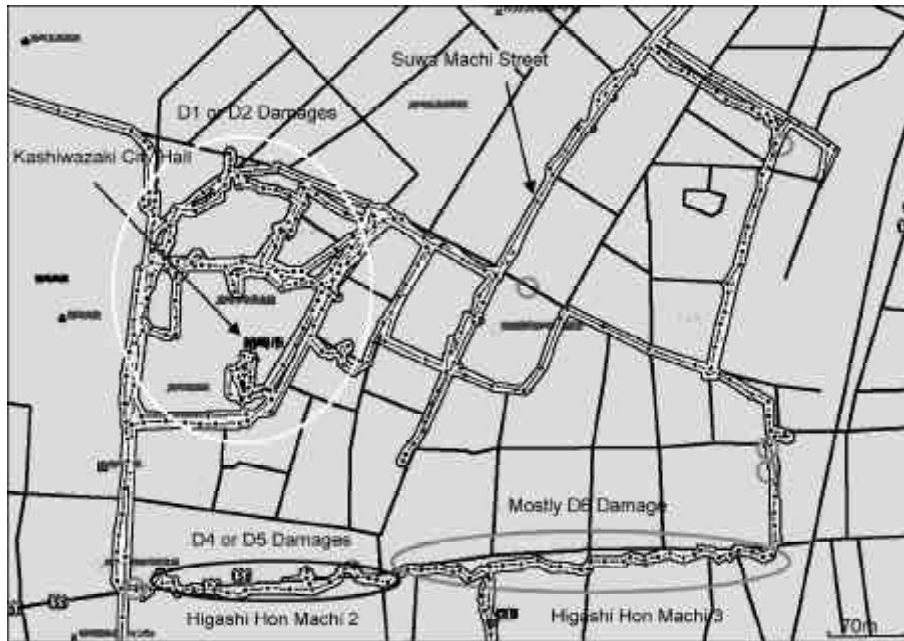
Figure 14. The area around Kashiwazaki city hall where the building damage survey was performed. The damage type and their distribution are also shown in the figure.

structural damage or collapsed). Most of the building damage is classified as *D1* and *D2* near the Kashiwazaki city hall. However, many wooden houses with Grade 5 and 6 damage were observed along the Higashi Hon Machi street (regions 2 and 3). Figure (16) shows typical collapse of wooden houses together with their collapse direction observed in this street. The Highashi Hon Machi street was almost directed along *EW* direction with a lenient slop in its south side. Besides this observation, the scares damage along the other streets was found that is mostly categorized as a *D2* or *D3* types. The place that damage *D6* was observed is shown in the map in Figure (14). Although it was not possible to visit all the damaged buildings, the ntensity based on collapsed buildings seems to be lower than the one announced based on instrumental *JMA* seismic intensity (6+ comparable to *IX* in *MMI* scale).

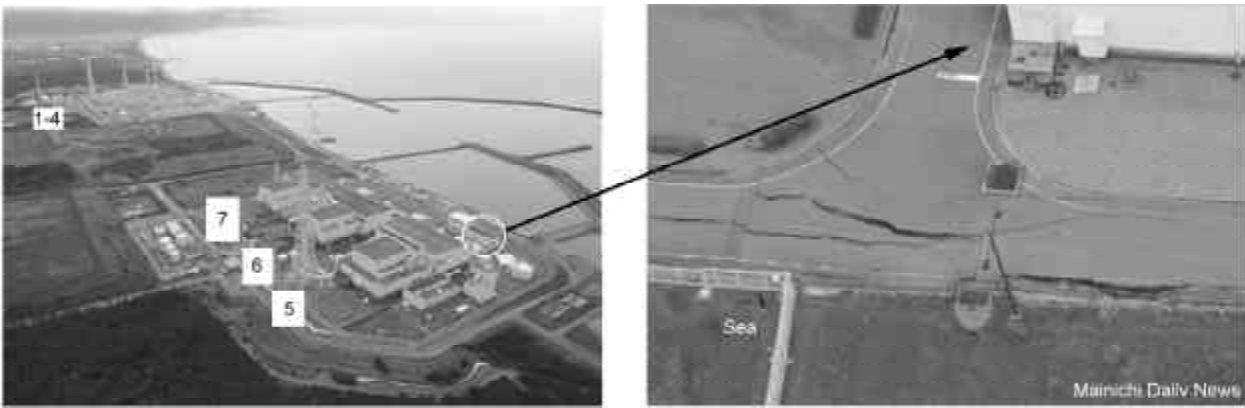
reactors that generate 8,200,000kw power for Tokyo area. It suffered serious damage in auxiliary facilities only during earthquake, see Figure (17). An electrical transformer at the plant fired and it could not be quickly extinguished due to the broken water pipes, Figure (18). Meanwhile, a small amount of water containing radioactive materials had leaked from a unit at its Kashiwazaki-Kariwa nuclear power plant. The contaminated water was also released into the ocean, but officials said it had produced no effect on the environment. The *PGA* of 680cm/s^2 was recorded at the nuclear power plant site. This was 2.5 times stronger than those its reactors had been designed to withstand. According to the Tokyo Electrical Power Company (*TEPCO*) website, the responsible company of Kashiwazaki nuclear power plant, the units were constructed on engineering bedrock for design *PGA* of 270cm/s^2 . A report by the Niigata prefectural government has stated that about 700 billion yen would be lost from the suspension of operations at Kashiwazaki-Kariwa nuclear power plant. Furthermore, prefectural authorities also estimated that Niigata farmers would lose between 100 billion and 200 billion yen due to consumer fears about radioactive fallout from the nuclear power plant. The Riken company, which manufactures ring piston for most automobile companies such as Toyota and Nissan,

Figure 17. The Kashiwazaki nuclear power plants consist of 7 reactors showing the damage due to liquefaction and ground settlement.

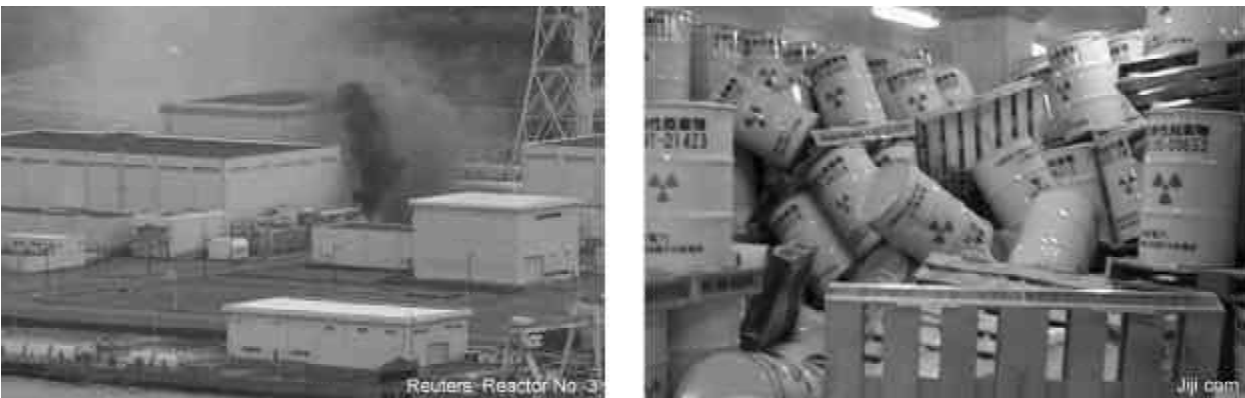
Figure 18. Fire in an electrical transformer at the nuclear power plant and displaced barrel of nuclear waste. The radioactive materials were also leaked to the ocean and contaminated the environment.

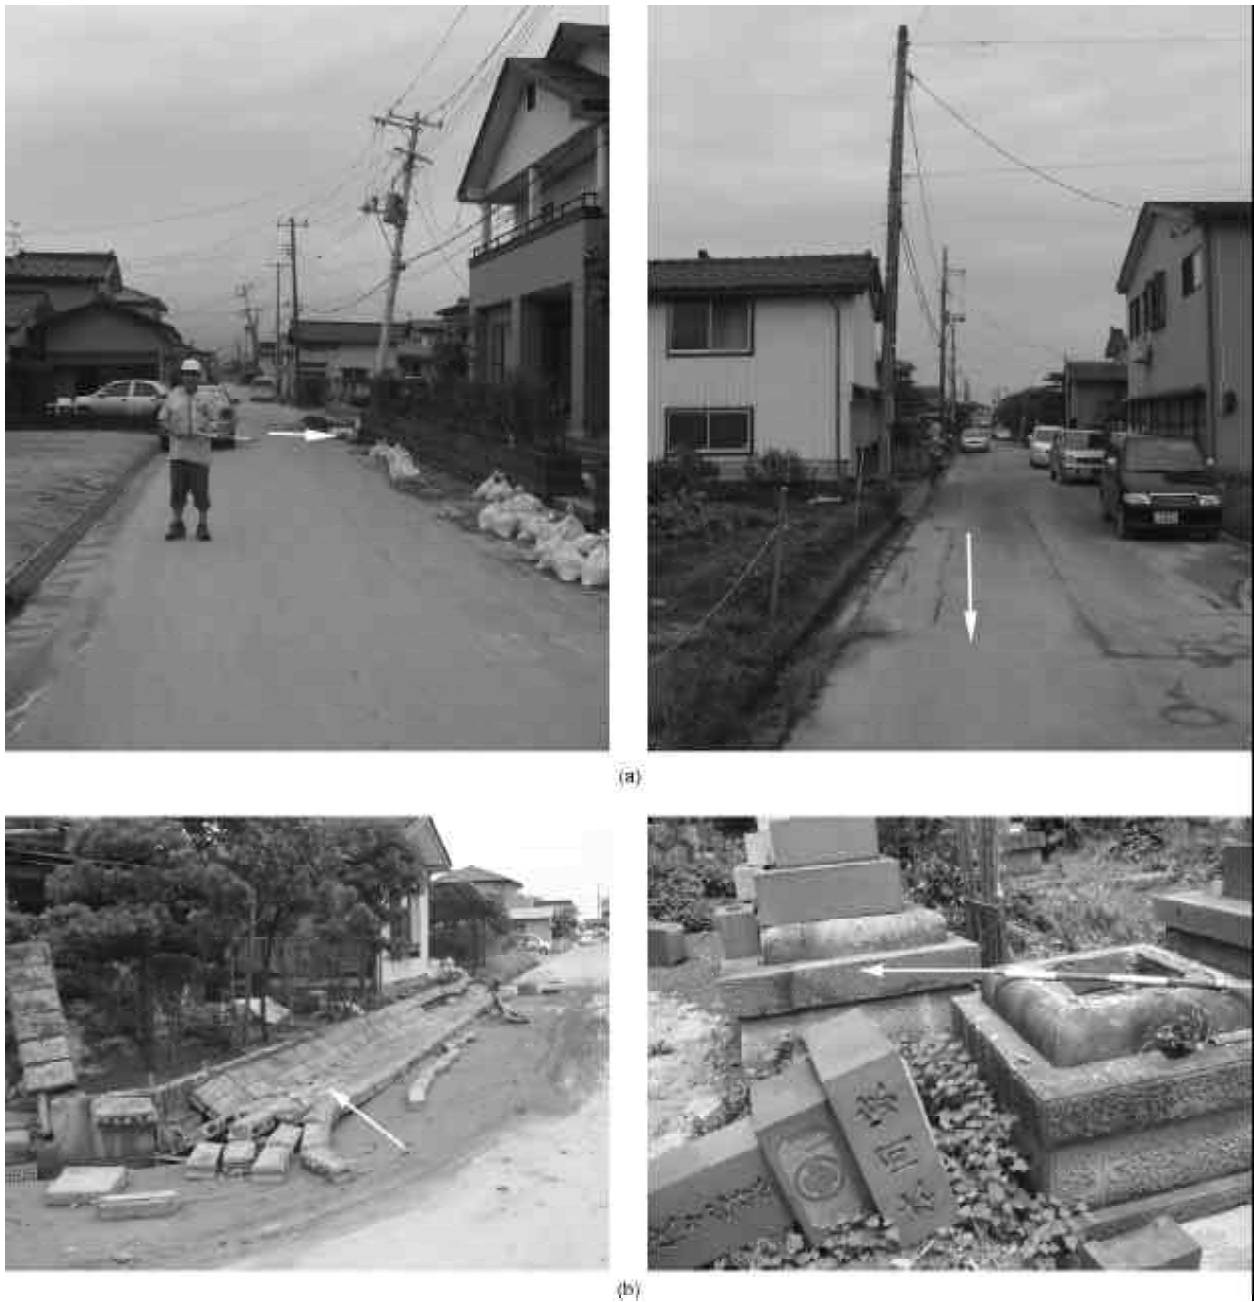
motions directed north-south than by motions directed east-west. Therefore, we investigated the damage concrete block fences and measured their toppling directions. The falling direction of tombstones and electrical poles was also measured. These are good objects to investigate ground motion directionality due to their unified constructions and no preferable structural directions. Figure (20a) shows an example of directional damage observed in Matsunami 2. The electrical poles directed along the *EW* displaced more than those directed in the *NS* direction. Furthermore, some examples of fallen concrete block fences and tombstone are shown in Figure (20b). Figure (21) summarized the estimated toppling direction of concrete block fences or tomb stones in the investigated area. Furthermore, the overturning ratio of tomb stones is calculated as a ratio of the number of overturning tombs to the total number of tombs in each investigation point. It is interesting to note that this direction is almost parallel to the fault normal and slip direction on the fault plain. Then, it might be attributed to the near-source effect. However, the deep geological structure may also affect the strong

Figure 20. Evidence for directional damage (the arrows show the north side); (a) electrical poles directed in EW direction displaced more in comparison with those directed almost in NS direction at Matsunami 2; (b) The toppling direction of the concrete block fences and tomb stones in Kashiwazaki area, see Figure (21).

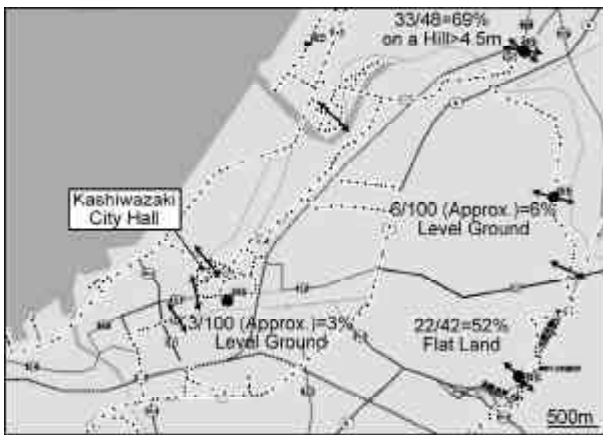
Figure 21. The outline of the area where the toppling direction of the concrete block fences and tomb stones were measured. The toppling direction is also shown together with overturning tomb stone ratios in graveyards.
