The Van, Turkey Earthquake of 23 October 2011, Mw7.2: A Preliminary Report on the Reconnaissance Visit Performed by IIEES Reconnaissance Team, November 17 to 21 2011

**Team members: Dr Mehdi ZARÉ, Dr Ebrahim HAGSHENAS, Dr Morteza BASTAMI
IIEES, Tehran, Iran**

Reported at 30 November 2011.

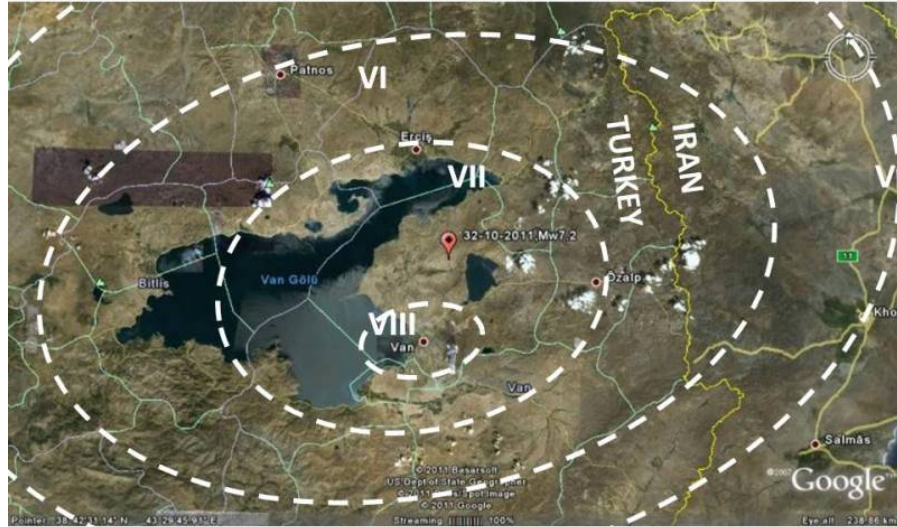
Iso Seismal Map (EMS98) of the Van Earthquake of 23 October 2011, Mw7.2, based on the IIEES Reconnaissance Team Visit to the Region, by: M. ZARE, E. HAGHSHENAS, M. BASTAMI, Nov. 2011

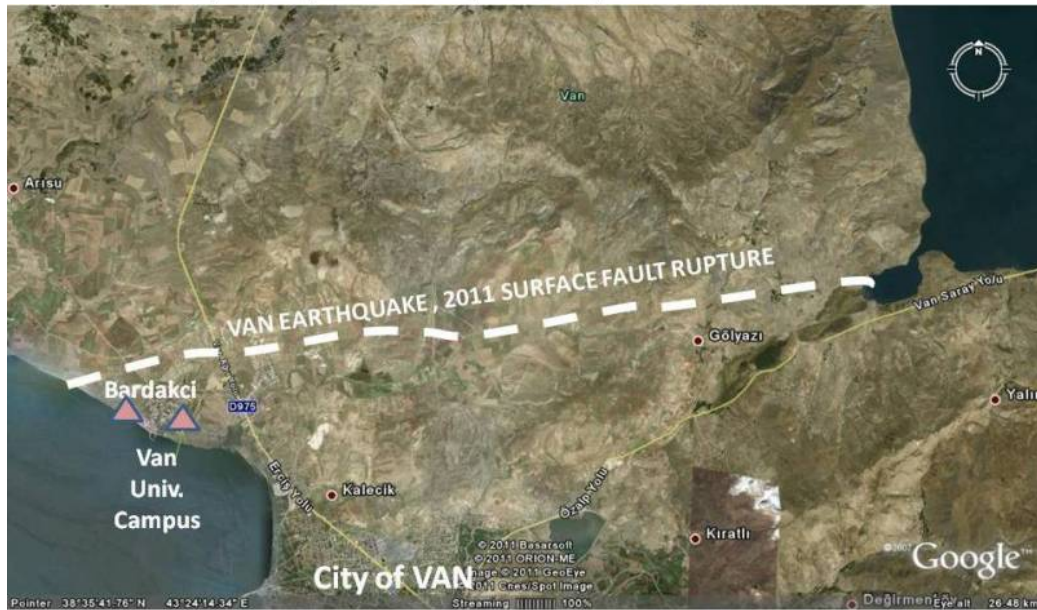
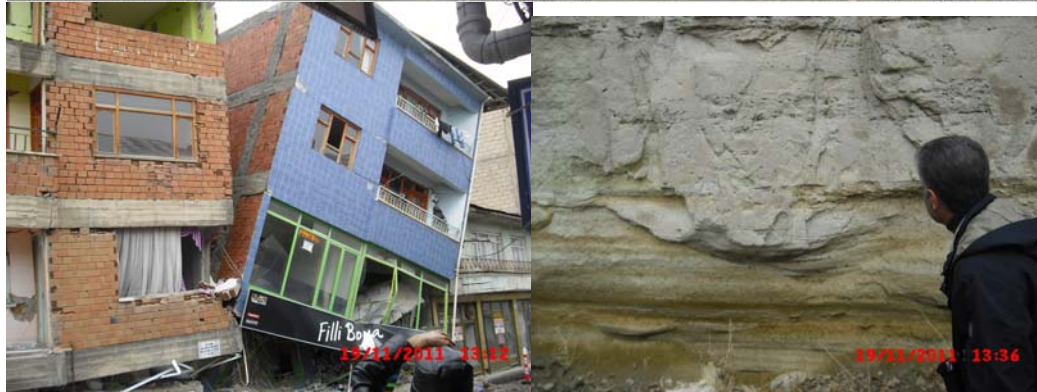
ERCIS: The Thick soft soil Deposits amplified the ground shaking and damages.
