Performance of Unreinforced Masonry Buildings in Canterbury Earthquakes

Rajesh P. Dhakal

ABSTRACT

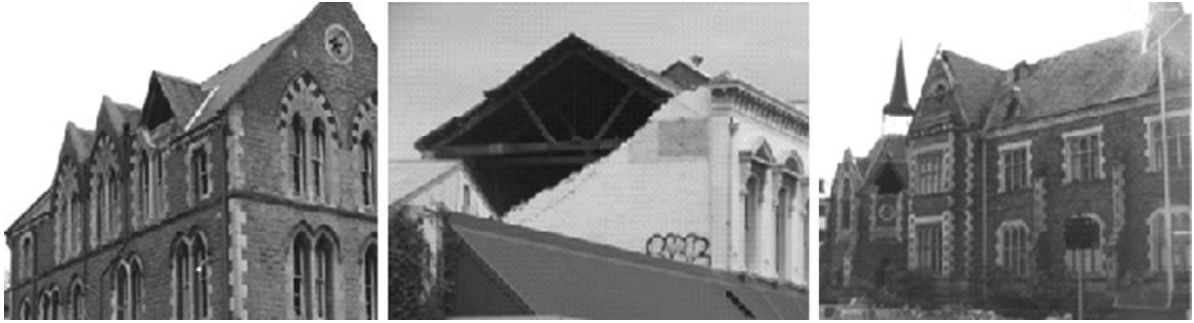
Damage to gable end walls, see Figure (3): Although gable walls are known to be the weakest component in *URM* buildings [7], they were intact in many *URM* buildings. In some cases the gable walls were still in their place but in a severely damaged state with several cracks. It was unlikely that these gable walls were taking vertical loads in addition to their self weights. In several *URM* buildings, a part of the gable walls had collapsed, often onto an adjacent building.

Figure 3. Typical damage to gable walls in the September 2010 earthquake.

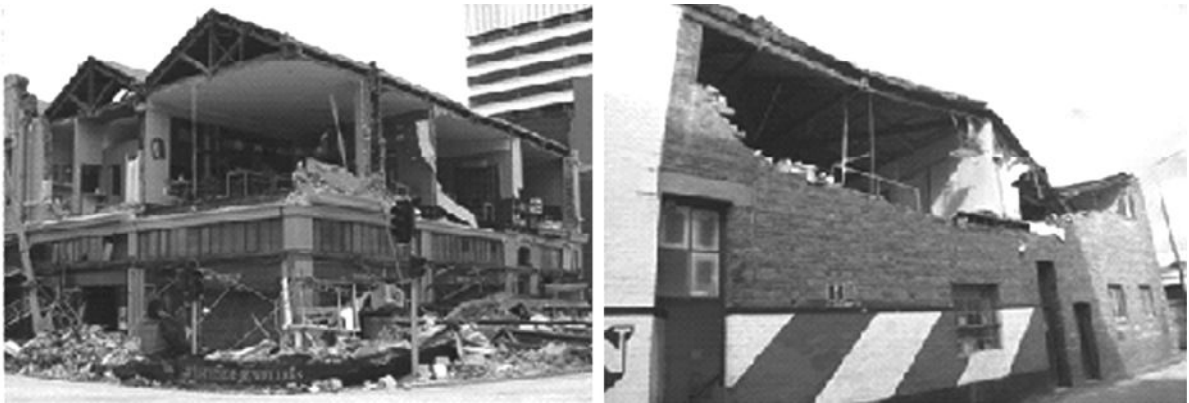
Out-of-plane failure of solid walls, see Figure (4): Out-of-plane failure of masonry walls

Figure 4. Typical out of plane failure of solid masonry walls in the September 2010 earthquake.

was one of the most common sights in the media following the September earthquake. In some cases, masonry walls collapsed even when they were apparently not taking any vertical loads except the self-weight (obvious from the fact that the roof structure was intact despite the collapsed walls). The main reason for out-of-plane failure of solid *URM* walls was the lack of adequate anchorage of the wall with the diaphragm. Alternately, if short masonry walls constructed with good mortar are tied firmly to the return walls at the ends, they could have satisfactory out-of-plane performance, but strong return wall connections were also missing in most cases.

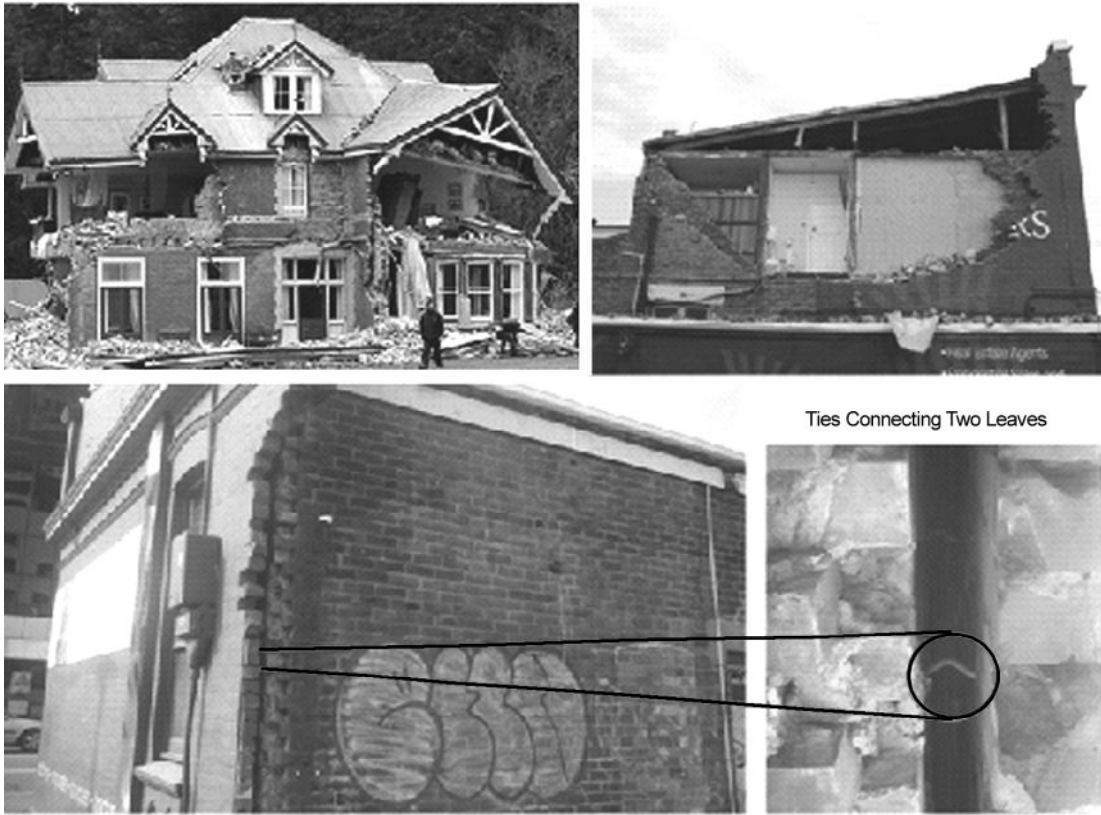
Failure of cavity walls, see Figure (5): Cavity walls are not as common as solid or multi-wythe walls in *URM* buildings in Christchurch. In a few cases where cavity walls were present, the ties connecting the two leaves were found inadequately detailed or corroded. For example, in the photo shown in Figure (5), the cavity ties were made of thin steel wires embedded in the two leaves without any end hooks. It was very unlikely that the tie had any noticeable ability to resist the separating tendency

of the two leaves. In such cases, it is no surprise that the front leaf collapsed in out-of-plane direction. In several cases, even the inner leaf failed because after the collapse of outer leaf, the slender inner leaf was unable to resist the vertical load imposed on it.

Figure 5. Typical failure of cavity walls in the September 2010 earthquake.

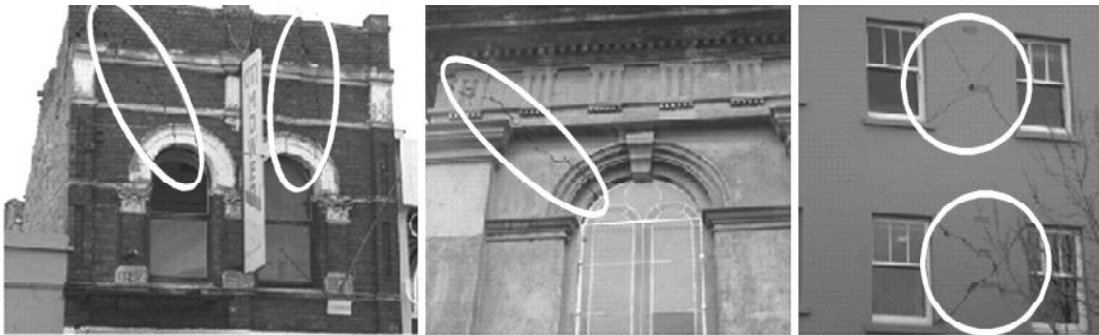
In-plane damage to masonry walls, see Figure (6): Diagonal in-plane cracks were visible in most *URM* walls. In infill masonry buildings too, diagonal cracks were present in the infill panels and *URM* piers between doors/windows. Diagonal cracks in *URM* walls typically started from a top corner of the wall and terminated at a window/door corner (or the apex where an arch existed above a window or door). In some walls, vertical cracks were also noticed, see Figure (6). In brick masonry, the cracks travelled in a stair-like path through the mortar joints. On-site inspection of the mortar used in some of the collapsed *URM* building was conducted, and the mortar could easily be crumbled by fingers; suggesting that the mortar had a low strength.

Figure 6. Typical in-plane failure of masonry walls in the September 2010 earthquake.

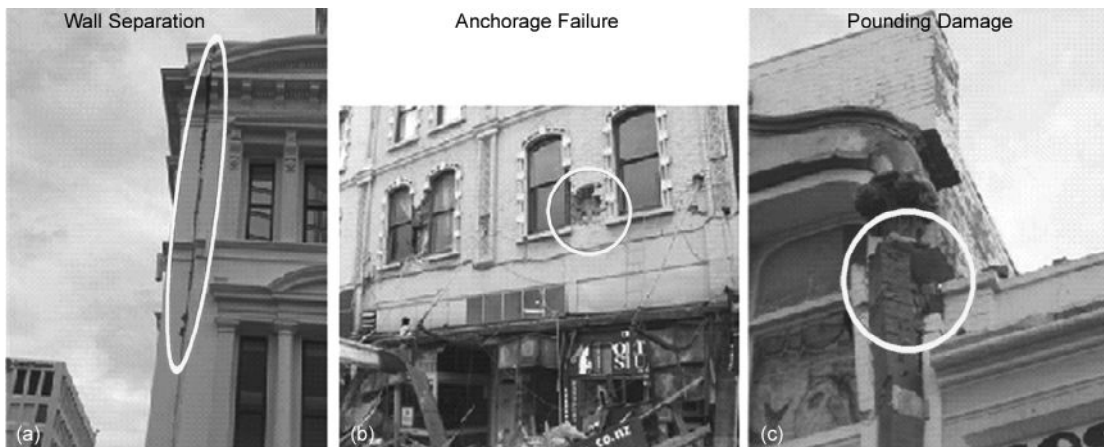
Other types of damage, see Figure (7): *URM* buildings also suffered other types of damage such as separation of return walls, anchorage failure,

Figure 7. a) Separation of return walls; b) Anchorage failure of masonry wall; c) Pounding damage observed in the September 2010 earthquake.

pounding damage. In some buildings, the connection between orthogonal walls at the corner opened up, making the walls (or their parts) vulnerable to out-of-plane collapse. In several buildings, the ties supporting canopies were anchored to the walls, and the anchors suffered punching failure [8]. In some cases where buildings were in a row without any gap in between; the out-of-phase response of two adjacent buildings caused the buildings to hit against each other; thereby inducing pounding damage. Despite the presence of several pounding prone buildings, the extent of pounding damage in September earthquake was not very high [9].

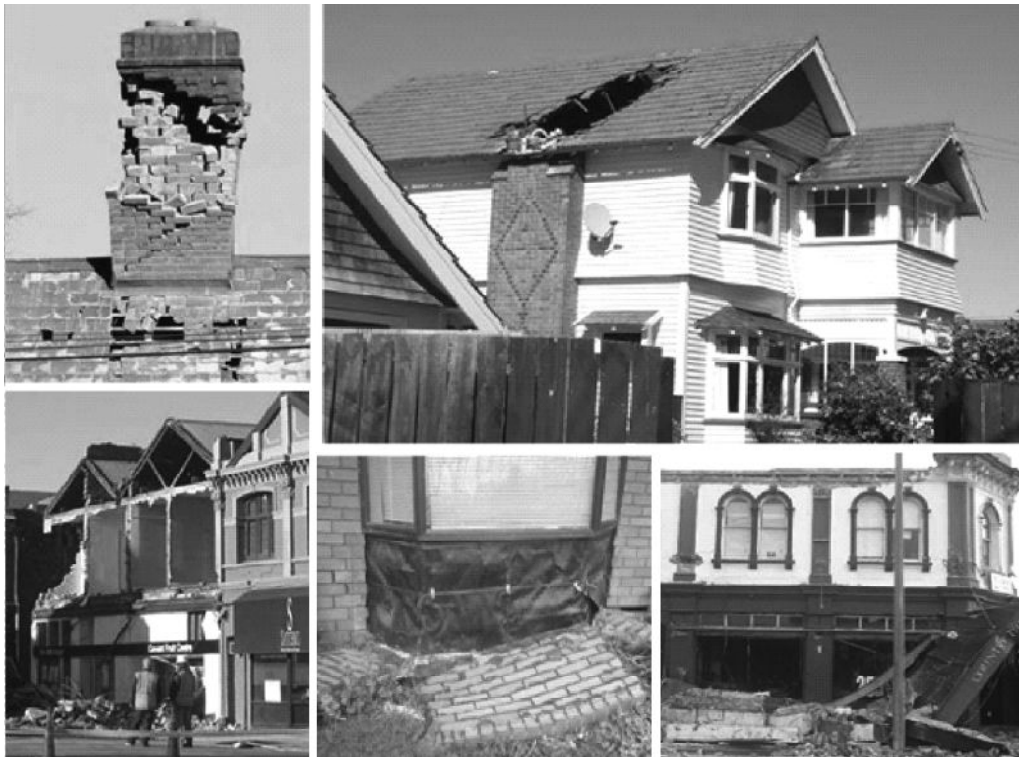
Damage to secondary URM elements, see Figure (8): In URM buildings as well as other types of old buildings; secondary elements such as chimneys, parapets, facades, infill, partitions made of URM are not uncommon. More than half of the brick chimneys in Christchurch were reported to be damaged and/or collapsed [8]. Similarly, severely damaged and collapsed brick parapets and facades were common sights in Christchurch buildings. In many cases, blocks of collapsed brick masonry components fell off other components as they fell. A significant risk was posed by these collapsed URM elements to the buildings, people and vehicles in the vicinity [10].

Figure 8. Failure of brick masonry chimneys, facades, walls and parapets observed in the September 2010 earthquake.

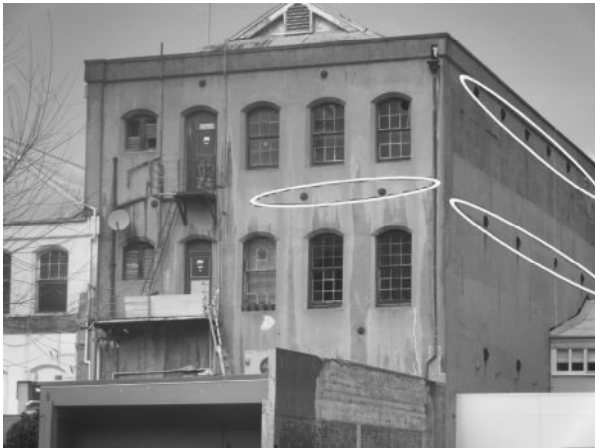
The use of anchors to tie walls with the floor and/or roof was found to be the most common form of retrofitting/strengthening applied to URM buildings in Christchurch. In several buildings, anchors bolted against metal plates on the perimeter walls were visible. Some buildings had closely spaced anchors at each floor and roof level in both orthogonal walls, whereas some buildings had only a few anchors at discrete locations without any specific trend. The size of the anchors and the spacing differed significantly between buildings; thereby raising suspicion that the decision on how to retrofit

was based on subjective judgement rather than on quantitative design calculations. However, as the level of shaking was not very demanding, especially for this type of short period buildings, even inadequately anchored walls were not fully tested. In general, apart from a few cases (describe later) these anchors were successful in avoiding out of plane failure of the anchored walls.

Figure 9. URM building with walls anchored to the floor/roof via a grid of bolted anchor ties.

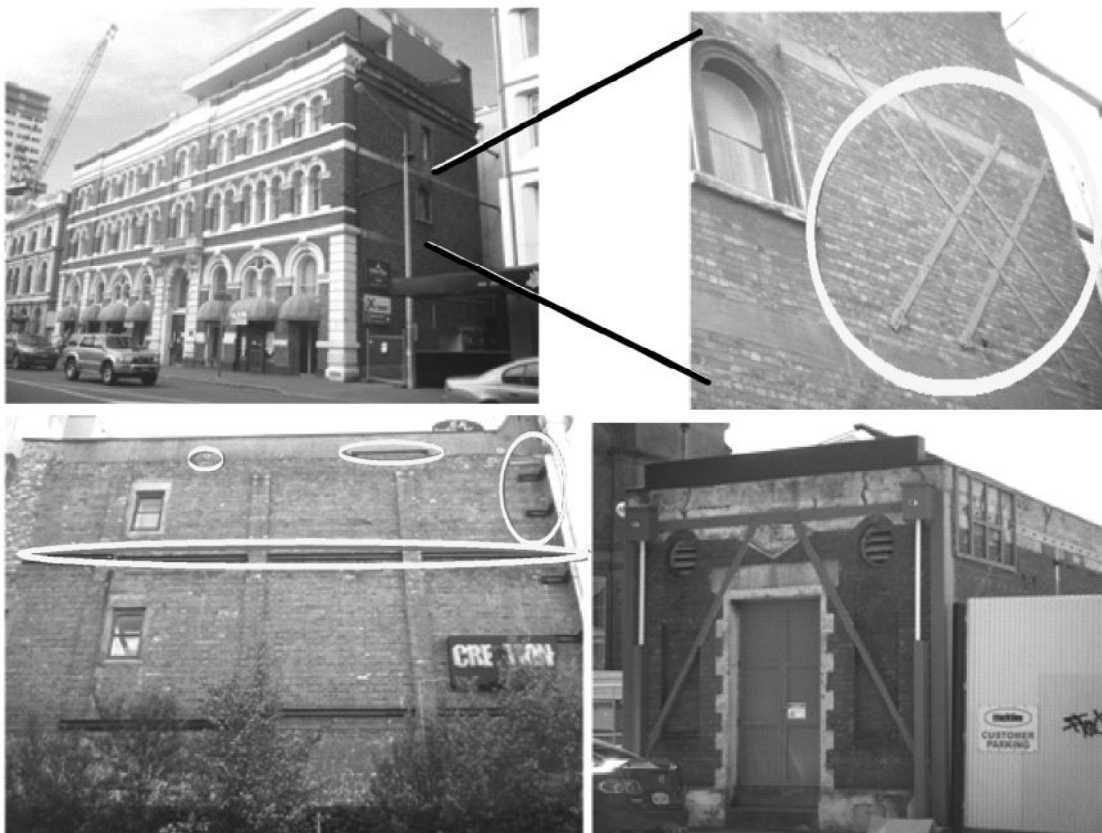
Using steel plates to integrate a wall was also found to be a common approach. Figure (10) shows

a 3-storey brick masonry building in which a side wall is retrofitted using bolted cross steel plates across the second storey, a three-storey URM building where steel tie beams are used to anchor a side wall with the floor and steel angles are used to tie the orthogonal return walls, and a single-storey brick masonry Power Station building heavily strengthened using a combination of steel braced frame and ties. All these buildings (especially the retrofitted walls) performed very well.

Figure 10. URM buildings retrofitted using different combinations of steel plates/ties/frames/angles.

damage noticeable from outside. The one-storey *URM* Powerhouse building in Madras Street, see Figure (10), which was retrofitted using steel braced frame on the front wall and a combination of steel tie beams on the side walls, was intact. The three-storey *URM* building in Gloucester Street which had steel cross plates bolted on the side walls, see Figure (10), also withstood the February earthquake with minor damage.

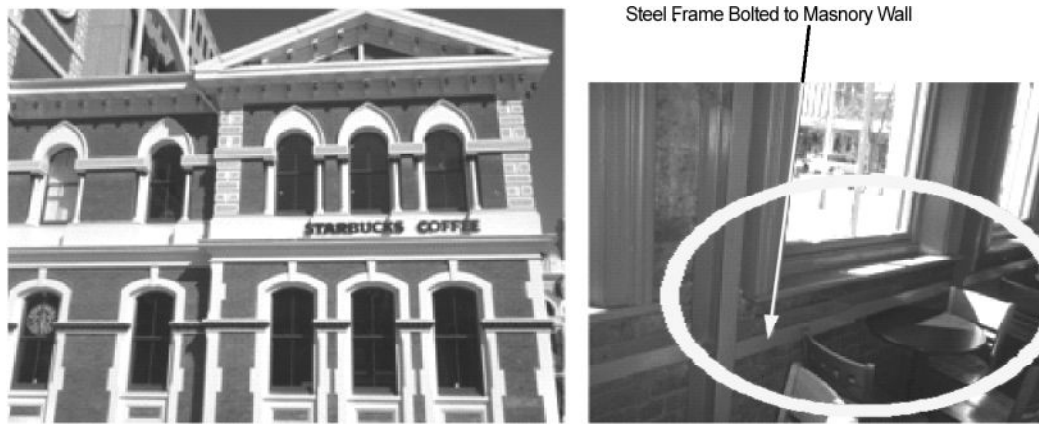
In one case, a 100-year-old URM building was found to be retrofitted by a steel frame inside the building (not visible from outside) bolted to the brick masonry wall, see Figure (11). The building did not suffer any noticeable damage. This building was checked again after the February earthquake, and it was found to have weathered the February earthquake also very well.

Figure 11. URM building at Cathedral Square retrofitted by steel frame bolted to the masonry wall.

As the ground shaking was more intense than what the modern buildings are designed for, even systematically retrofitted *URM* buildings suffered damage in the February earthquake. *URM* buildings which had retrofit measures other than the traditional wall anchors did well. Retrofitted by an internal steel frame, the two-storey *URM* building in Cathedral Square, see Figure (11), did not have any

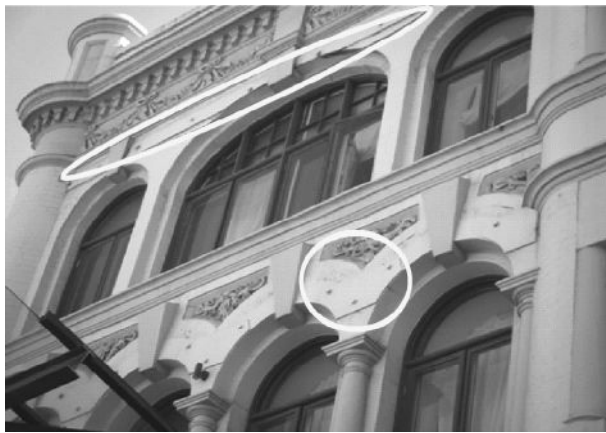
In some buildings, steel plates were bolted to the wall; mainly above the arched windows, see Figure (12). These plates seemed to have worked well because no in-plane cracks were seen in these walls. The author noticed that in other similar buildings without the plates, the walls had suffered in-plane damage in the form of diagonal cracks starting from

Figure 12. In-plane strengthening of masonry wall using bolted steel plates.

the corner of the wall to the window arches, see Figure (6). In this case, the plates seem to have effectively arrested the weak shear plane.

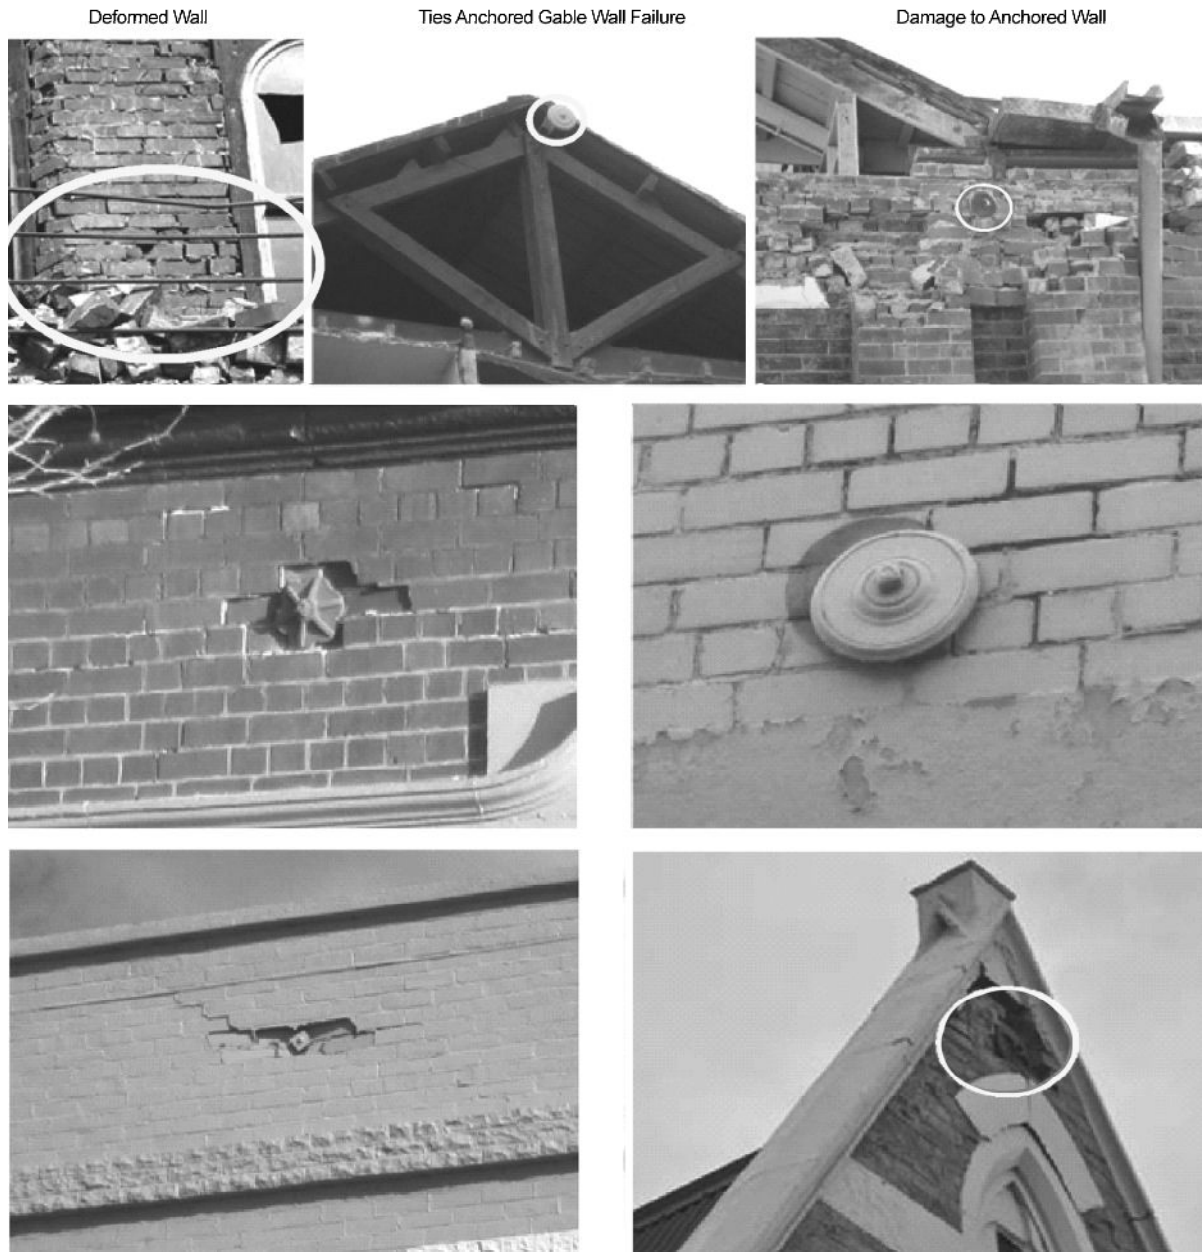
Although retrofitted structures in general performed very well in the September earthquake, some buildings which had some form of retrofitting suffered some damage. These damages could be mainly attributed to two reasons. The first is insufficient anchors between the walls and the floor/roof. As shown in Figure (13) (top row), inadequate number and size of anchors could not hold the walls (including gable ends), and could not stop them from damaging. The second type of damage observed in retrofitted URM buildings was related to the failure of anchorage. As shown in Figure (13) (middle and bottom rows), the anchor plates punched through the wall in several buildings; and in some cases the anchor plates moved. A proper design using a better estimate of the likely force could have resulted in a larger anchor plate which could have avoided these punching failures.

Figure 13. Typical damage to anchored walls observed in the September 2010 earthquake.

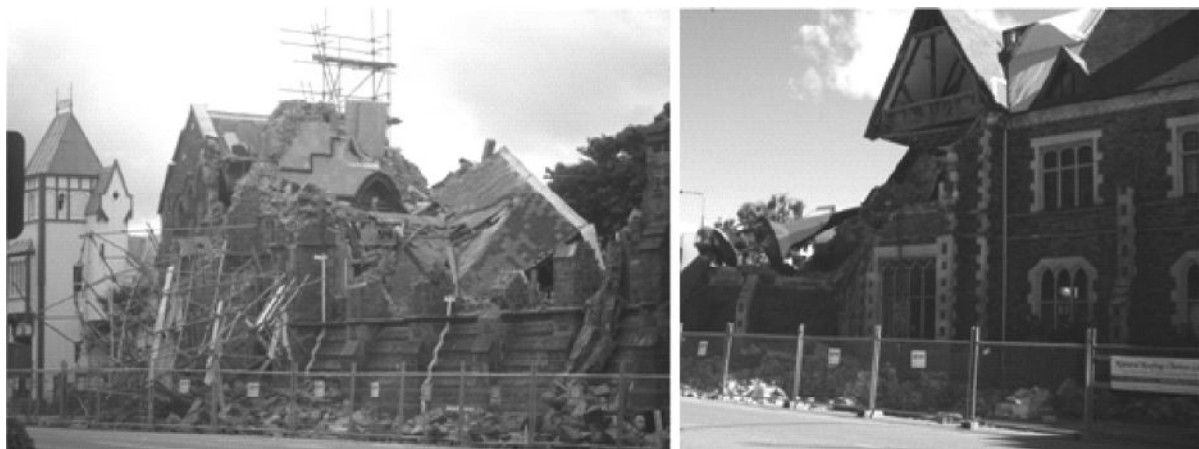
The February earthquake posed a much greater demand (than the current design level demand) even on low-rise buildings with short natural period; a category in which most *URM* buildings fall. As the *URM* buildings are inherently weaker than what we currently design for, it was not a surprise that most *URM* buildings either collapsed or were very severely damaged. The building inspection record showed that out of 471 *URM* buildings inspected, only 58 (12%) were green-tagged, 122 (26%) were yellow-tagged and 291 (62%) were red-tagged. The total number of inspected *URM* building is significantly less than the number of *URM* buildings in Christchurch. This may be due to a number of *URM* buildings demolished after the September earthquake. Among the remaining *URM* buildings, many completely collapsed and did not need any formal inspection/evaluation. It is believed that most of the green tagged *URM* buildings had been retrofitted. Apart from some heritage buildings for which economic considerations are secondary, it will be very difficult to economically justify repair of most other yellow-tagged *URM* buildings. Hence, it is very likely that there will be very few unretrofitted *URM* buildings left in Christchurch when the post-earthquake rebuilding is completed. In the absence of slightly or moderately damaged *URM* buildings, it was impossible to deeply analyse what features of *URM* construction worked well and what did not. In most cases, unretrofitted *URM* buildings collapsed partly or wholly, see Figure (14). To some extent, the extensive collapse of *URM* buildings may have been contributed by the September earthquake and the following aftershocks which may already have

Figure 14. Collapse of URM buildings in the February 2011 earthquake.

softened these buildings significantly.

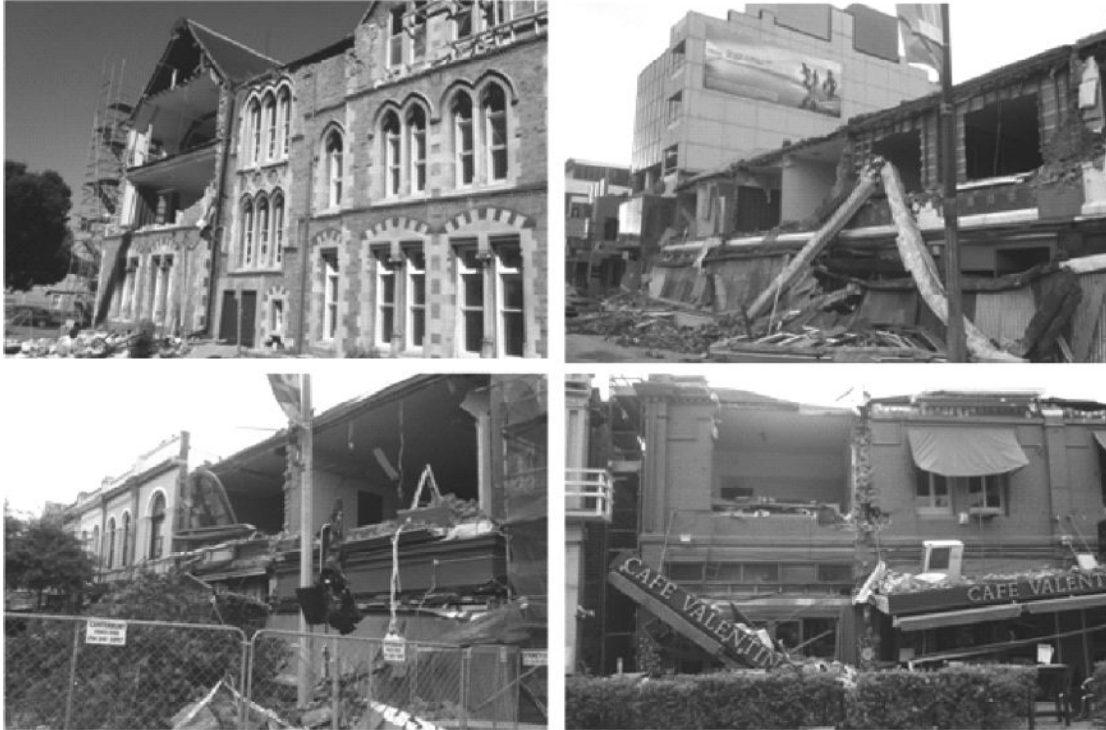
In URM buildings which did not completely collapse, different damage mechanisms were prevalent. There were out-of-plane wall failures, see Figure (15), collapse of gable walls and parapets, see Figure (16);

Figure 15. Out-of-plane failure of URM walls observed in the February 2011 earthquake.

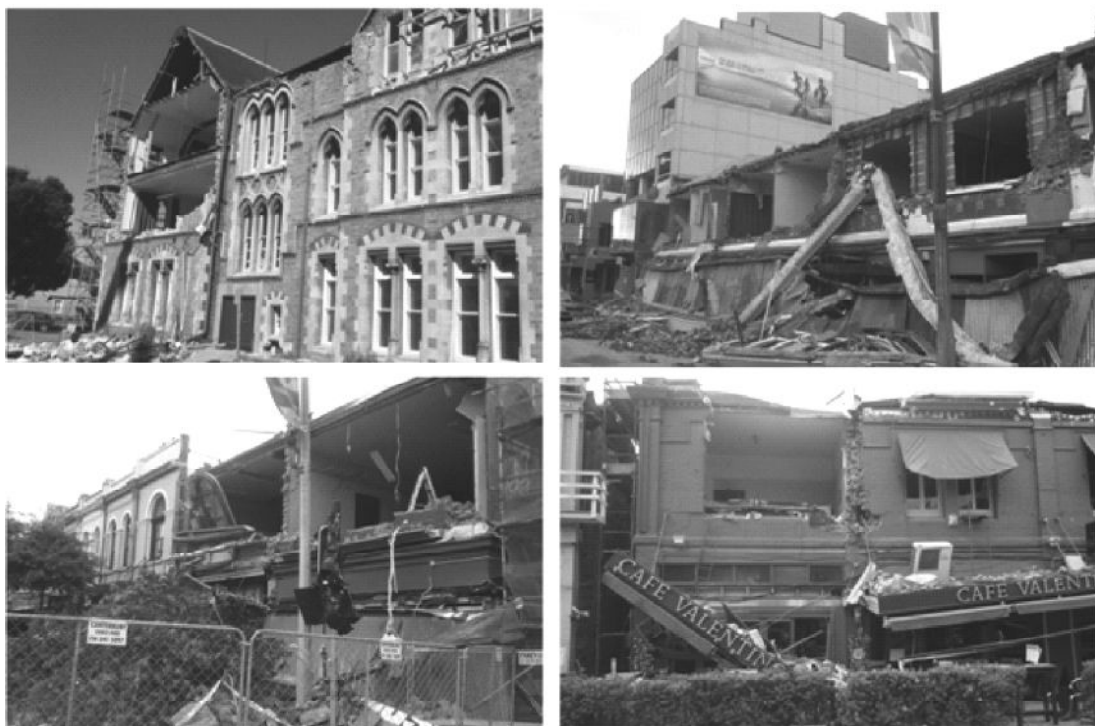
Figure 16. Failure of gable walls and parapets observed in the February 2011 earthquake.

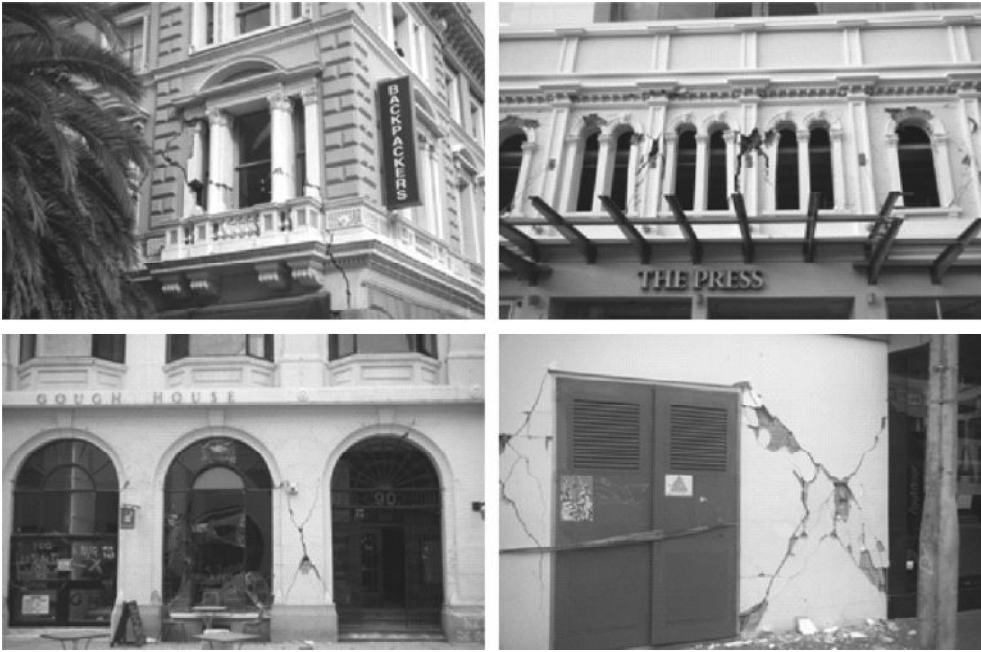
damage to in-plane masonry walls/columns/piers arches, see Figure (17); anchorage failure, see Figure (18); and cavity wall failure due to inadequate interleaf tie, see Figure (19). In most buildings, more than one form of the aforementioned damages occurred.

Figure 17. In-plane damage to walls/piers/columns/arches observed in the February 2011 earthquake.

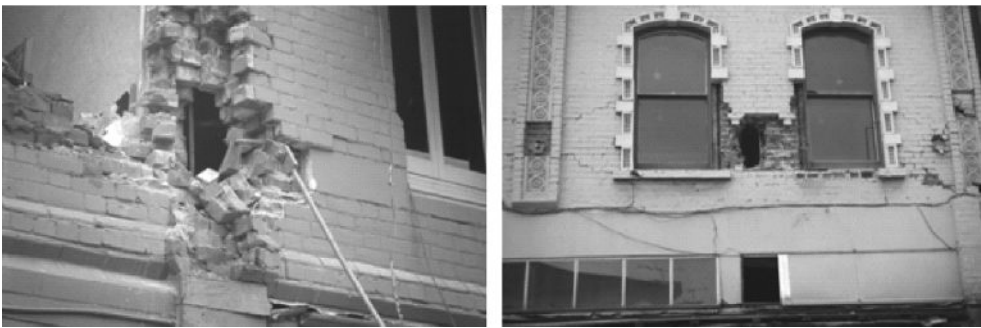
Figure 18. Punching failure of masonry walls due to inadequate anchorage (February 2011 earthquake).

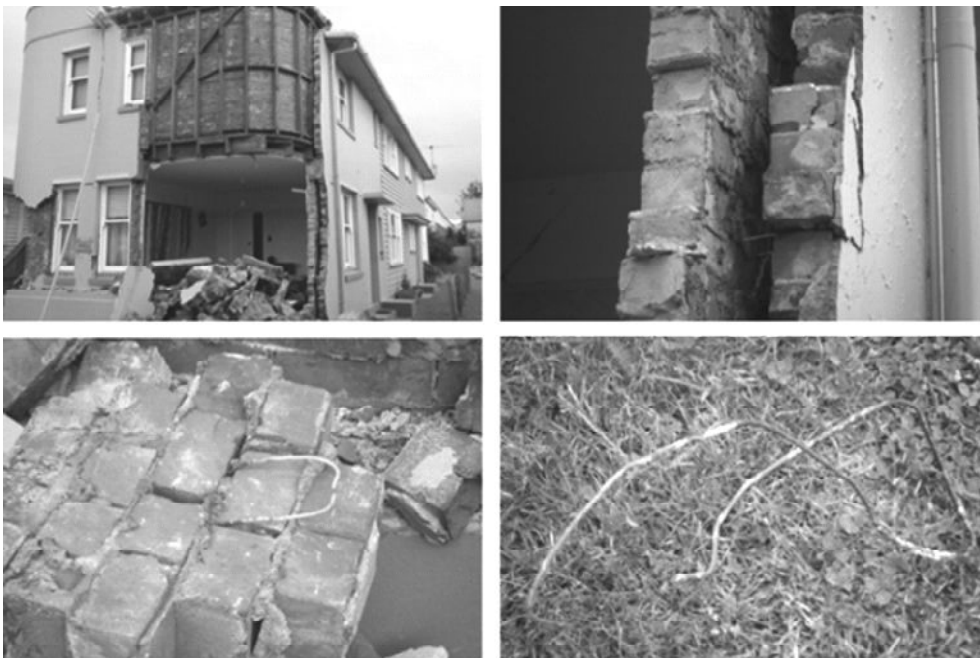
Figure 19. Failure of cavity walls due to inadequate ties (February 2011 earthquake).

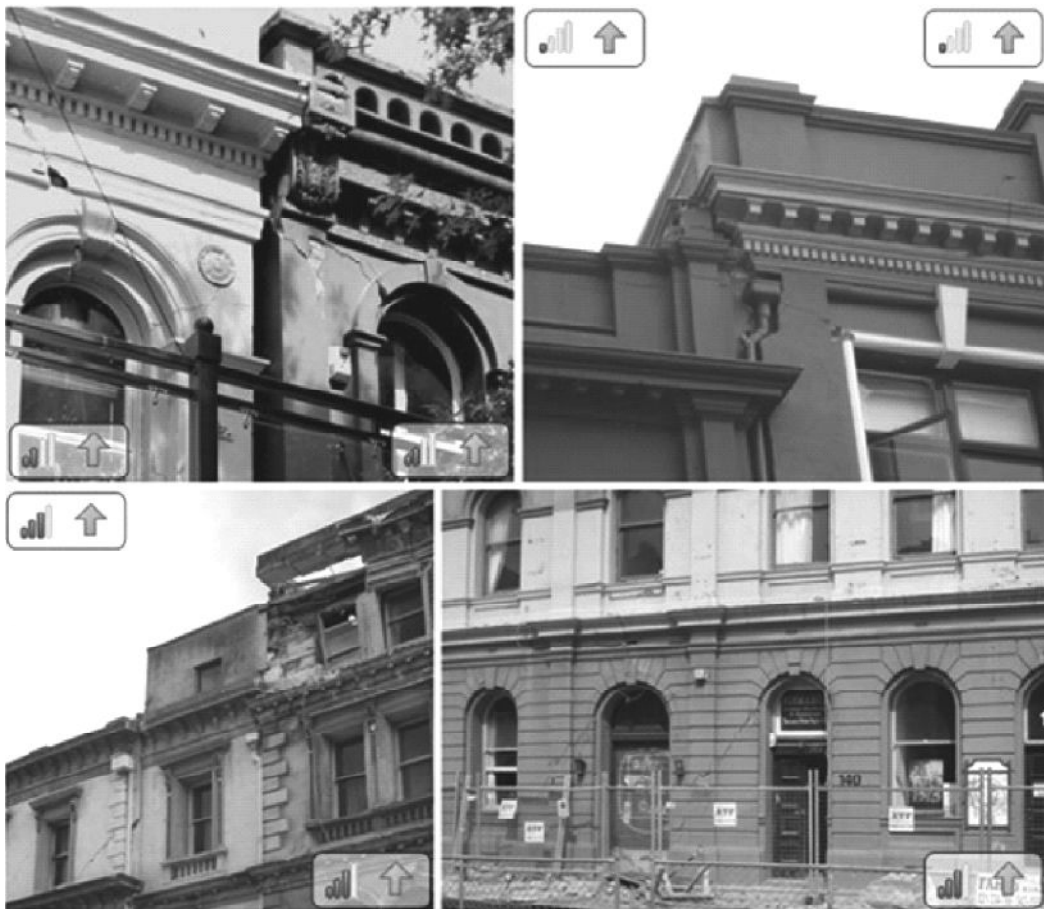
A form of building damage that was significantly more pronounced in the February earthquake compared to the September earthquake was building pounding damages [11]. During a rapid pounding survey conducted within the *CBD* after the earthquake, about 120 buildings were identified to have suffered damages of different extent due to pounding with the adjacent building. This is more than a quarter of the total buildings surveyed; pounding damage of this extent is unheard of in previous earthquakes. Some typical building pounding damages are shown in Figure (20).

Figure 20. Building pounding damage observed in the February 2011 earthquake (Photos: Greg Cole).

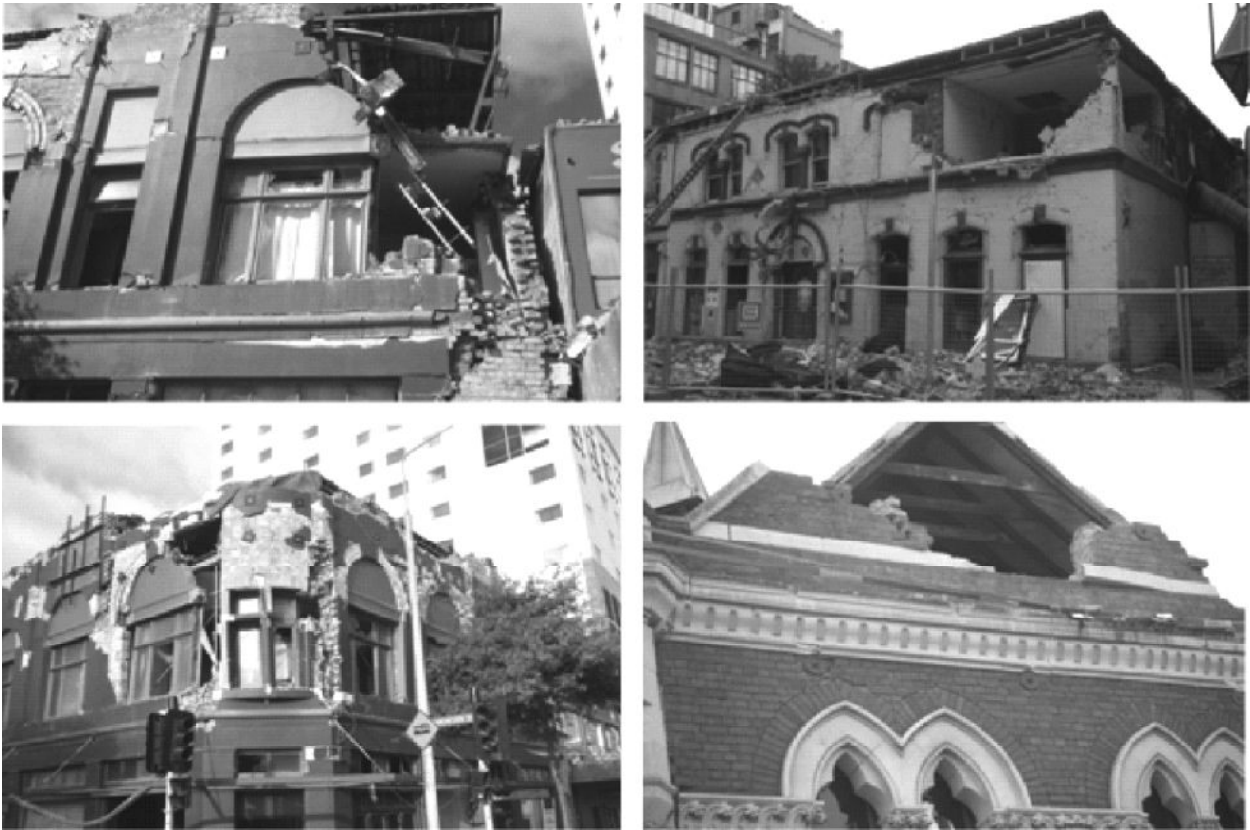
On the other hand, several buildings which had walls (in one or both directions) anchored to the floor suffered damage of different extent. One of the lessons taught by this earthquake is that we should not be fooling ourselves that so-called retrofit solutions, which tie into one or two bricks, will work. There were several *URM* buildings in Christchurch which had used some anchors to tie the wall with the floor. However, looking at the size, number and spacing of the anchors a question on its effectiveness would immediately come to the mind. Some inadequately anchored walls, which expectedly suffered damage, are shown in Figure (21). In some buildings, the anchors were of very thin size, in

Figure 21. Performance of inadequately anchored masonry walls in the February 2011 earthquake.

some others a number of anchors were concentrated in a small region and other parts of the wall were left unanchored; in some buildings the anchors were too far apart; in some the anchors were provided only at one level, and a number of buildings had only the side walls anchored. Obviously, in a strong shaking, these solutions will not be able to securely hold all portions of the perimeter masonry walls, gable walls and the parapet in place. Unsurprisingly, the walls of such buildings suffered partial or complete out-of-plane collapse.

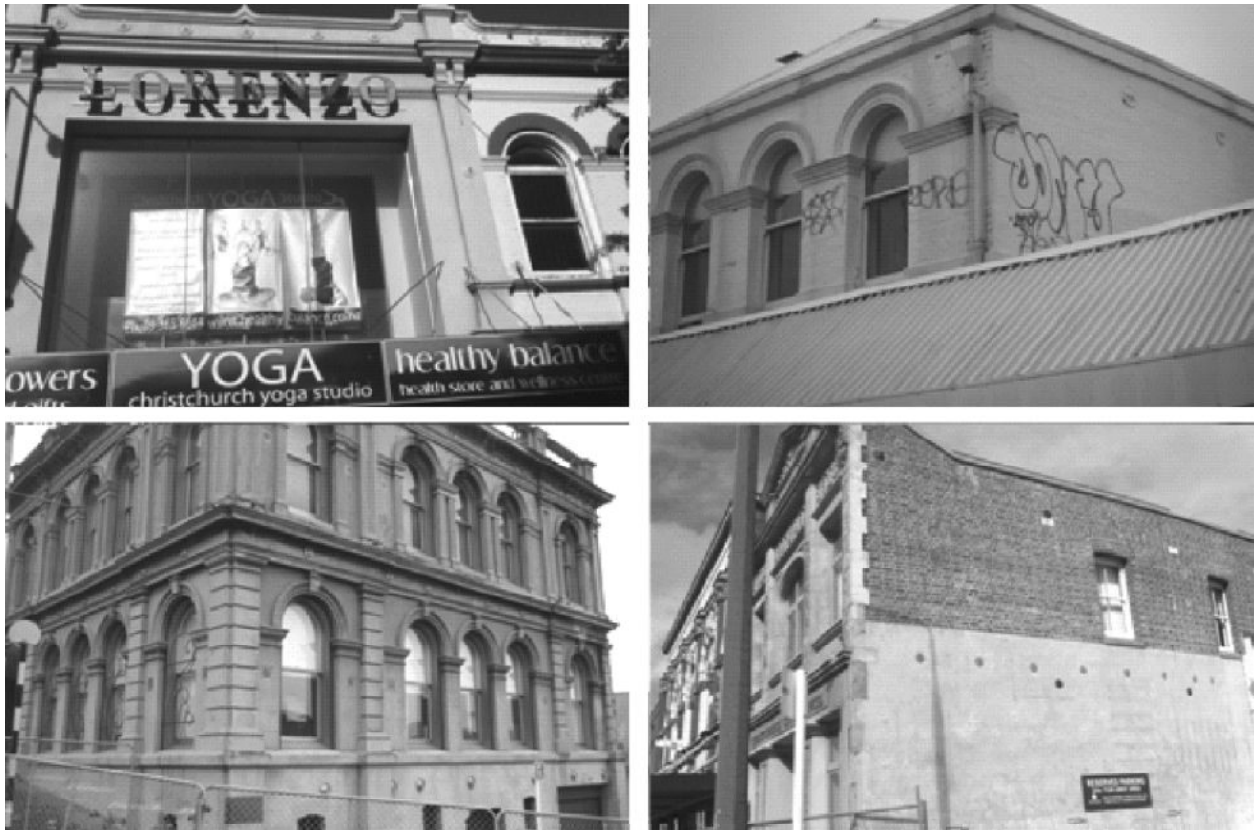
In many *URM* buildings in which the perimeter walls had an extensive grid of two-dimensional anchors, the performance was very good. Some such buildings are shown in Figure (22). In a very few buildings, the visible damage was almost non-existent despite the external walls not showing a very efficient anchorage system. The author suspects that these buildings may have some other form of retrofitting in addition to the sporadic wall anchors visible from outside.

Figure 22. Good performance of some URM buildings with anchored perimeter walls in the February 2011 earthquake.

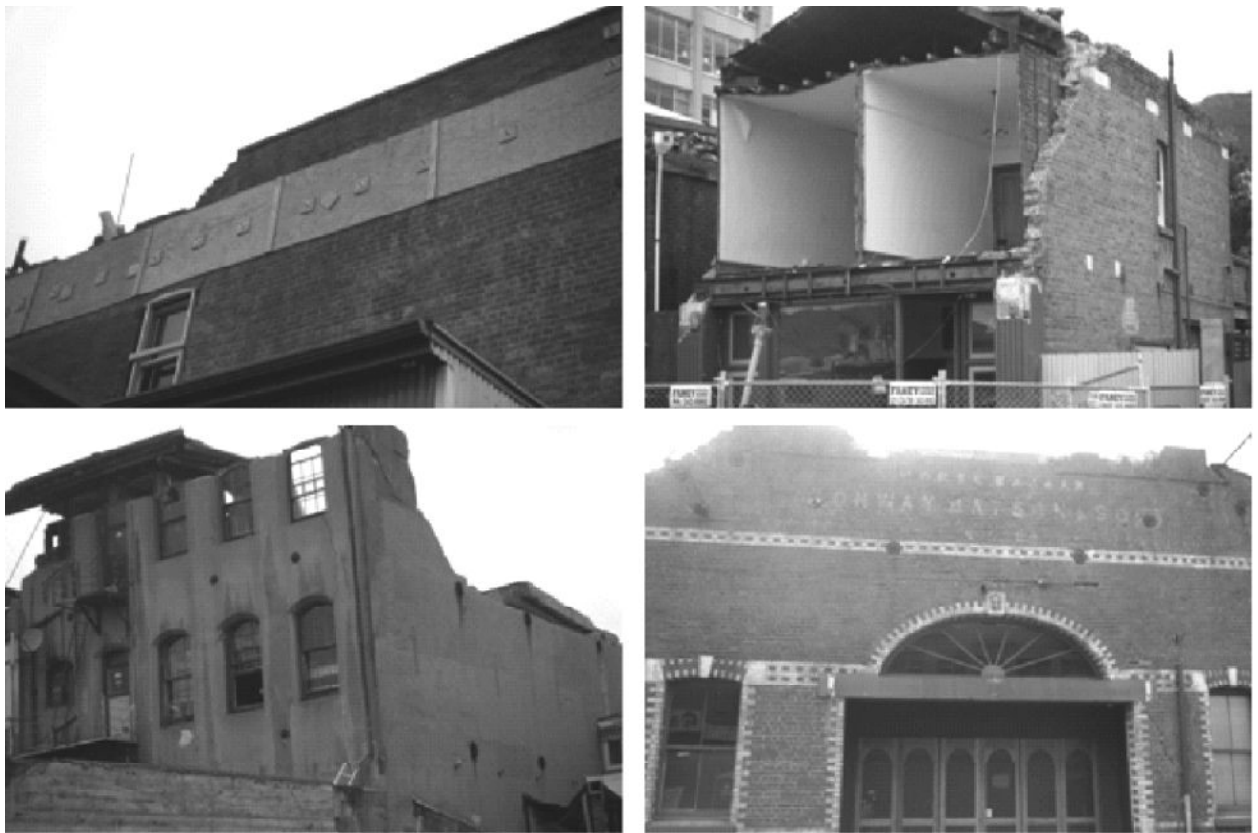
Several *URM* buildings, despite having a reasonable anchorage system, suffered significant damage. Some such cases are shown in Figure (23). In

some buildings, although the anchors seemed to be of good size and well distributed throughout the length and height of the building, parts of the perimeter walls still suffered out of plane failure. In some cases, the part of gable wall above the line of highest anchor bolts collapsed; probably, this could have been avoided by providing one or more anchors close to the apex. In some buildings, the anchors were sufficiently provided in the side walls but very few and sporadic in the front wall; which resulted in the out-of-plane failure of the front wall. As the anchor bolts are aesthetically less appealing, in deciding the retrofit system it is normally the tendency to use as few anchors/plates as possible in the front wall. The February earthquake exposed the inherent deficiency of such retrofit solutions used in several *URM* buildings in *NZ*.

Figure 23. Damage to systematically anchored masonry walls in the February 2011 earthquake.
