# Bam (SE Iran) earthquake of 26 December 2003, Mw6.5: A Preliminary Reconnaissance Report

(First Edition: prepared on 29/12/2003)

Dr Sassan Eshghi<sup>1</sup> and Dr Mehdi Zaré<sup>2</sup> International Institute of Earthquake Engineering and Seismology, Tehran, P.O.Box: 19395/3913, IRAN e-mails: 1)s.eshghi@iiees.ac.ir, 2)mzare@iiees.ac.ir

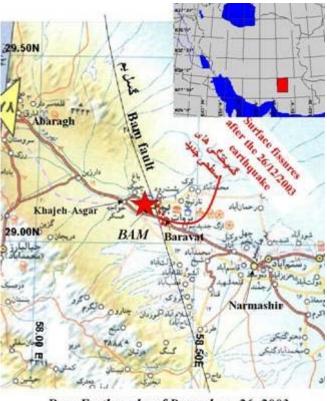
Figure-1: The location map of the epicenter and the reactivated Bam fault. The surface fissures created after Bam earthquake of 26/12/2003 are shown with dashed lines.

The Bam earthquake of December 26, 2003 (Mw6.5) occurred at 01:56:56 (GMT, 05:26:26 local time) around the city of Bam in the southeast of Iran (Figure-1). The earthquake happened at 5:26 am local time when most of the inhabitants were sleeping, which could be one of the causes of the great life loss at the time of the preparation of this report (29/12/2003). The number of victims was officially declared to be more than 25000 .Also more than 50000 people are declared to be injured and about 100000 people remaine homeless.

The Bam fault with a near north-south direction passes from the vicinity of the city of Bam (less that 1km distance to the east of Bam, and between the cities of Bam and Baravat (Figure-2). The surface fissures created after the Bam earthquake are observed around the Bam fault between the cities on Bam and Baravat (Figure-4). The fissures are created in the form of the sinkholes in the city of Baravat (Figure-5).

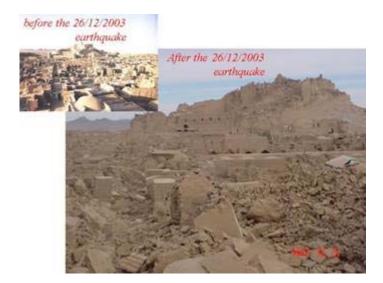
Figure-2: The historic site of Arg-e Bam in NE of the city of Bam (the image of the site Before the 26/12/2003 earthquake is inserted in the top-left of the picture).

The city of Bam is well-known by the historical citadel of Arg-e-Bam which is more than 2000 year old, and was destroyed in the 26/12/2003 Bam earthquake (Figure-2). Arg-e Bam is the largest mud-brick complex in the world. This historical monument is located on an igneous hill, on the verge of the Silk Road It has an area of some 240,000 square meters. The monument was

constructed mainly from mud-brick and clay. The total area of this castle is about  $6 \text{ km}^2$ . There is no information about the exact date of the construction but according to Persian history it goes back to more than 2000 years ago and has been repaired many times, and was residential till 150 years ago.

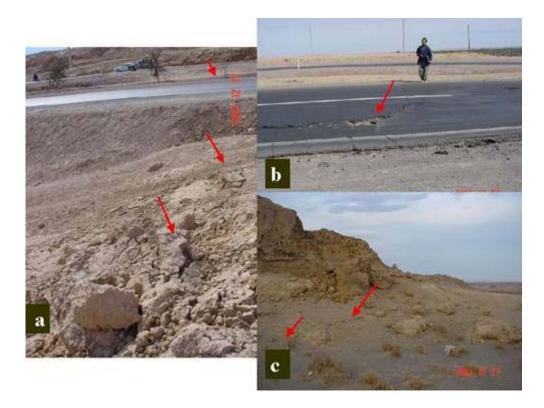
Figure-4: The surface fissures along the Bam fault (near Baravat) in the prone area of the 26/12/2003 earthquake). a) The fissures nearby Baravat, b) the fissure that ruptured the road from Bam to Baravat, and c) the fissures in the foot of the fault scarp of the Bam fault.

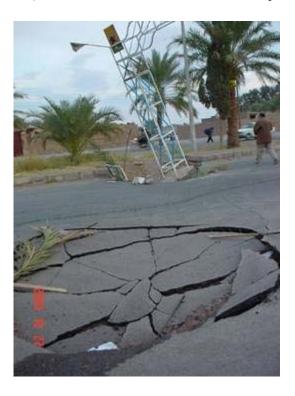
Figure-5: The sinkholes created during the 26/12/2006 earthquake in Baravat.
