Turkiye Syria 6 February 2023 Earthquakes;

Reconnaissance Visit Report and Seismological Aspects

Mehdi Zaré

12 June 2023

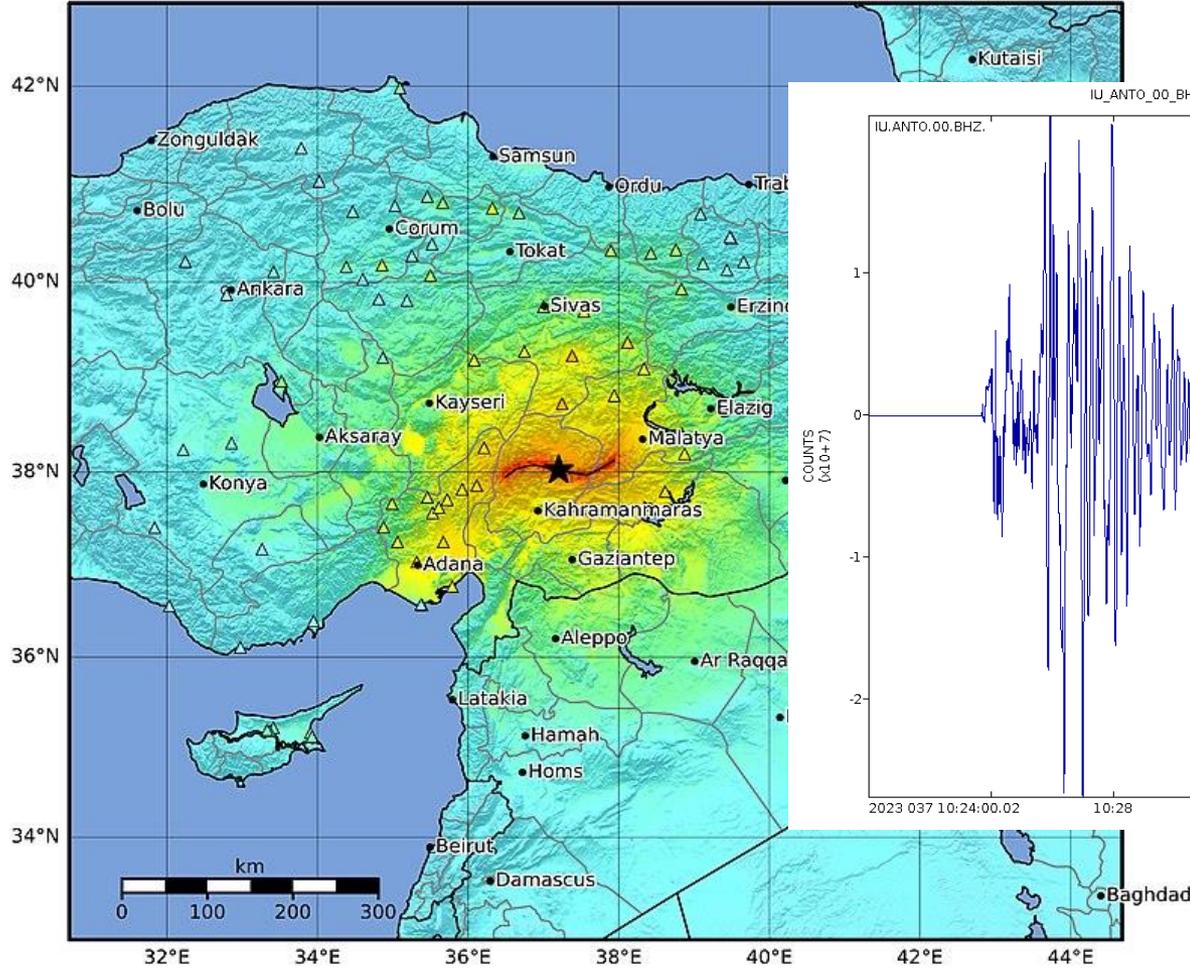
Macroseismic Intensity Map USGS
 ShakeMap: 4 km SSE of Ekinözü, Kahramanmaraş, TR
 Feb 06, 2023 10:24:49 UTC M7.5 N38.02 E37.20 Depth: 10.0km ID:us6000jlqa

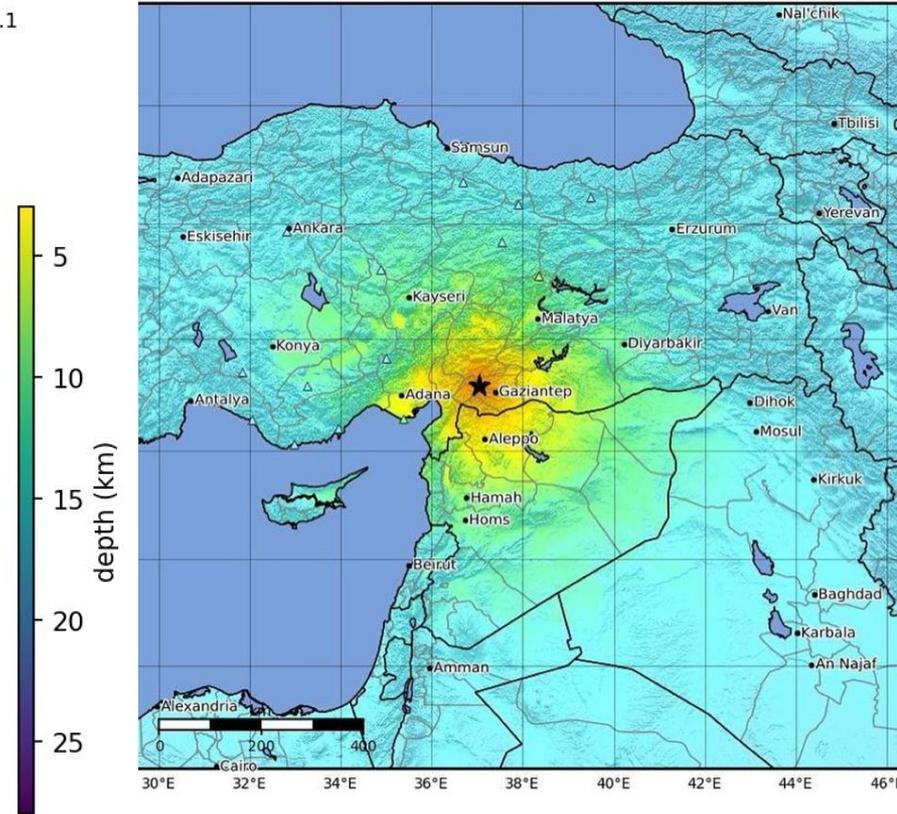
Macroseismic Intensity Map USGS
ShakeMap: 26 km E of Nurdagi, Gaziantep, TR
Feb 06, 2023 01:17:35 UTC M7.8 N37.17 E37.03 Depth: 17.9km ID:us6000jllz

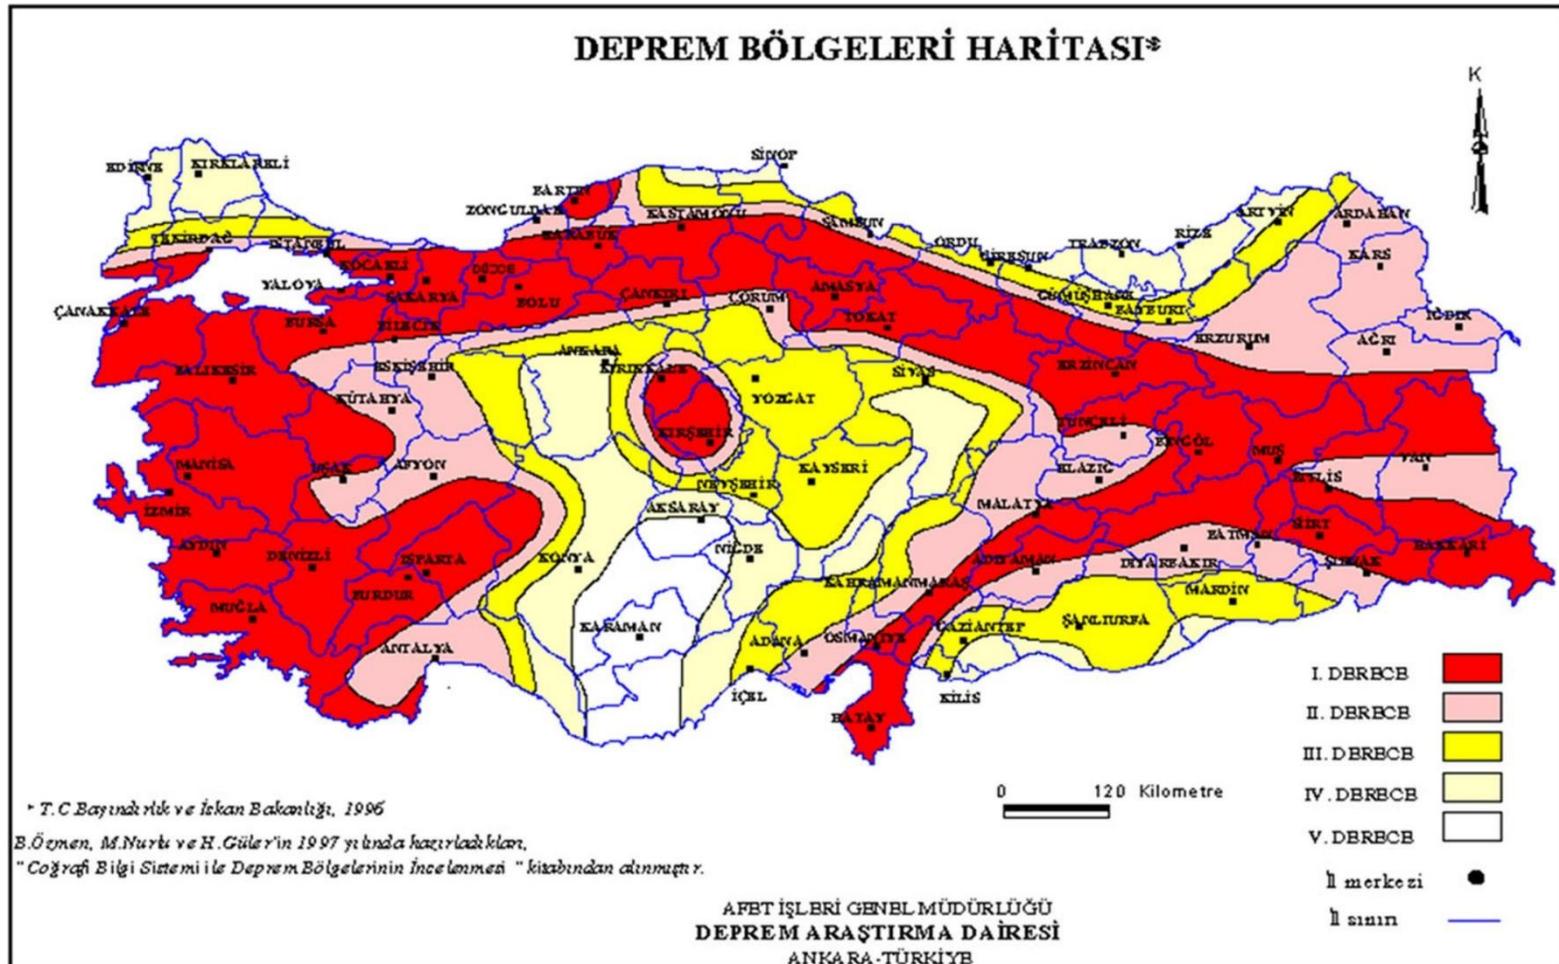
THE 1996 EARTHQUAKE ZONATION MAP OF TURKEY

The 1996 earthquake zonation map of Turkey (<http://www.deprem.gov.tr/tr/kategori/deprem-bolgeleriharitasi-28841>). **Zone 1** represents the **highest seismic hazard** whereas pink, yellow and light yellow colors represent Zones 2, 3 and 4 respectively that display the decreasing trend in seismic hazard. The white color is the no seismic hazard zone. Source: Akkar et al. (2018).

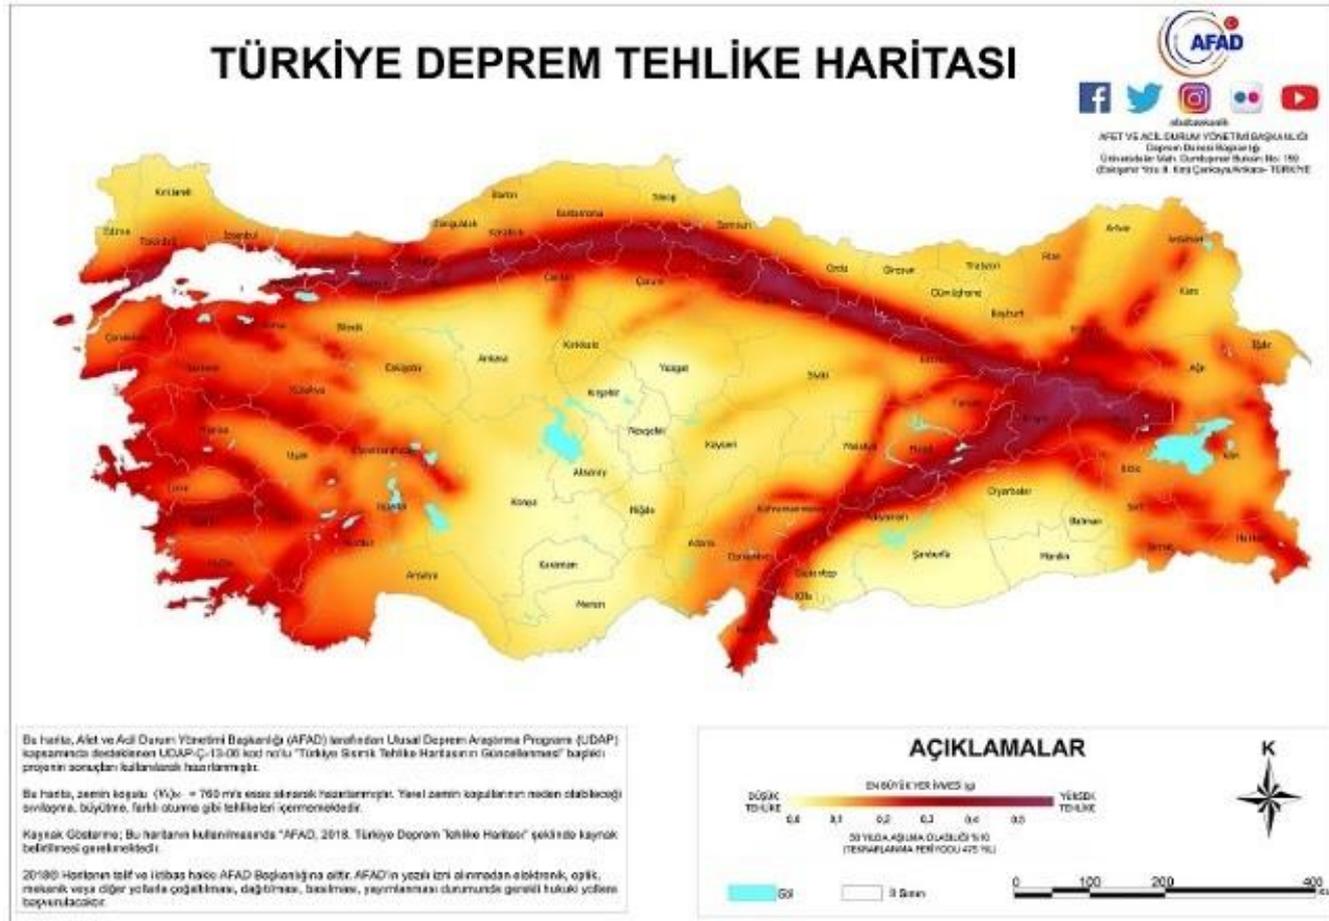
THE 2019 EARTHQUAKE HAZARD MAP OF TURKEY

The new Earthquake Hazard Map of Turkey has been prepared with much more detailed data considering the latest earthquake source parameters, earthquake catalogs and new mathematical models. It came into force on January 1, 2019. Unlike the previous earthquake zonation map, in the new map, instead of the earthquake zones, the highest ground acceleration values were shown and the concept of "earthquake zone" was eliminated.

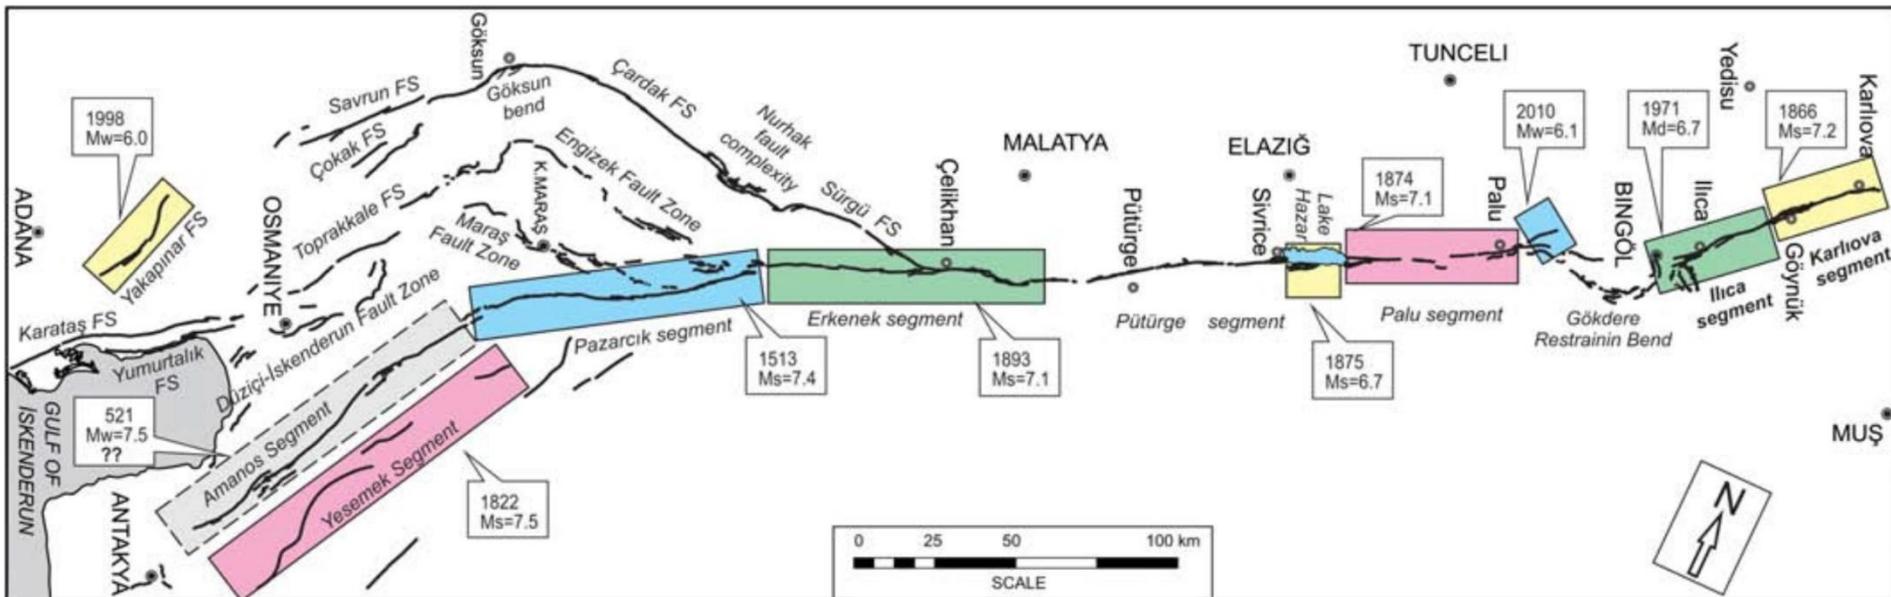
Surface ruptures produced by large earthquakes during the 19th and 20th centuries along the East Anatolia Fault System. Ruptured fault segments are highlighted (Duman and Emre, 2013). The 2023 earthquake was generated by the rupture of the southern part of the main strand of the East Anatolia Fault System comprising the Erkenek, Pazarçık and Amanos fault segments.

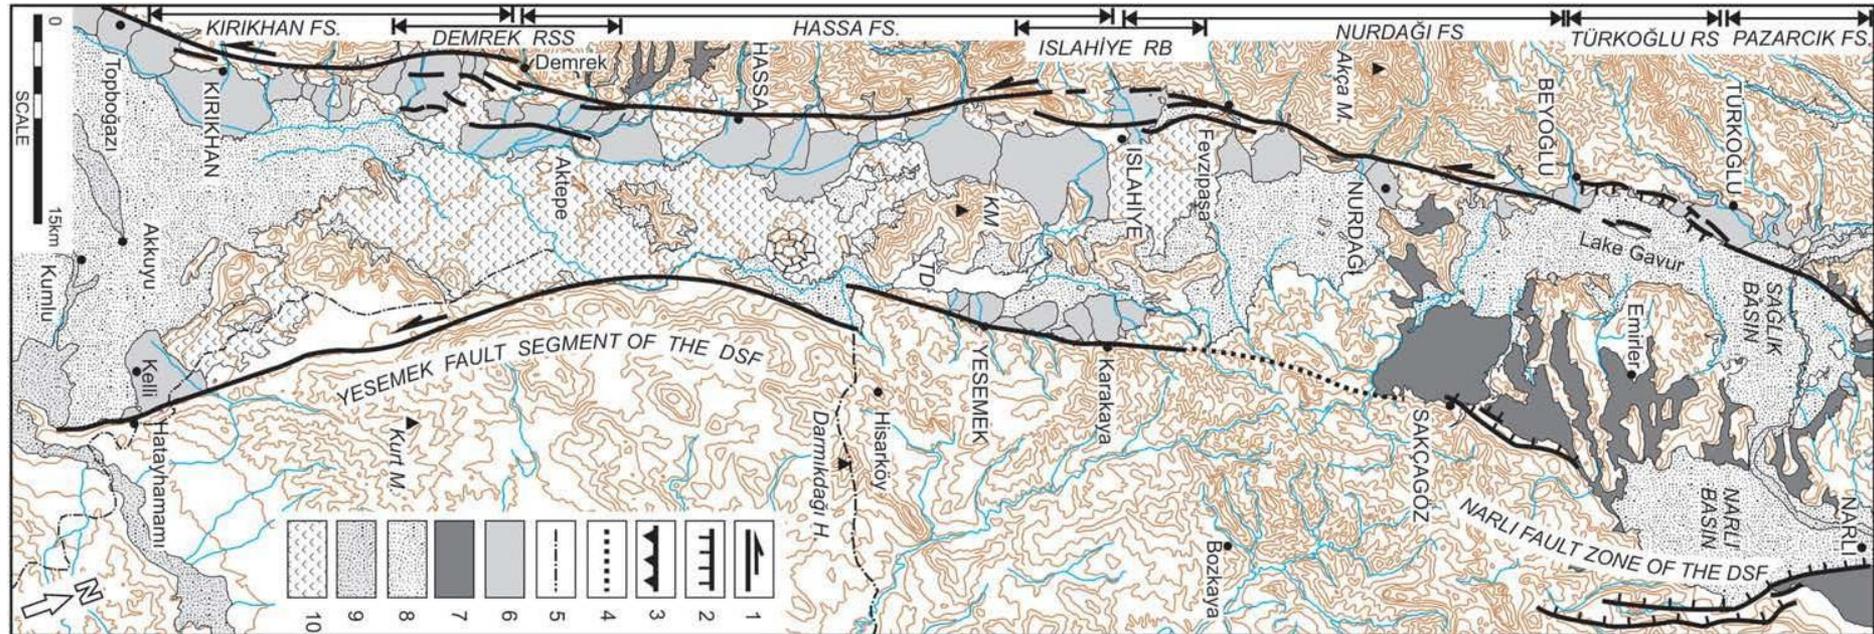
Map of the Amanos fault segments of the East Anatolian fault system. **1:** left-lateral strike-slip fault; **2:** normal fault; **3:** reverse or thrust fault; **4:** inferred fault; **5:** national boundary; **6:** undifferentiated Holocene deposits; **7:** undifferentiated Quaternary deposits; **8:** Holocene lake and floodplain deposits; **9:** Holocene riverbed deposits, **10:** undifferentiated Quaternary volcanics. Source: [Duman and Emre \(2013\)](#)

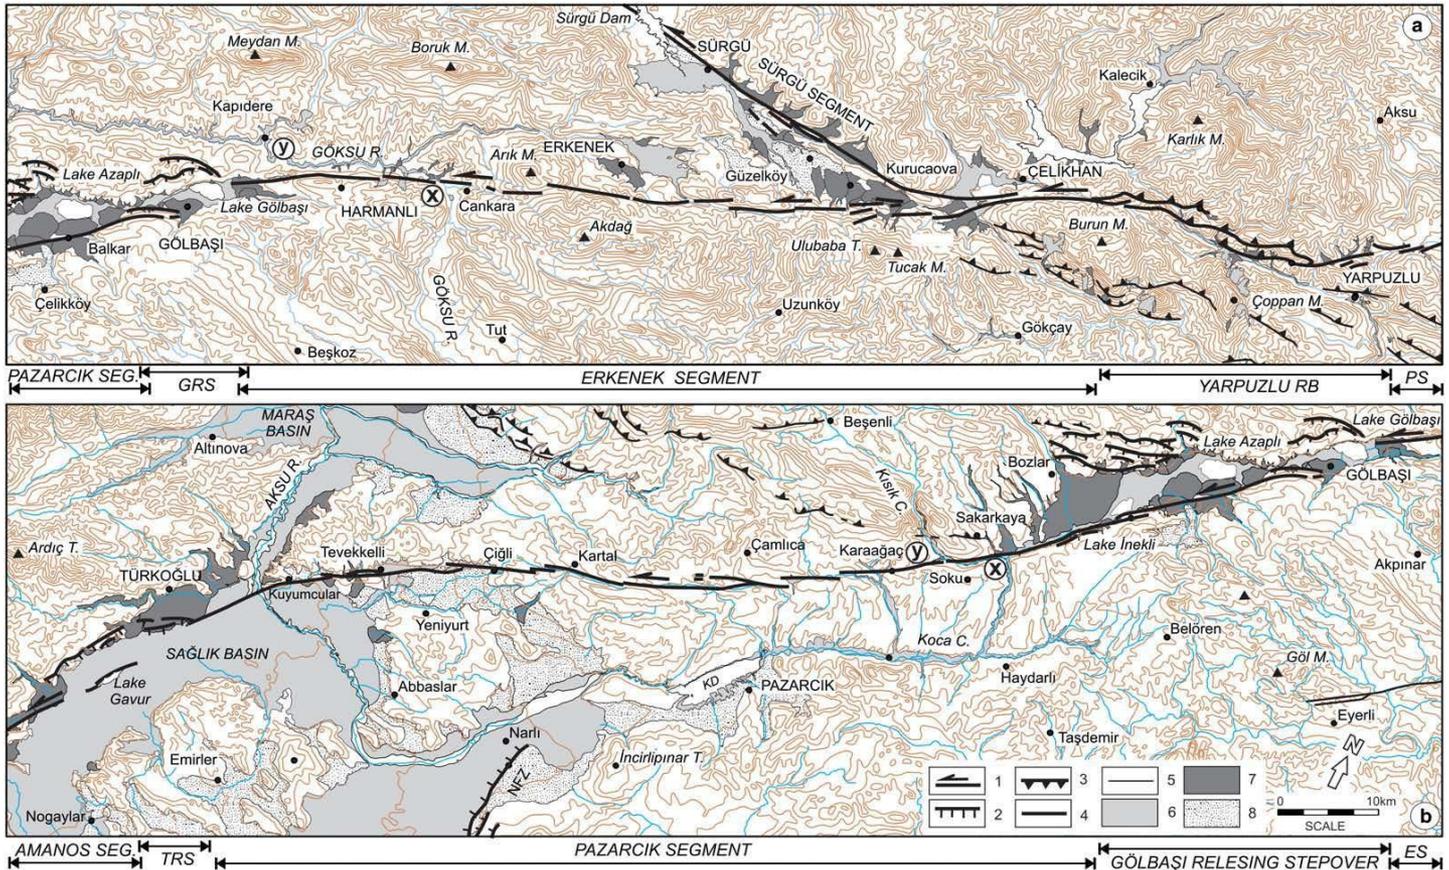
Map of the Erkenek and Pazarcik fault segments of the East Anatolia fault system. **1:** left lateral strike-slip fault; **2:** normal fault; **3:** reverse or thrust fault; **4:** East Anatolian Fault; **5:** Southeastern Anatolian Thrust Zone; **6:** undifferentiated Holocene deposits; **7:** undifferentiated Quaternary deposits; **8:** landslide Source: Duman and Emre (2013)

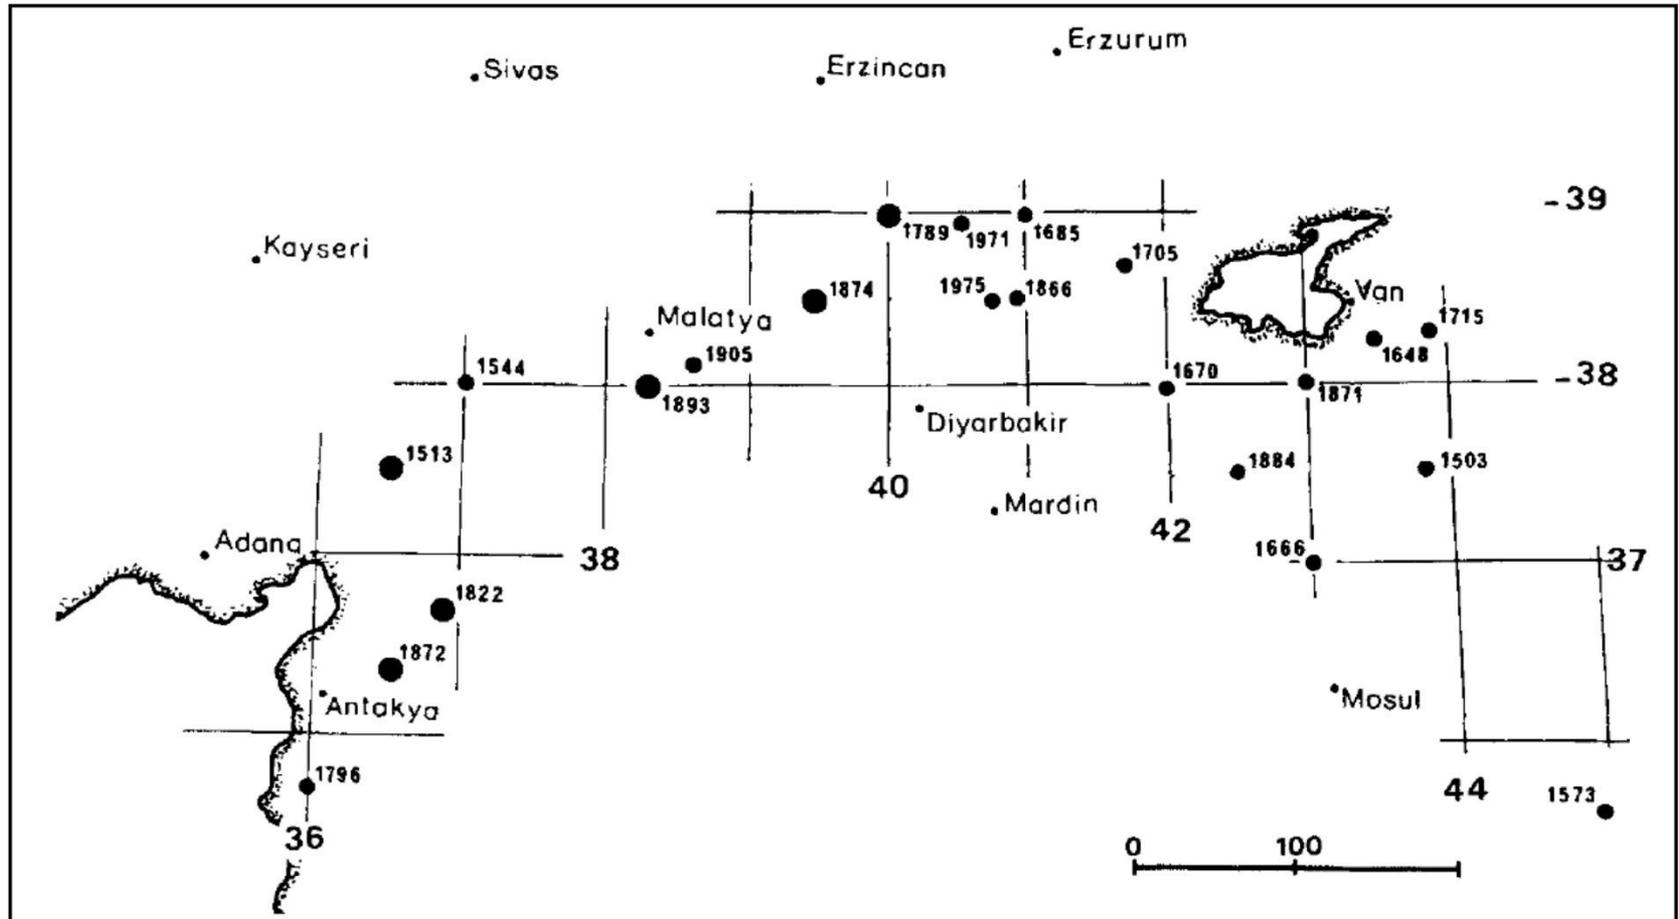
Distribution of earthquakes in the East Anatolian fault zone from 1500 to 1988, marked with year of occurrence. Size of dots corresponds to magnitudes 6.0 and 7.0 respectively. Source: [Ambraseys \(1989\)](#)

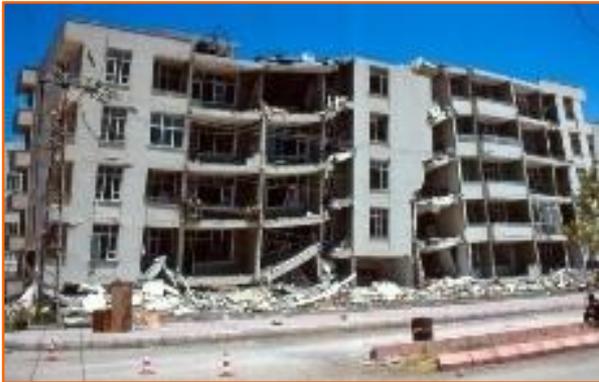
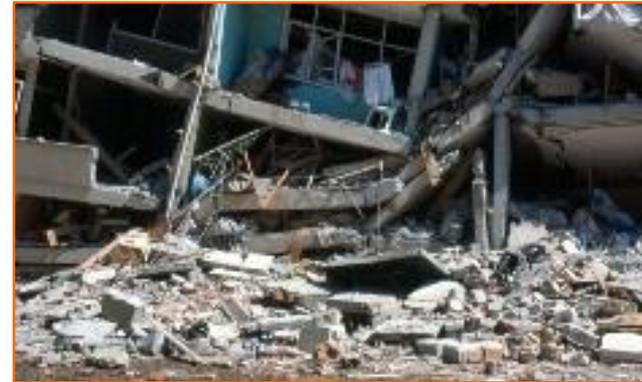
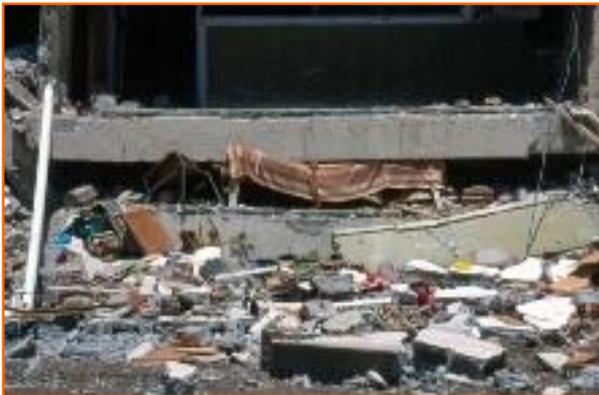
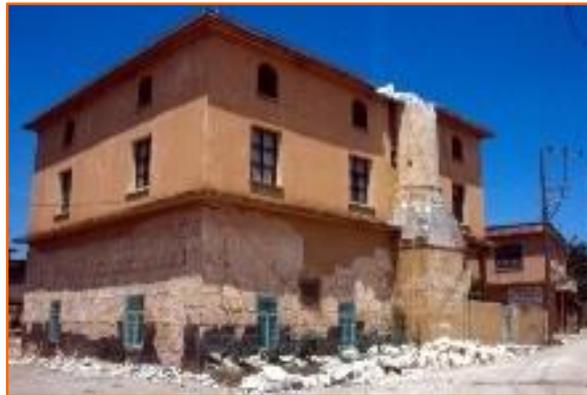
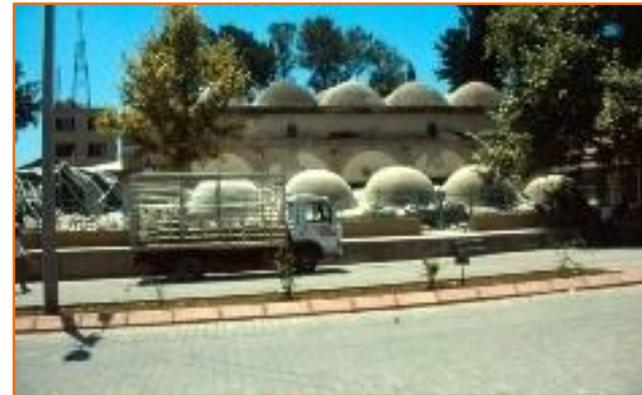
STRONGEST EARTHQUAKES IN THE EAST ANATOLIAN FAULT SYSTEM SINCE 1998
THE 27 JUNE 1998 Mw=6.3 ADANA EARTHQUAKE

Characteristic views of the impact of the earthquake on residential reinforced-concrete buildings, buildings with load-bearing masonry walls and monumental structures in the area affected by the 1998 Adana earthquake. Source: personal archive of Professor Dr. Eftymis Lekkas, available online: <https://www.elekkas.gr/index.php/en/epistimoniko-ergo/scientificmissions/1621-adana-ceyhan-1998>.

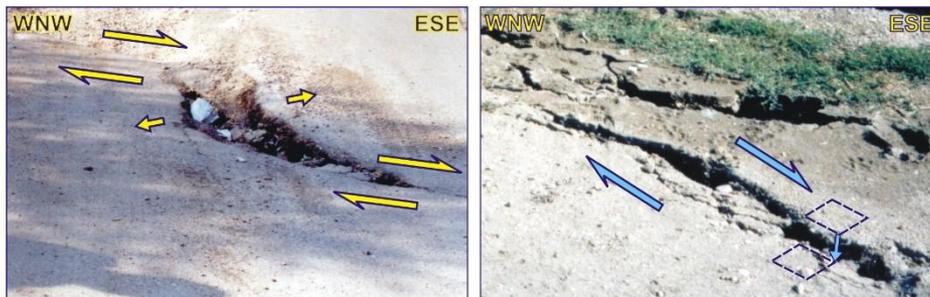
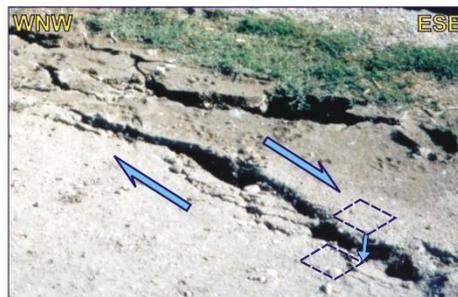
THE 1 MAY 2003 Mw=6.4 BINGÖL EARTHQUAKE

(B) Simplified seismotectonic regime of the area affected by the 1 May 2003 Bingöl earthquake.

(C) Kinematic interpretation of the NW-SE surface ruptures mapped in the field of the area affected by the 1 May 2003 Bingöl earthquake.

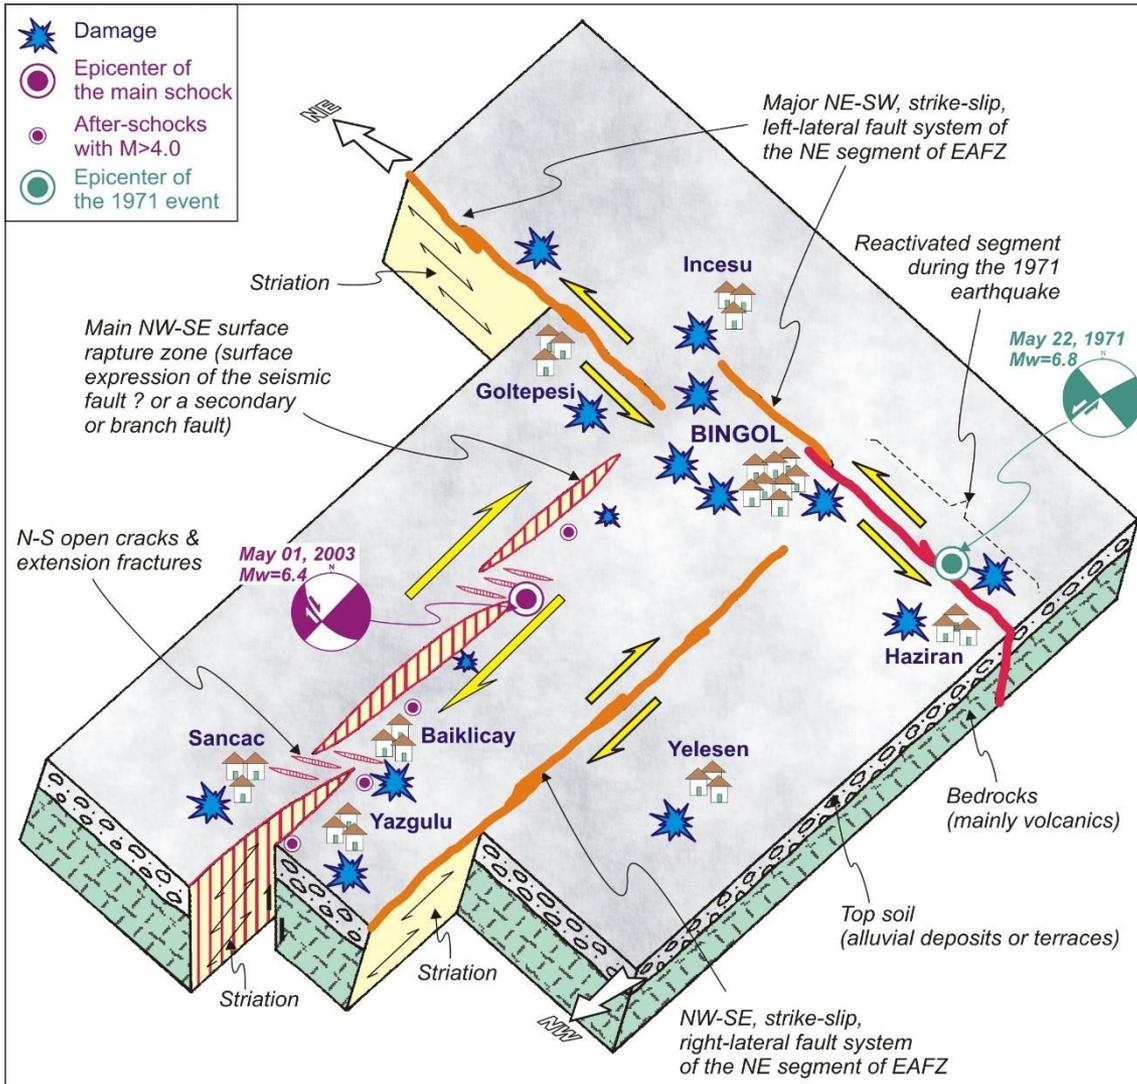
Schematic block-diagram representing the tectonic structures, environmental effects and damages occurred during the 1 May 2003, Mw=6.4 Bingöl earthquake.

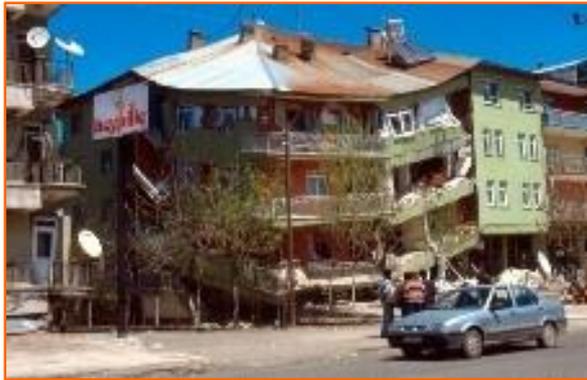
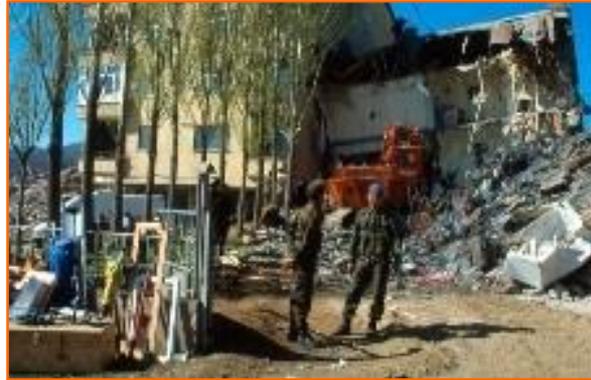
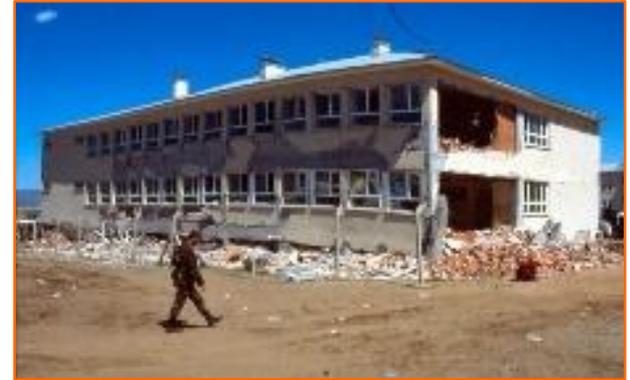
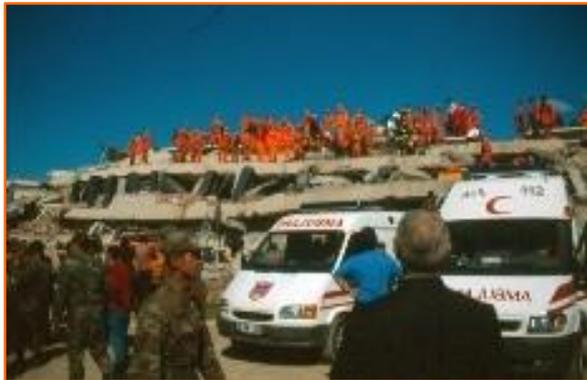
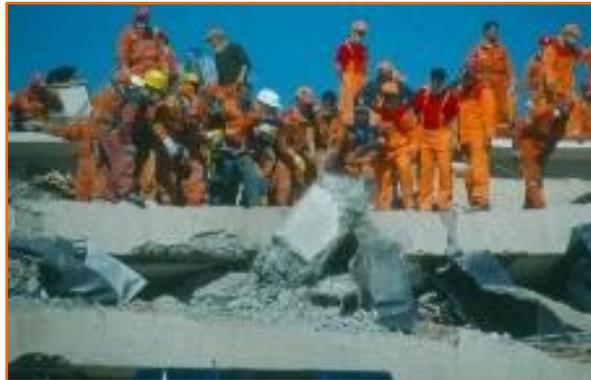
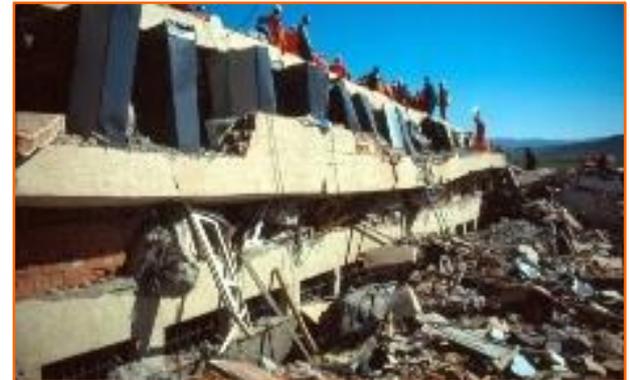
STRONGEST EARTHQUAKES IN THE EAST ANATOLIAN FAULT SYSTEM SINCE 1998
THE 1 MAY 2003 Mw=6.4 BINGÖL EARTHQUAKE

Characteristic views of the impact of the earthquake on residential reinforced-concrete buildings in the area affected by the 2003 Bingöl earthquake. Source: personal archive of Professor Dr. Efthymis Lekkas, available online: <https://www.elekkas.gr/index.php/en/epistimoniko-ergo/scientificmissions/1627-bingol-2003>.

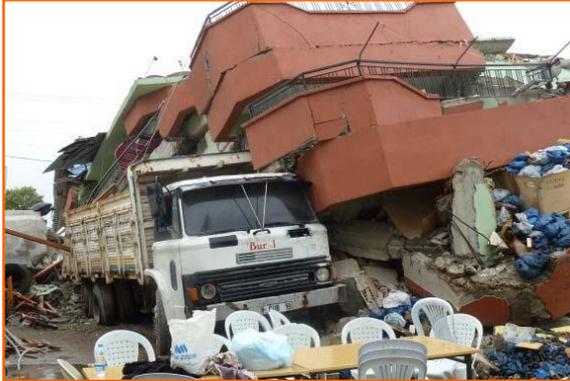
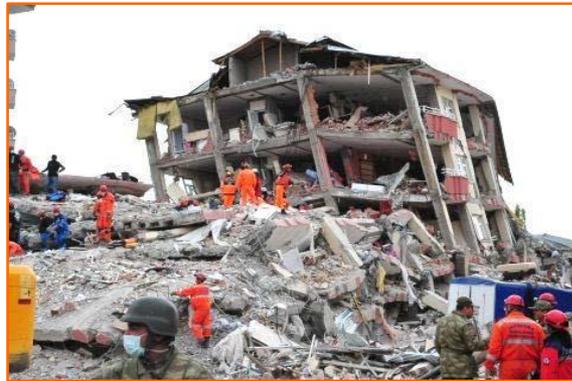
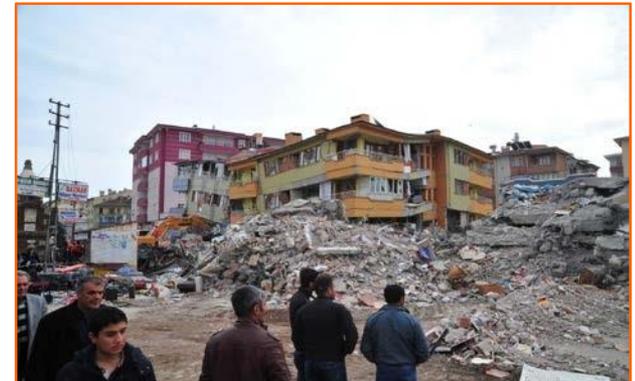
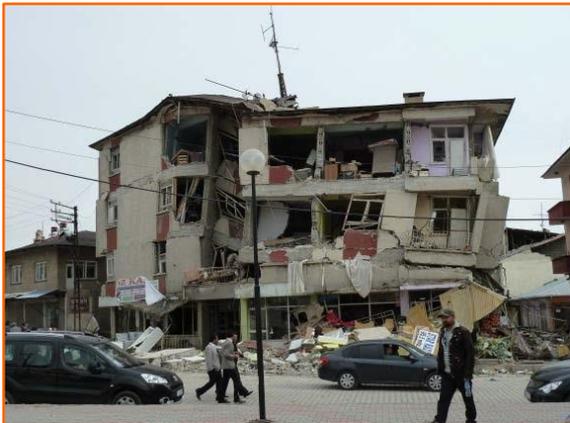
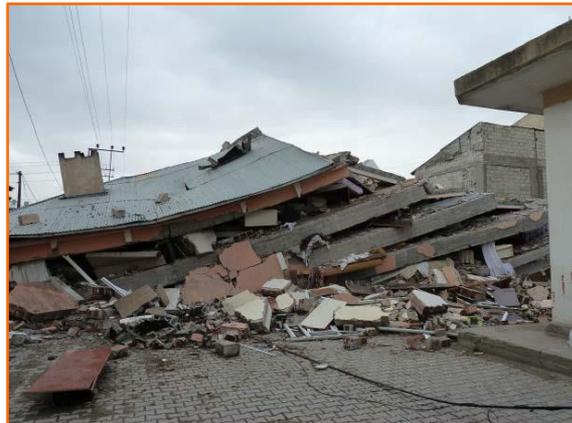
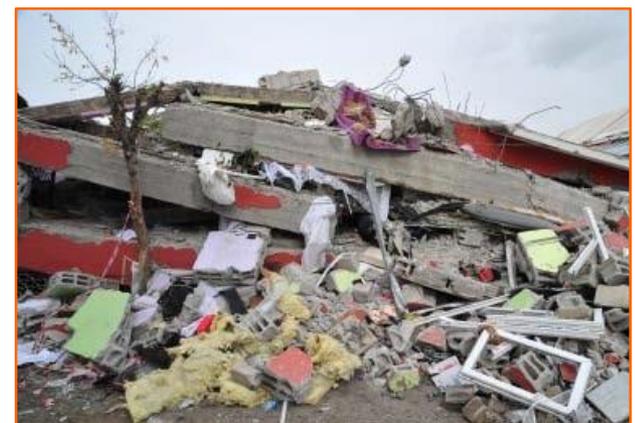
STRONGEST EARTHQUAKES IN THE EAST ANATOLIAN FAULT SYSTEM SINCE 1998 **THE 23 OCTOBER 2011 Mw=7.2 VAN EARTHQUAKE**

Characteristic views of the impact of the earthquake on residential reinforced-concrete buildings, buildings with load-bearing masonry walls and monumental structures in the area affected by the 2011 Van earthquake. Source: personal archive of Professor Dr. Efthymis Lekkas, available online: <https://www.elekkas.gr/index.php/en/epistimoniko-ergo/scientificmissions/1082-m-turkey>.

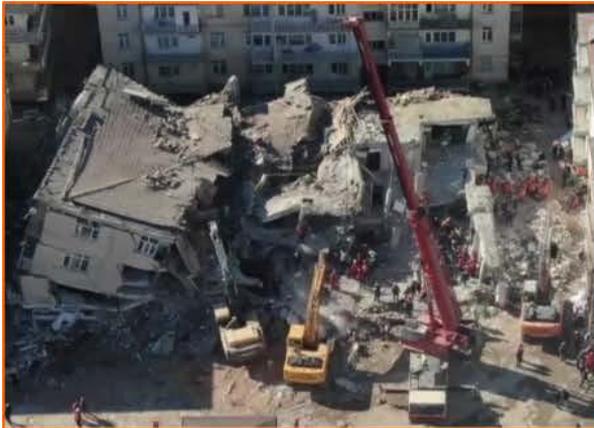
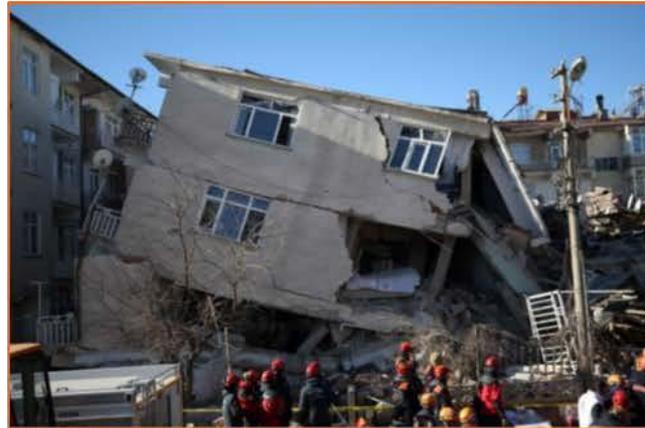
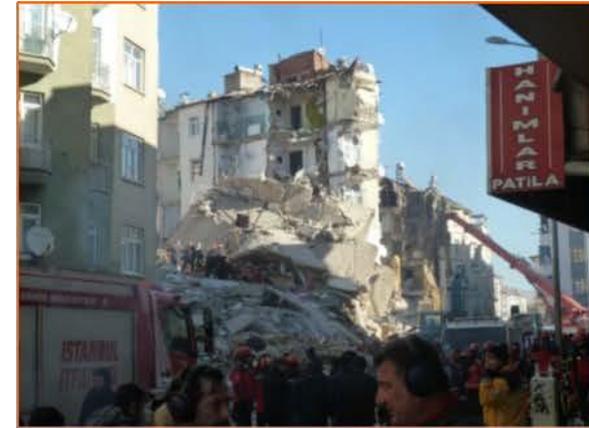
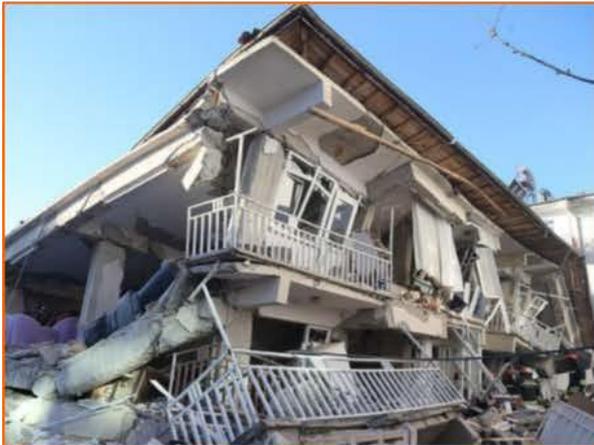
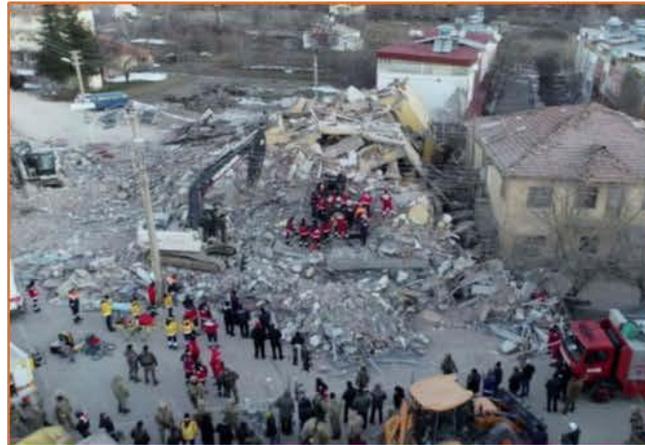
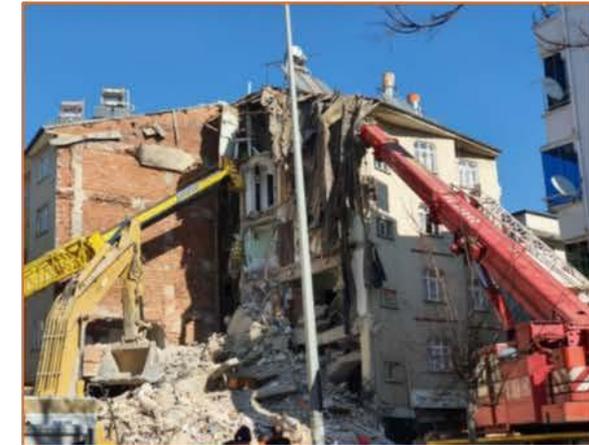
STRONGEST EARTHQUAKES IN THE EAST ANATOLIAN FAULT SYSTEM SINCE 1998 THE 24 JANUARY 2020 Mw=6.8 ELAZIĞ EARTHQUAKE

Characteristic views of the impact of the earthquake on residential reinforced-concrete buildings in Elazığ city that suffered the most by the earthquake. Source: [Lekkas, Carydis and Mavroulis \(2020\)](#), in the Newsletter of the EDCMS.

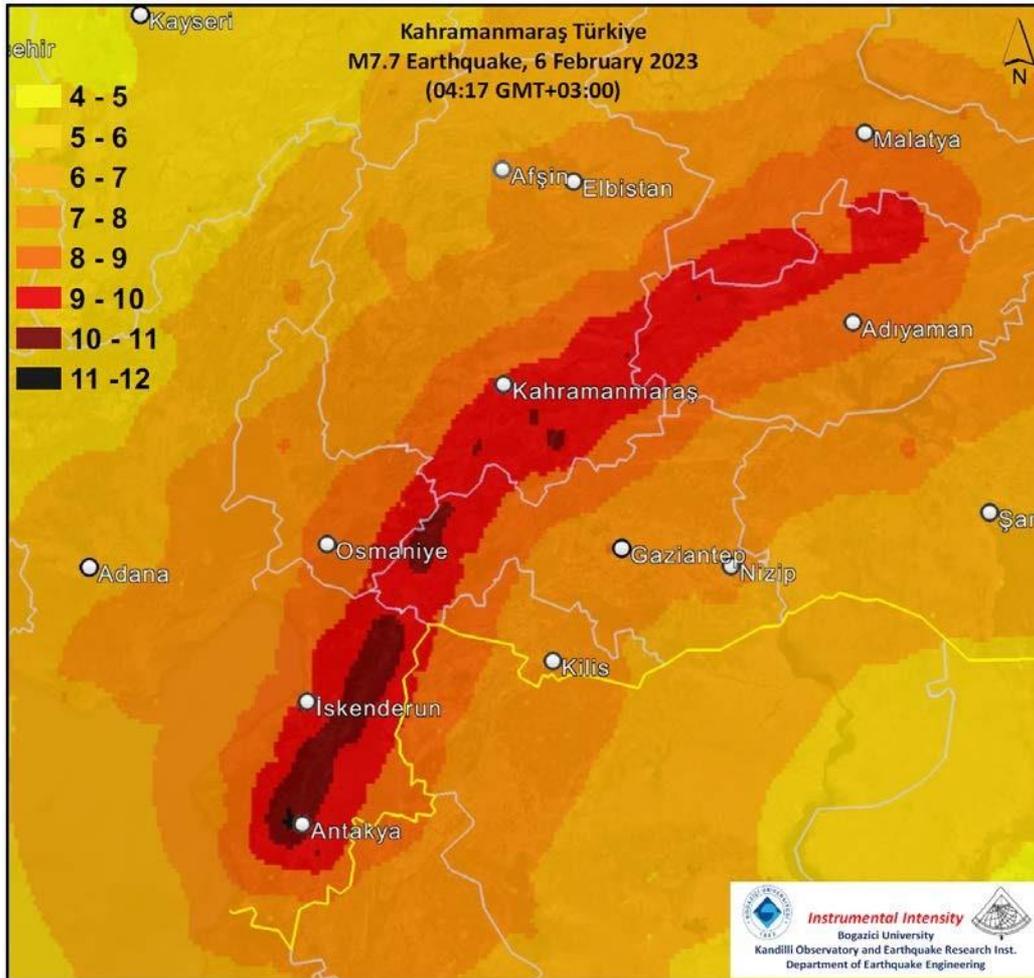
INSTRUMENTAL INTENSITY FOR THE 6 FEBRUARY 2023 Mw=7.8 EARTHQUAKE

A fault rupture of 290 km length corresponding to the Erkenek, Pazarcık and Amanos segments of the East Anatolian Fault Zone (Emre et al., 2018) and station recordings within a distance of 100 km from the fault are considered in the ground motion estimation.

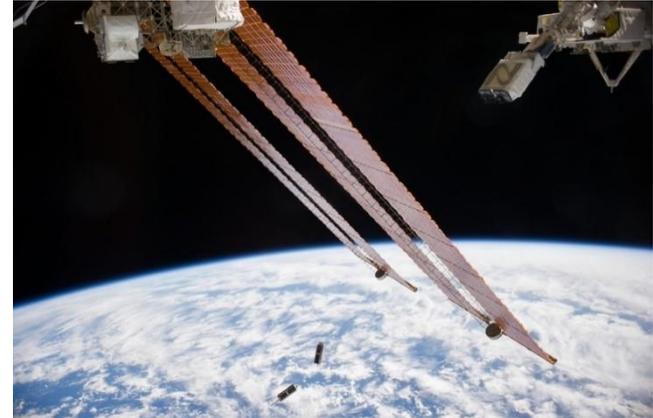
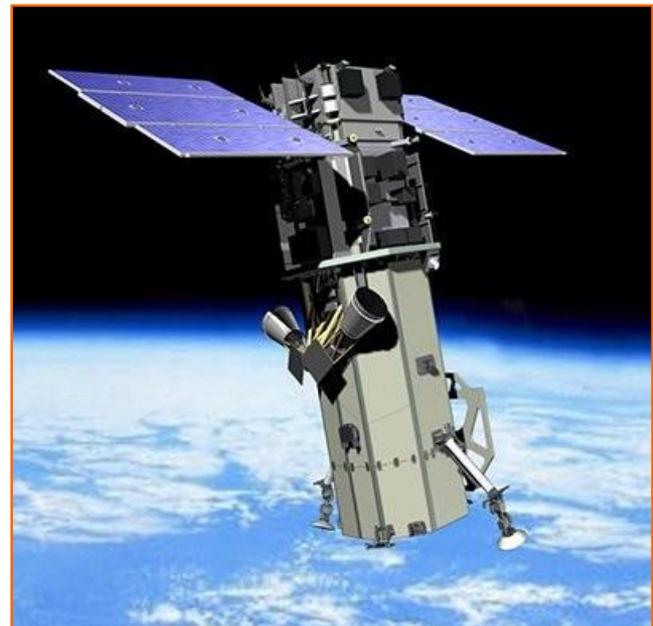
Satellite images from Planet and WorldView2 satellites with a spatial resolution of 3 m and 0.30 m respectively, before and after the earthquake were used. They revealed the formation and widening of ruptures with a dominant left-lateral component and major failures in the building stock due to synergy of aggravating factors.

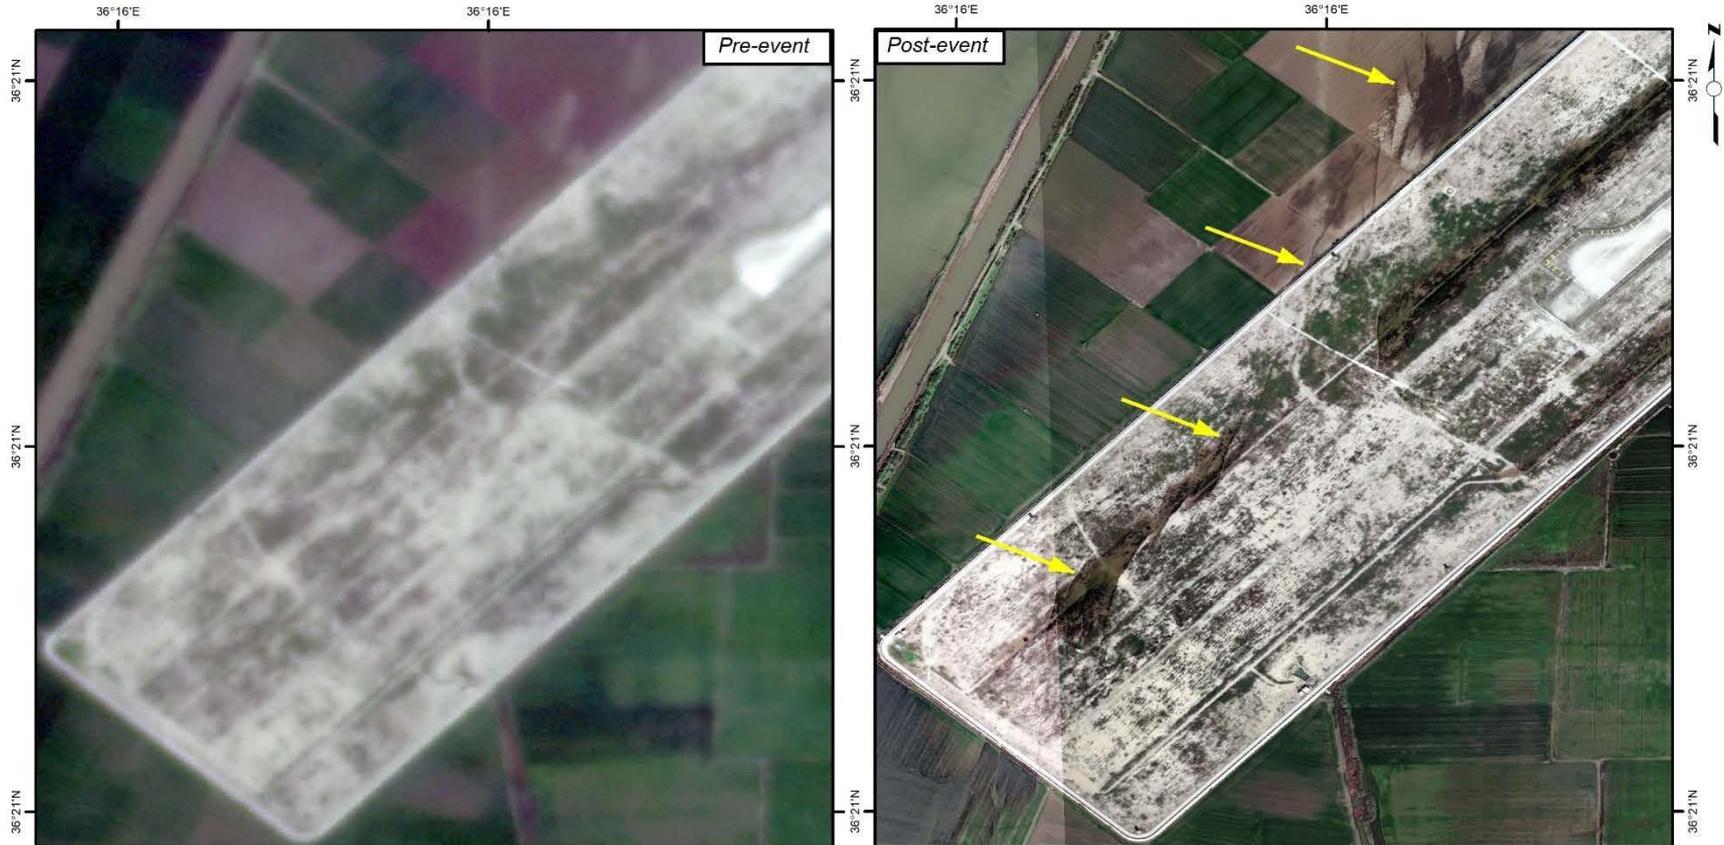
Earthquake dates: February 6, 2023
Magnitude: 7.8
Location: Hatay airport
Remote Sensing data used: Planet/WorldView2
Spatial resolution: 3/0.3 meters
Pre Data Acquisition: 02.02.2023
Post Data Acquisition: 09.02.2023
Processing: Vassilakis, Konsolaki

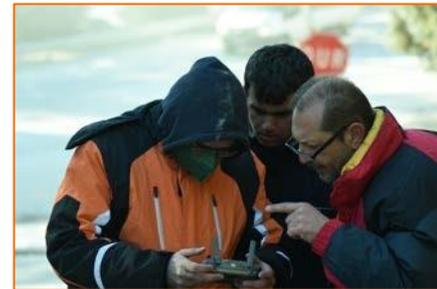
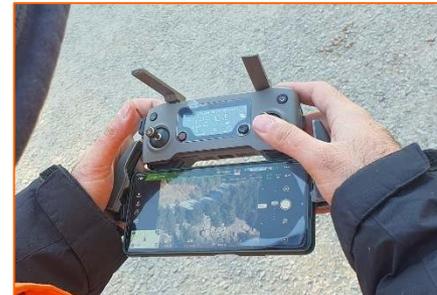
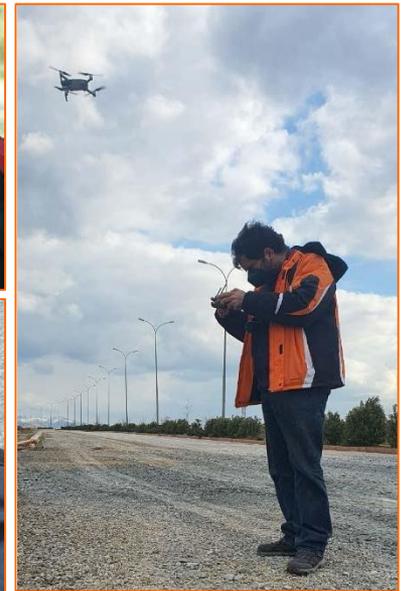
DETECTION OF SURFACE RUPTURES IN THE FIELD

These ruptures present the same orientation with the active faults of the main strand of the East

Anatolian Fault System in the area. Their properties (length, width, offset and throw) presented variations from site to site.

They caused considerable impact on several elements of the built environment of the area including buildings, segments of the road network, house and warehouse perimeter walls, irrigation canals, railways and other facilities and structures. They also caused deformation in farmlands.

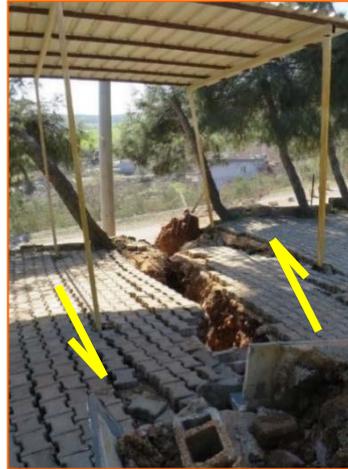
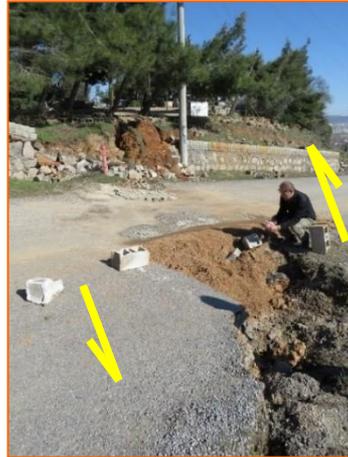
DETECTION OF SURFACE RUPTURES FROM FIELD SURVEY

Surface ruptures were observed in the Gökçedere area, located close to the mountain front of Nurdağı area. The ruptures cut the road and adjacent slopes and fields and caused damage to pavements and tombs in a cemetery. The residential buildings with which the ruptures intersected partially collapsed.
