Turkiye Syria 6 February 2023 Earthquakes;

Reconnaissance Visit Report and Seismological Aspects

Mehdi Zaré

12 June 2023

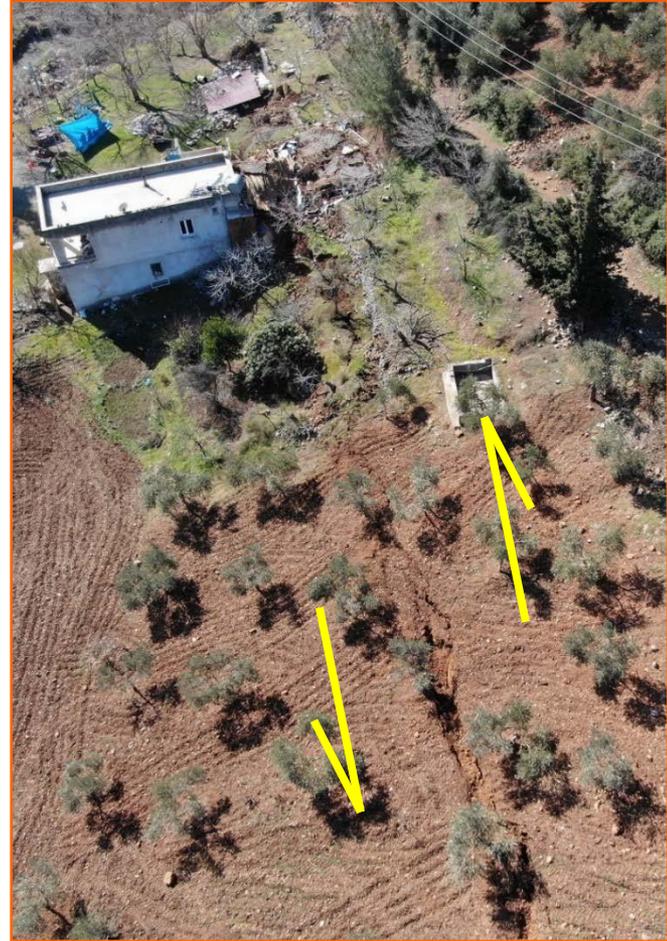
Surface ruptures were observed in the Gökçedere area, located close to the mountain front of Nurdağı area. The ruptures cut the road and adjacent slopes and fields and caused damage to pavements and tombs in a cemetery. The residential buildings with which the ruptures intersected partially collapsed.

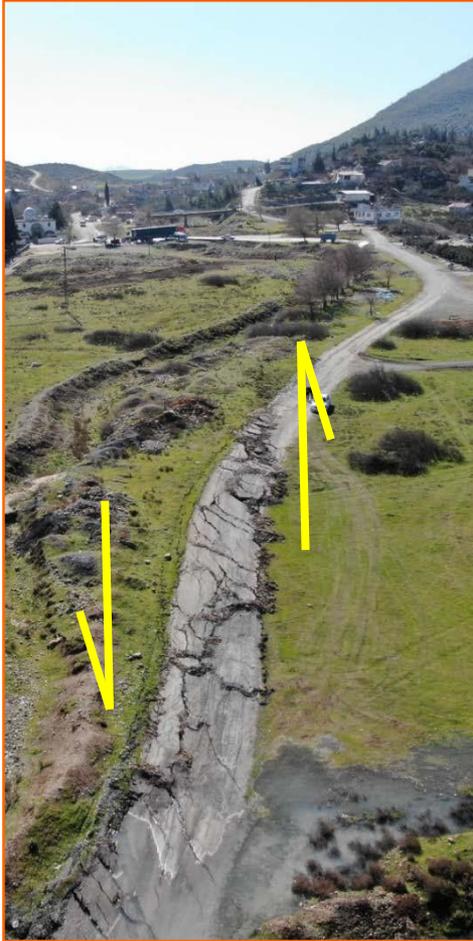
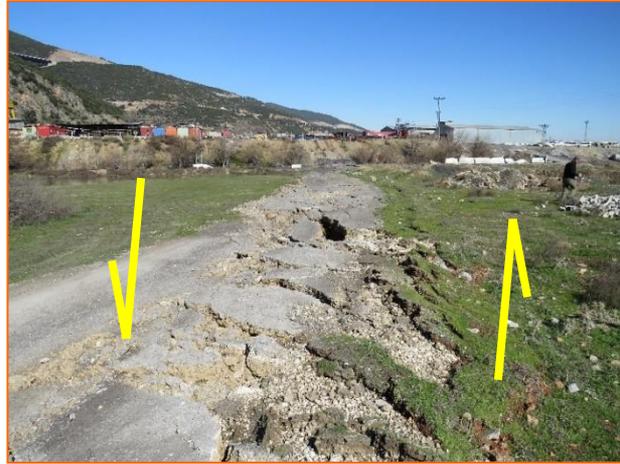
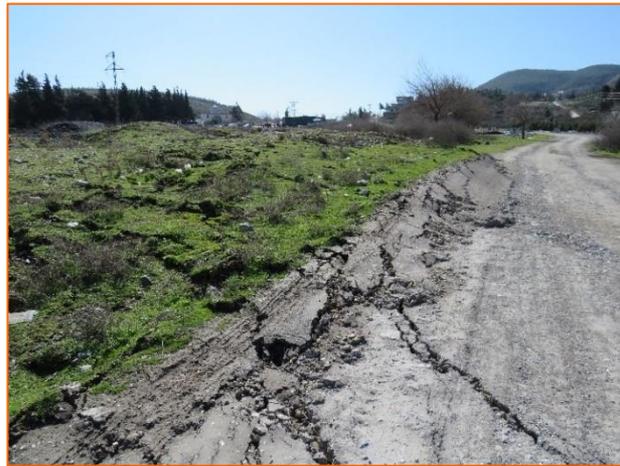
DETECTION OF SURFACE RUPTURES FROM FIELD SURVEY

In this site the surface ruptures destroyed part of the road network of the Gökçedere area. The structures formed in the field revealed strike-slip motion along the fault which coincides with the active structures of the main strand of the East Anatolian Fault System in this part of the earthquake-affected area.

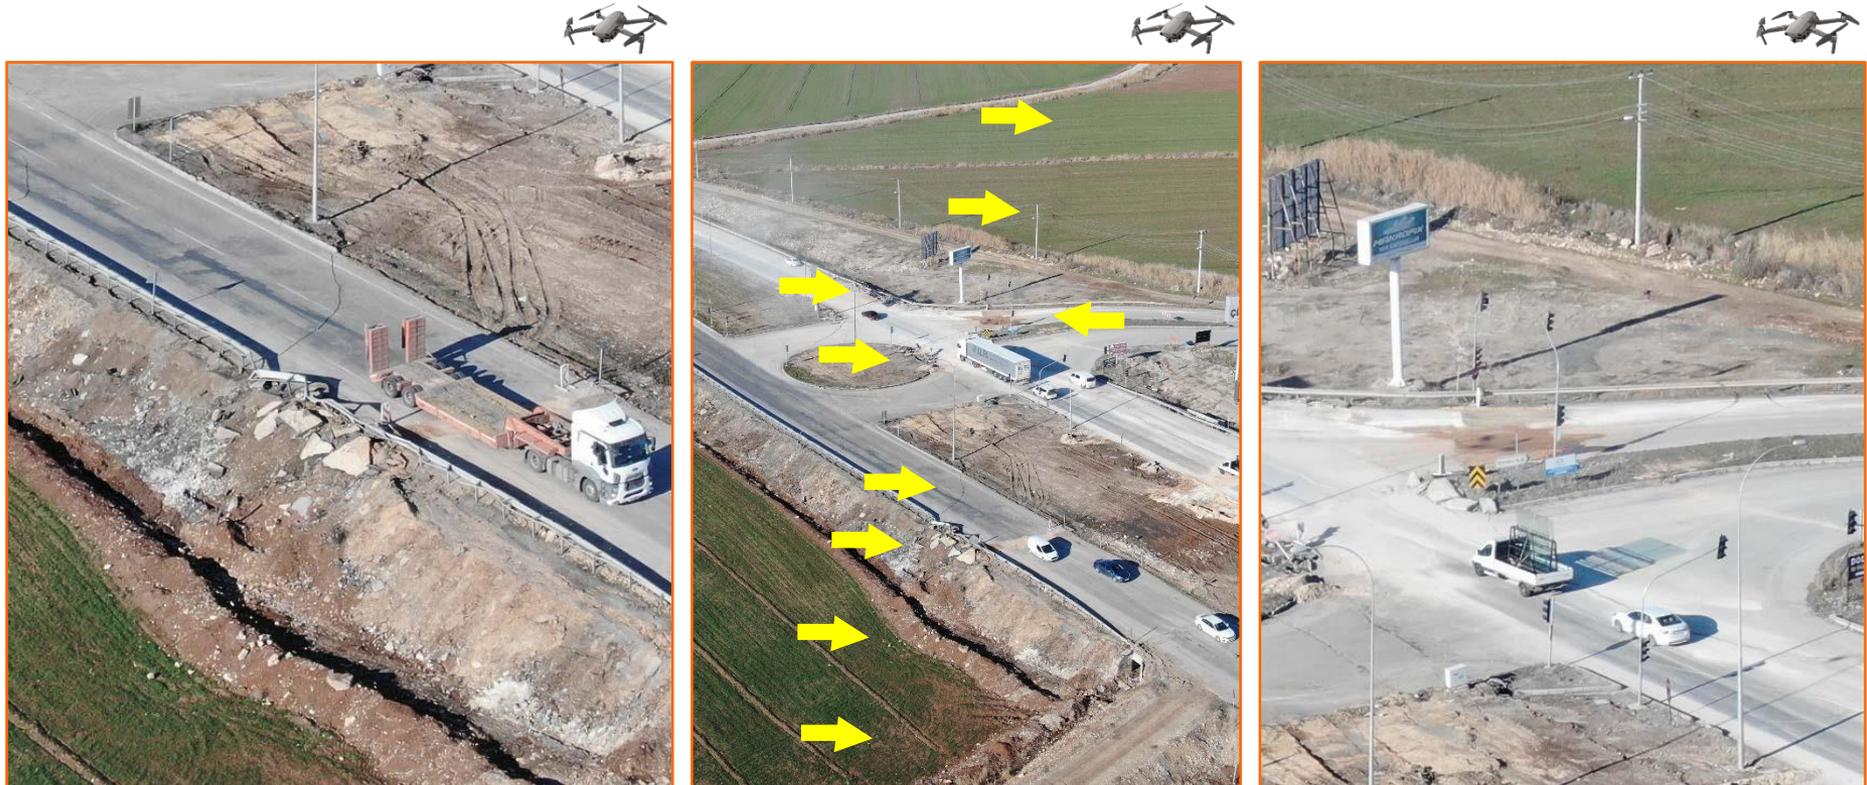
The ground ruptures destroyed many parts of the road network. Others suffered minor damage due to the strike-slip motion along the ruptures, which were immediately repaired and traffic continued, while others suffered major damage that could not be repaired quickly and traffic was interrupted for a long period of time. In this site, the ruptures were observable over a long distance on both sides of the road and in adjacent fields.

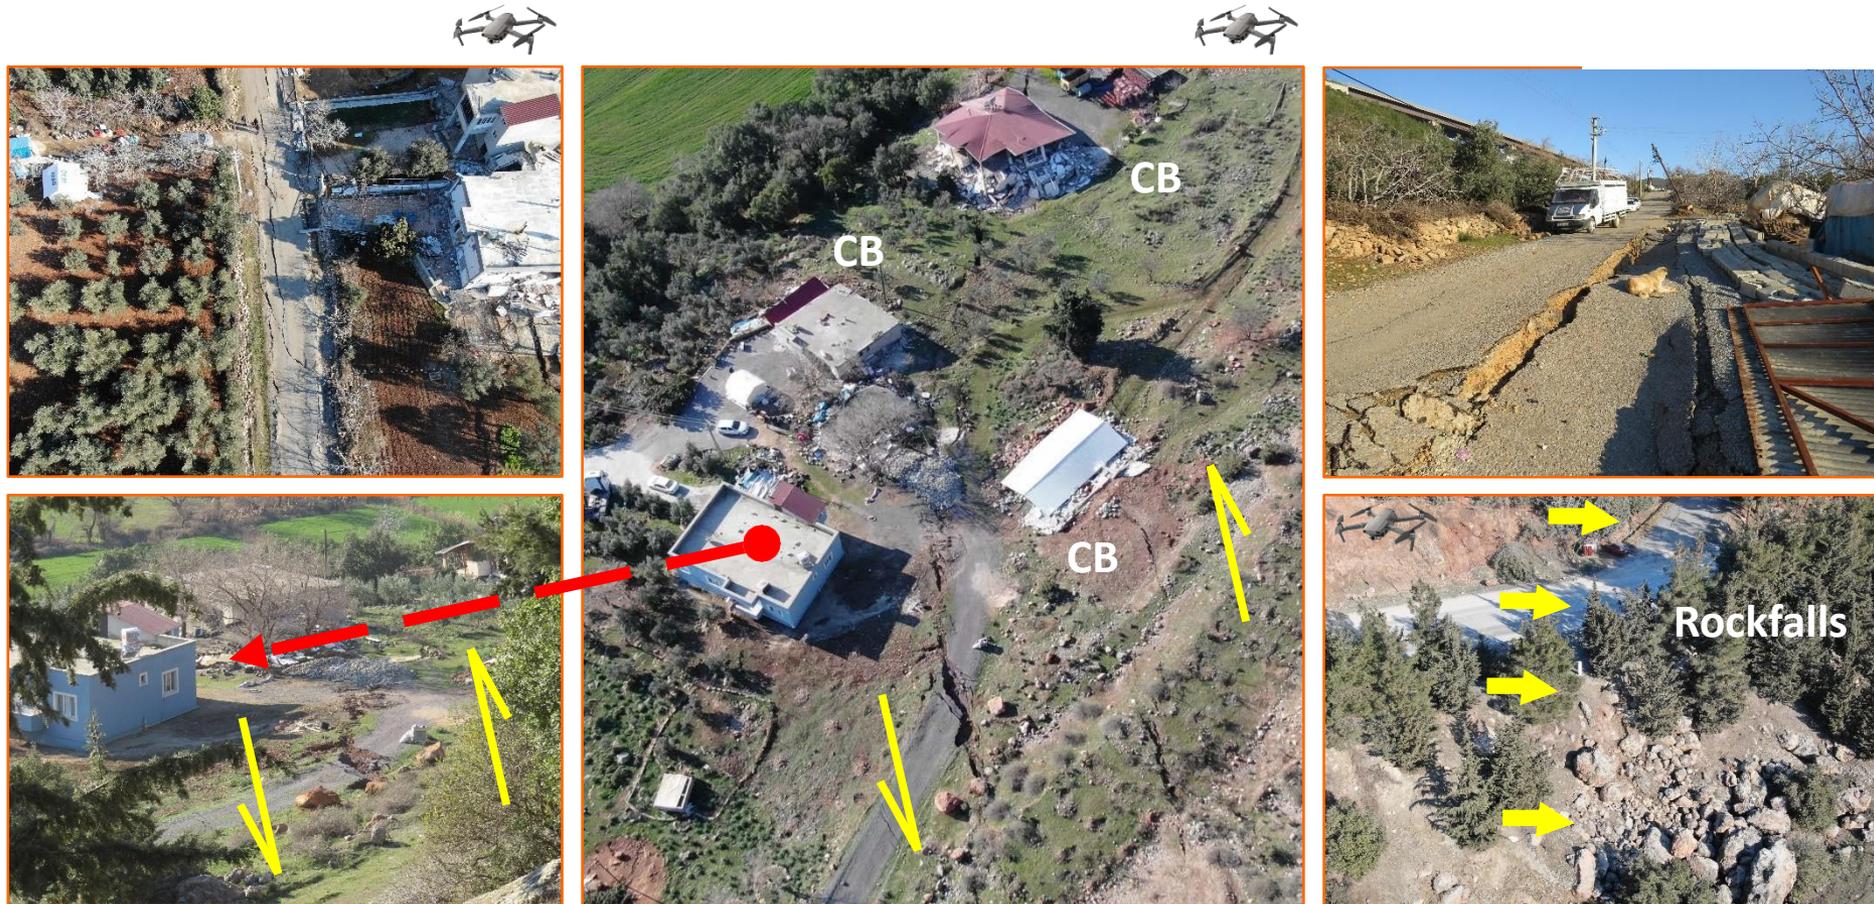
Buildings and infrastructure located within the deformation zone of the coseismic surface ruptures suffered very heavy structural damage including total collapse. The buildings in this site were totally destroyed (CB: Collapsed buildings in the middle figure). Along the same ruptured zone, rockfalls were also triggered.

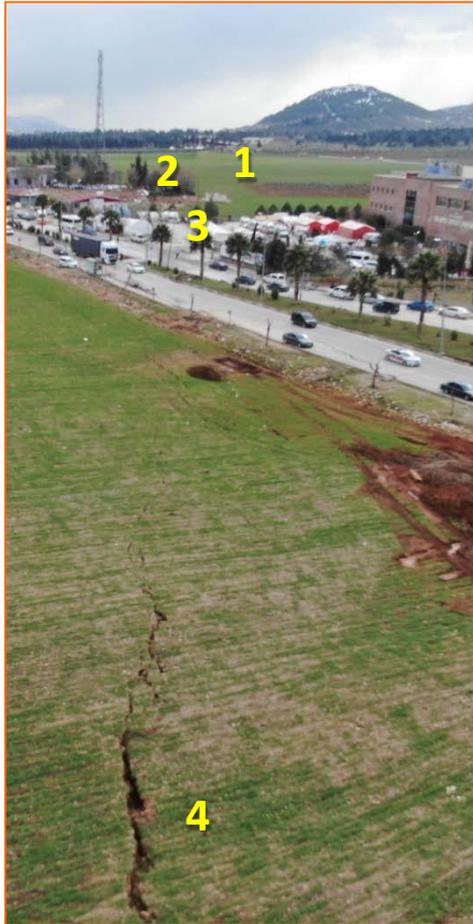
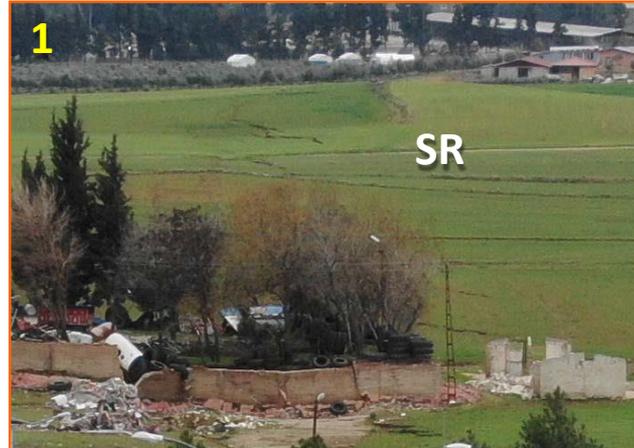
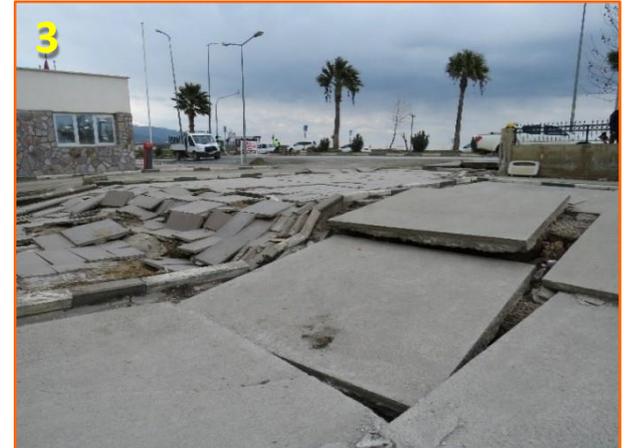
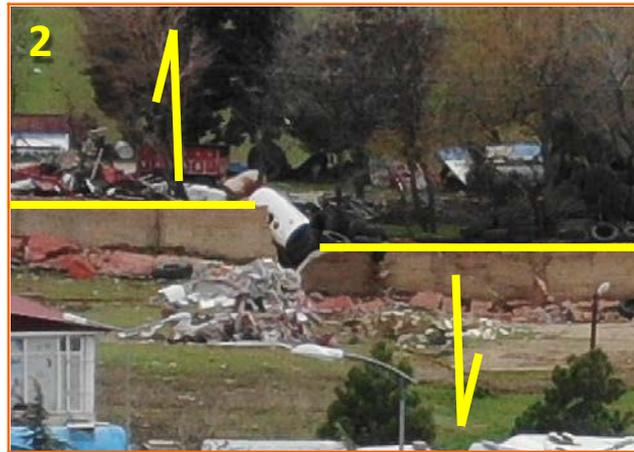
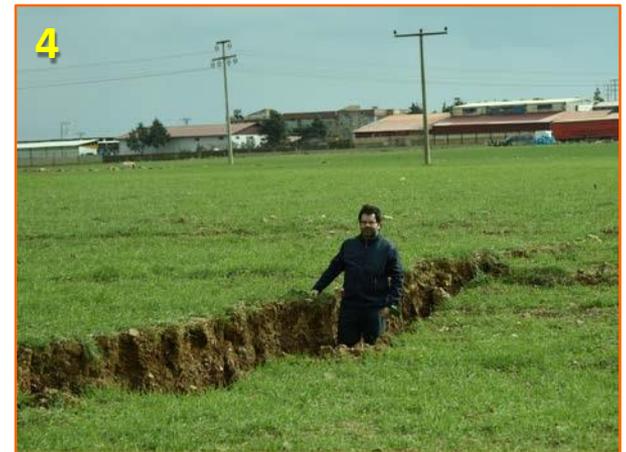
DETECTION OF SURFACE RUPTURES FROM FIELD SURVEY

Surface ruptures caused damage in roads, pavements and warehouse perimeter walls and deformation in fields and concrete slabs. **1:** Surface ruptures in a field. **2:** Cracked and disrupted perimeter wall. **3:** Deformed concrete slabs. **4:** Large gaps were formed along the observed surface ruptures.

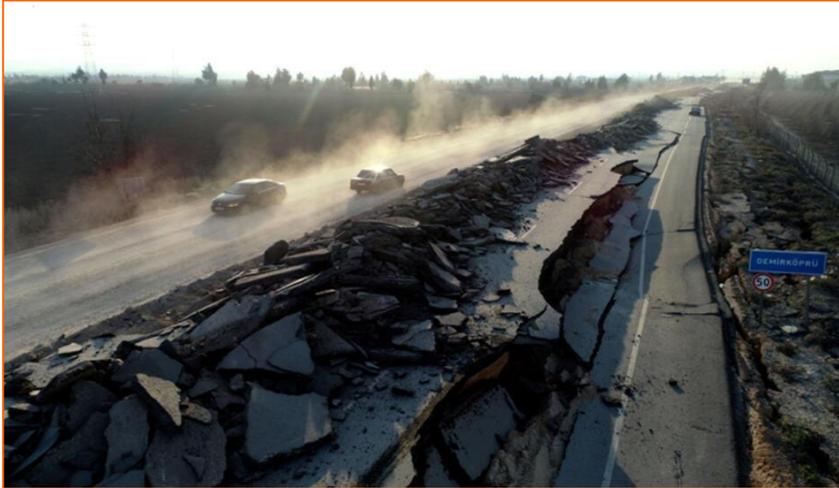
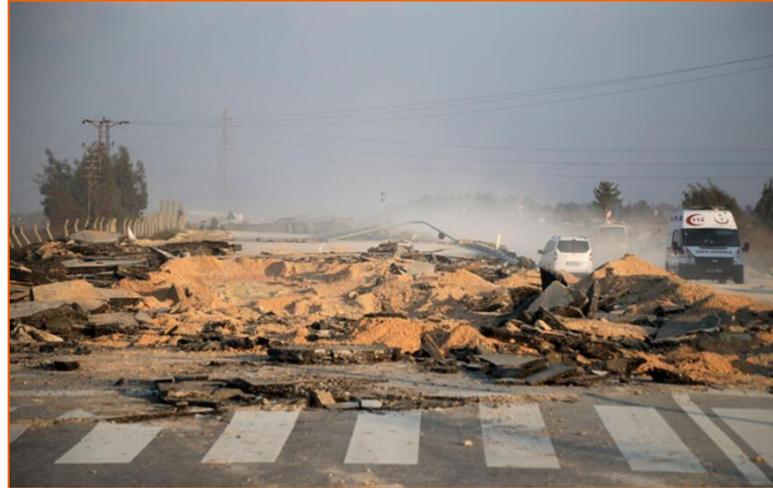
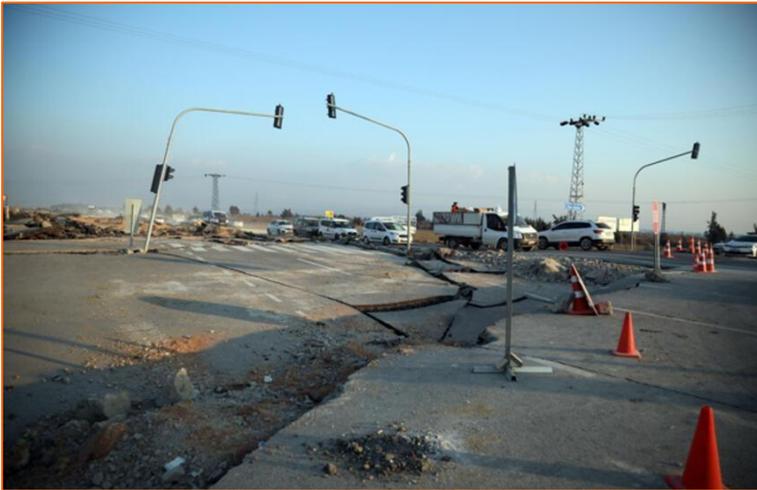
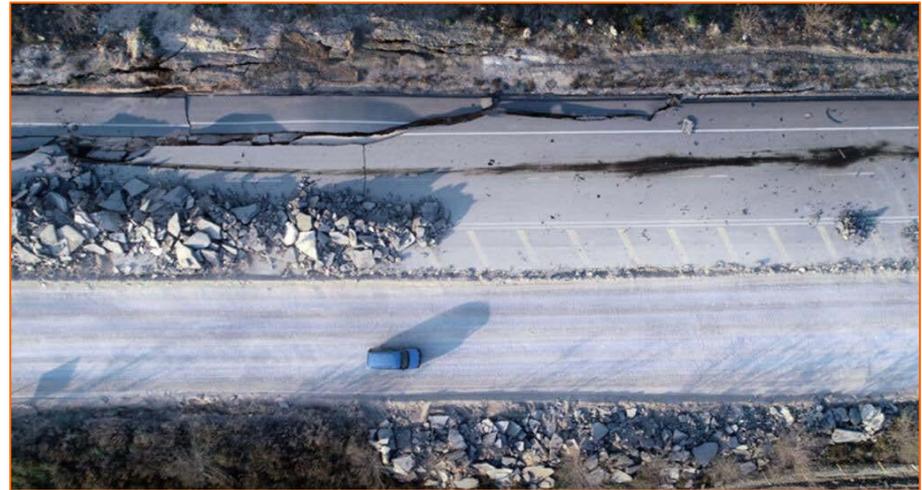
SURFACE RUPTURES OF THE 6 FEBRUARY 2023 EARTHQUAKES

The Antakya Demirözü highway, the road connecting Antakya to Reyhanlı district suffered heavy damage by the severe earthquake ground motion. The road was heavily cracked for a length of about 1 km.

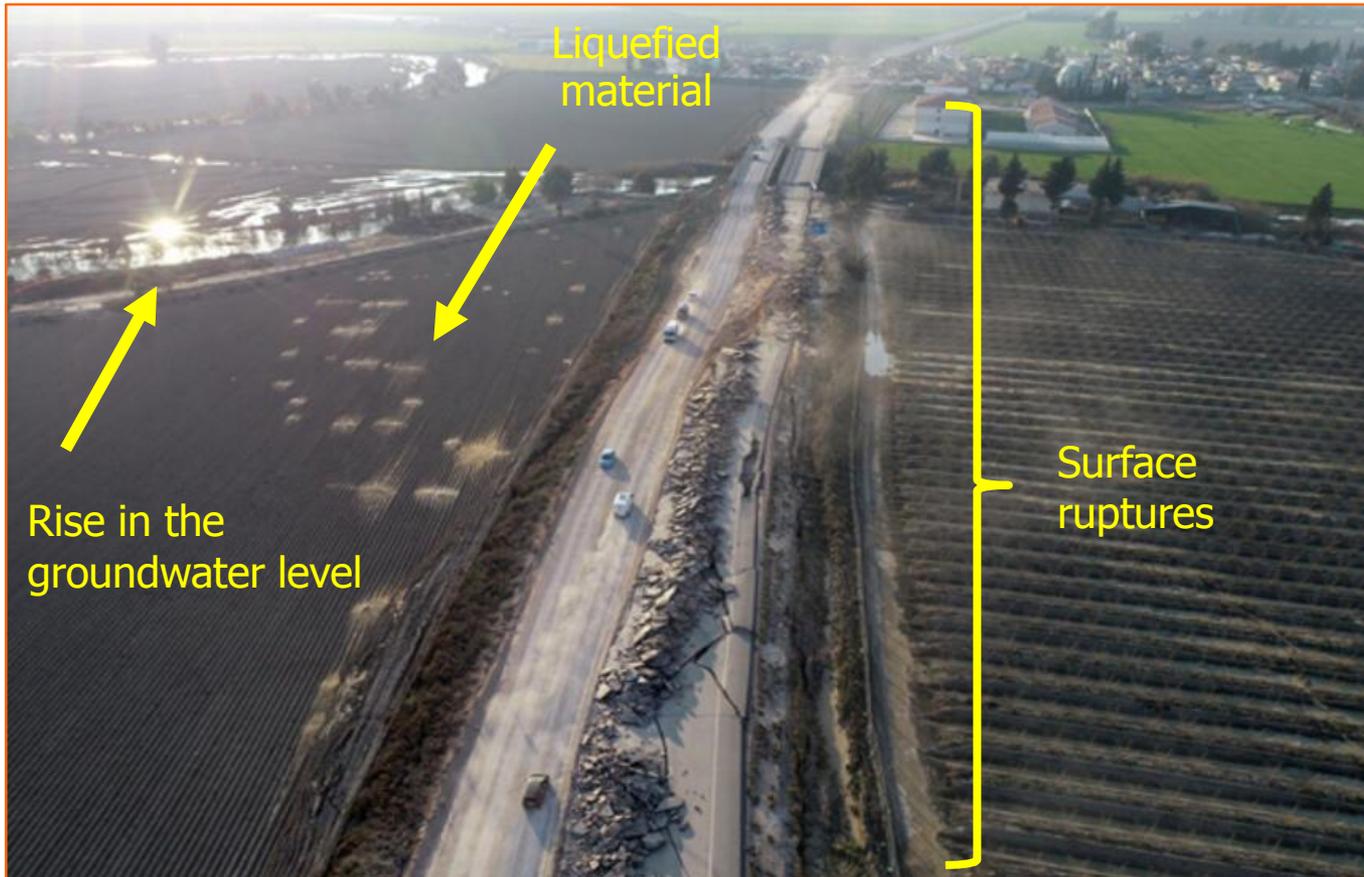
The ruptures observed in the road connecting Antakya to Reyhanlı district were accompanied by lateral spreading related to liquefaction phenomena and generated close to the affected road. The liquefaction phenomena included ejection of liquefied material through cracks and formation of sand boils. Furthermore, large parts of adjacent fields were covered by water due to groundwater level rising.

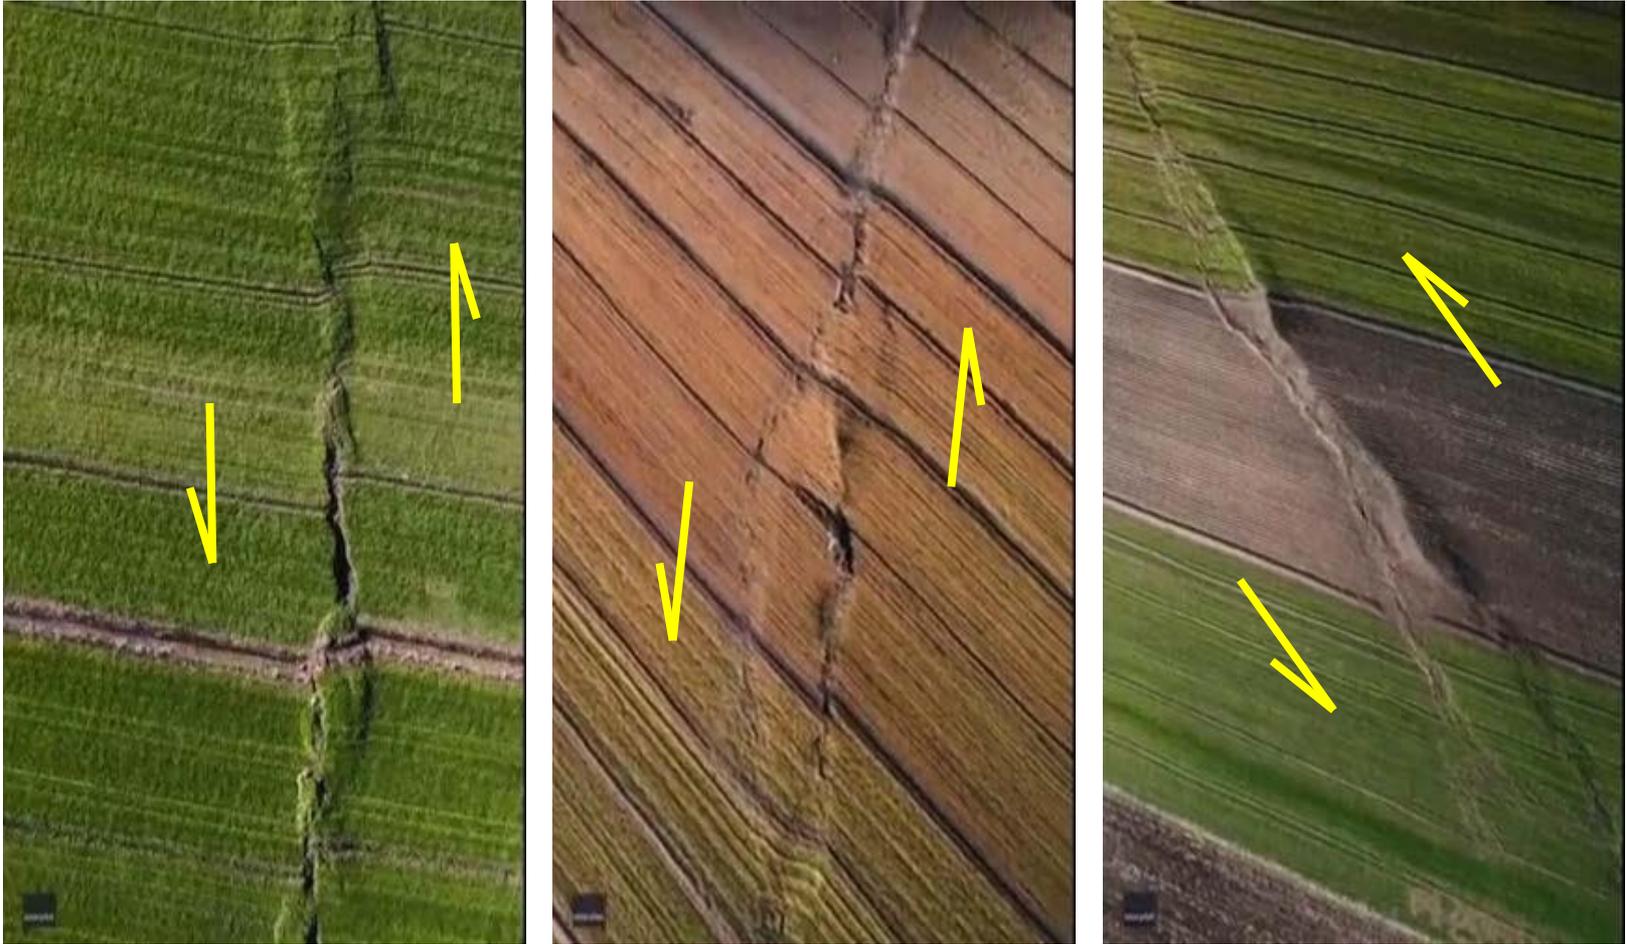
Surface ruptures observed in the Kahramanmaraş located in the northern part of the earthquake-affected area. The ruptures have affected farmland and displaced irrigation channels and roads.

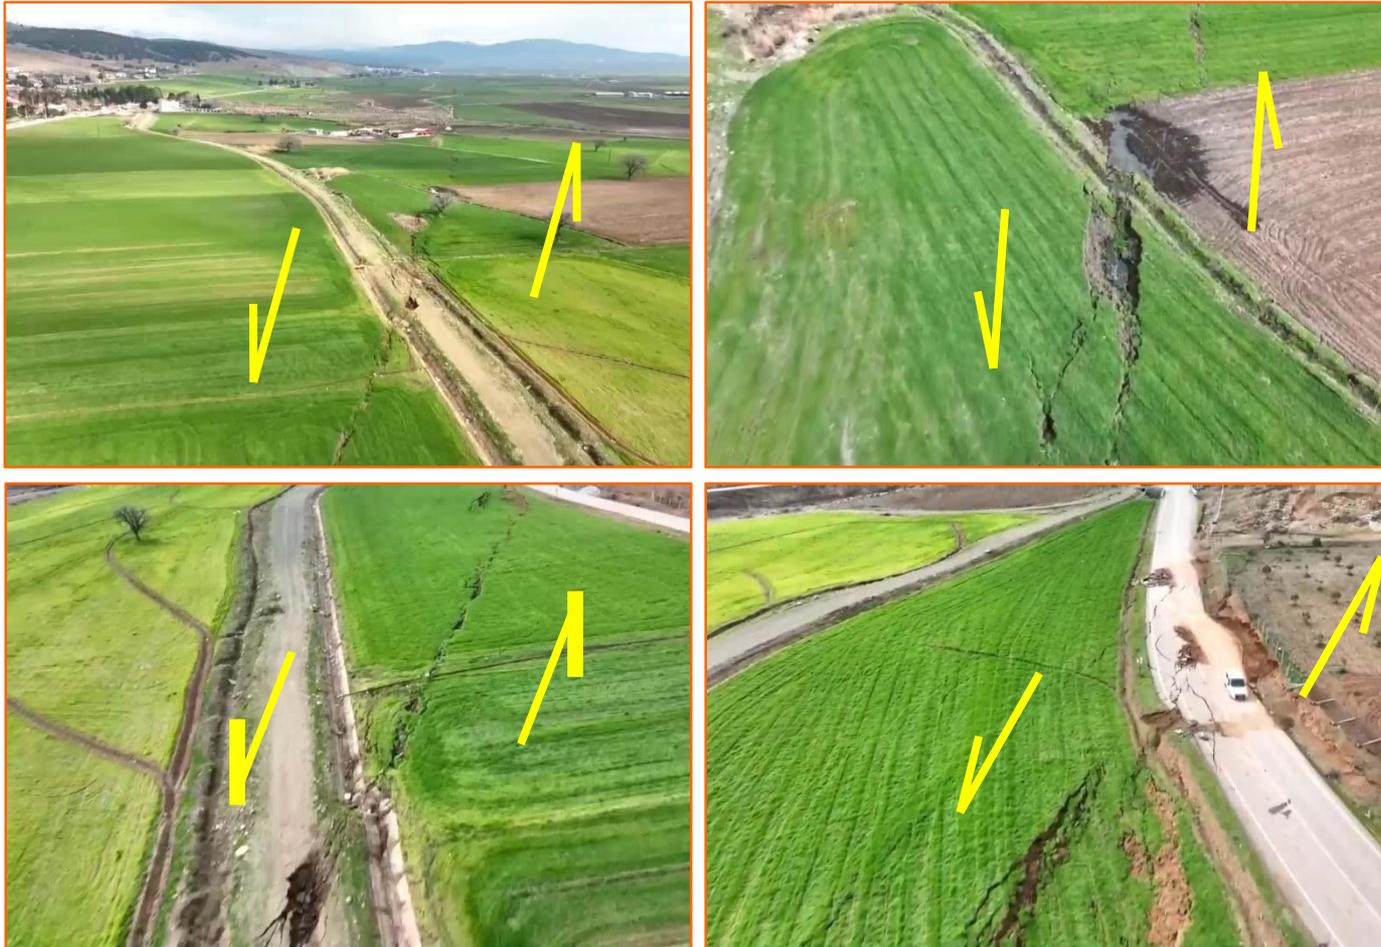
Surface ruptures observed near Tevekkelli, Kahramanmaraş. The ruptures have affected farmland, displaced irrigation channels and caused damage to roads.

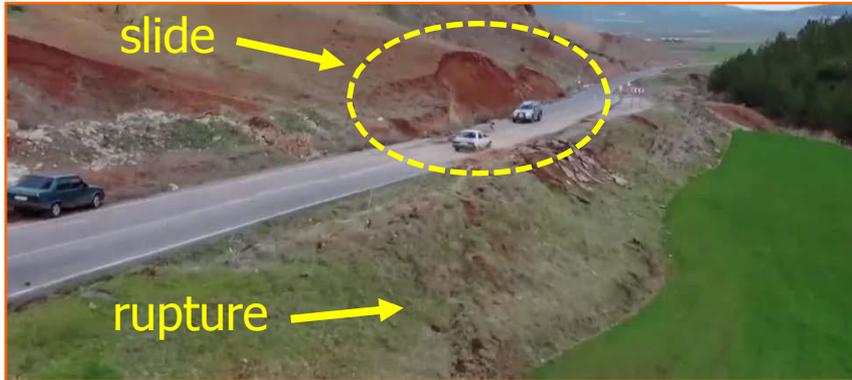
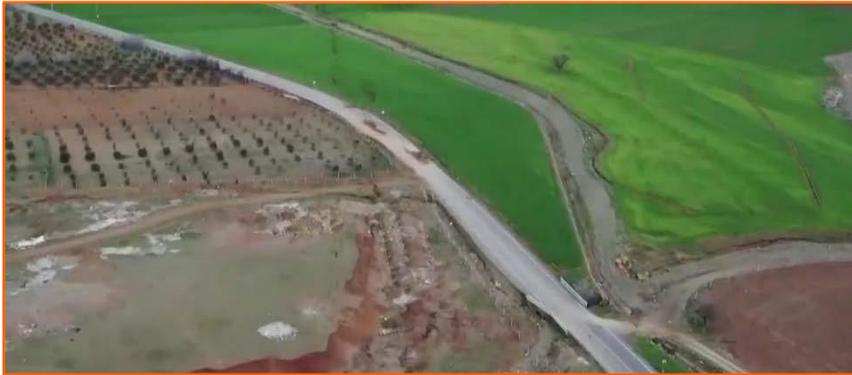
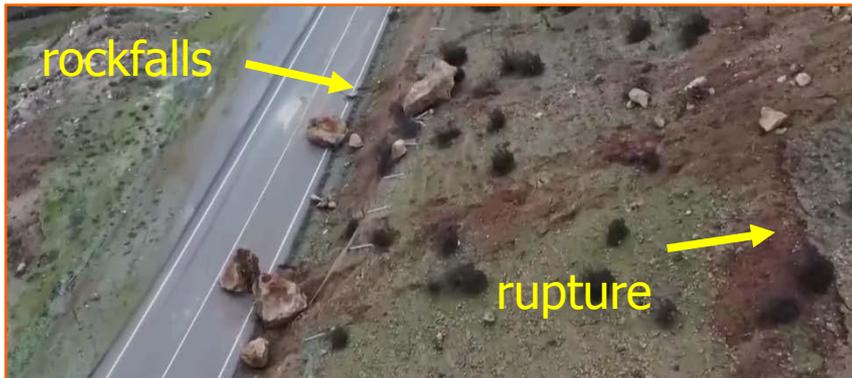
SURFACE RUPTURES OF THE 6 FEBRUARY 2023 EARTHQUAKES

Surface ruptures in Kahramanmaraş. They affected roads and farmlands and triggered rockfalls and landslides along their path. The mobilized material reached adjacent segments of the road network resulting in temporary traffic disruption in lanes.

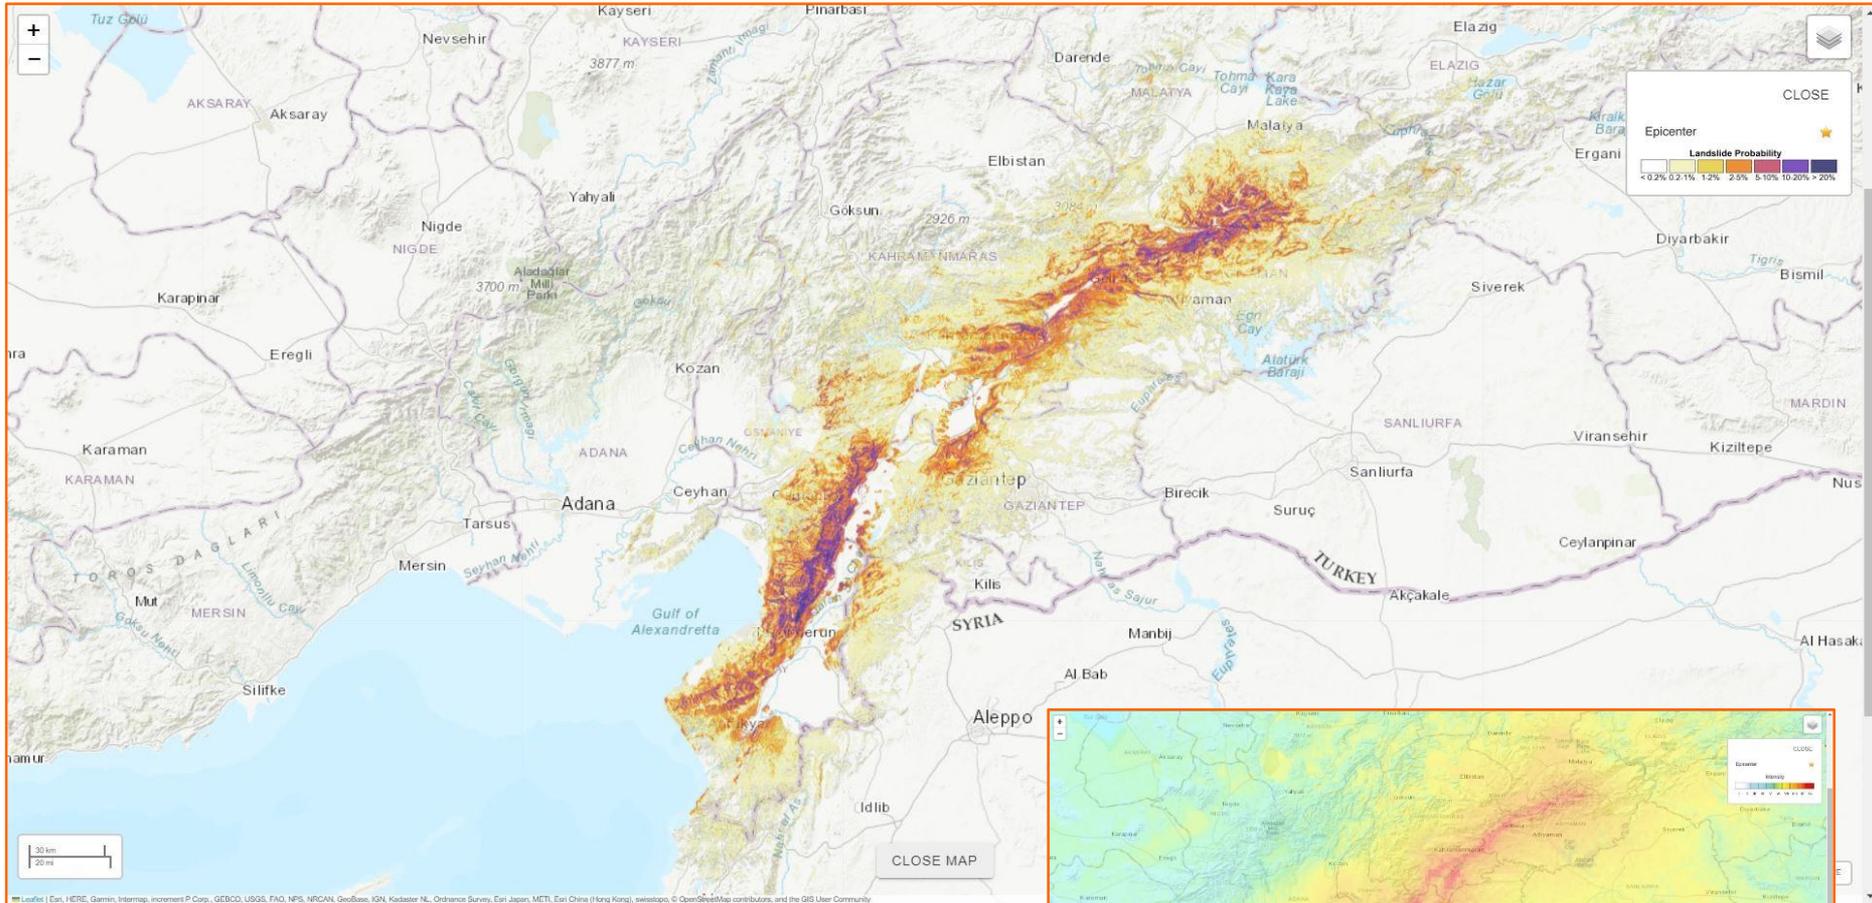
Map of landslide probability along the activated area of the East Anatolian Fault System. Larger probability is found in areas of maximum intensities.

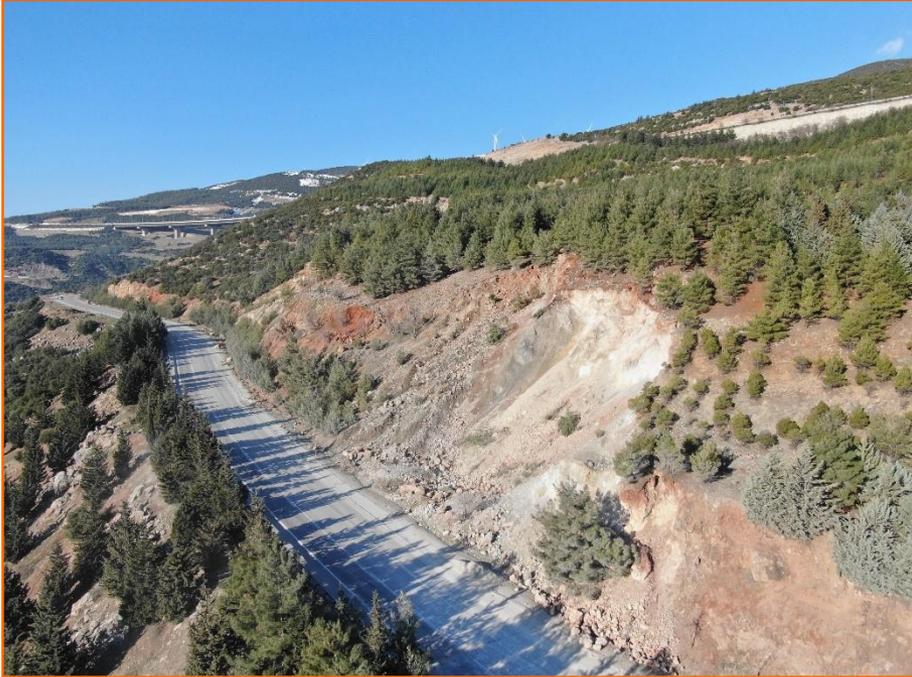
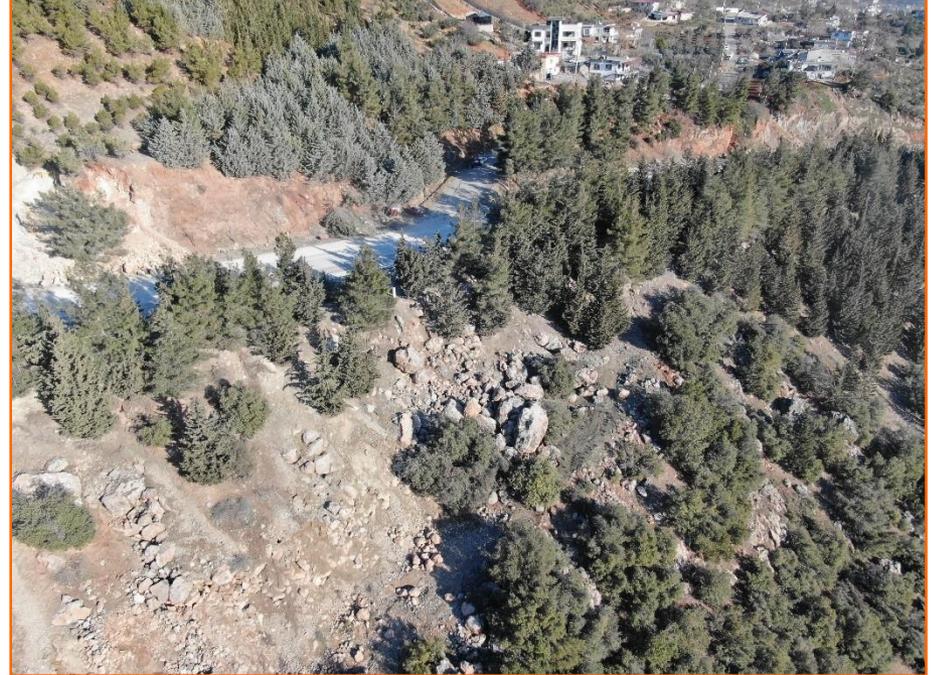
Earthquake-triggered landslides were observed close or along the surface ruptures. They included slides (left figure) and rockfalls (right figure). Characteristic drone views from Nurdağı area (Gaziantep province).

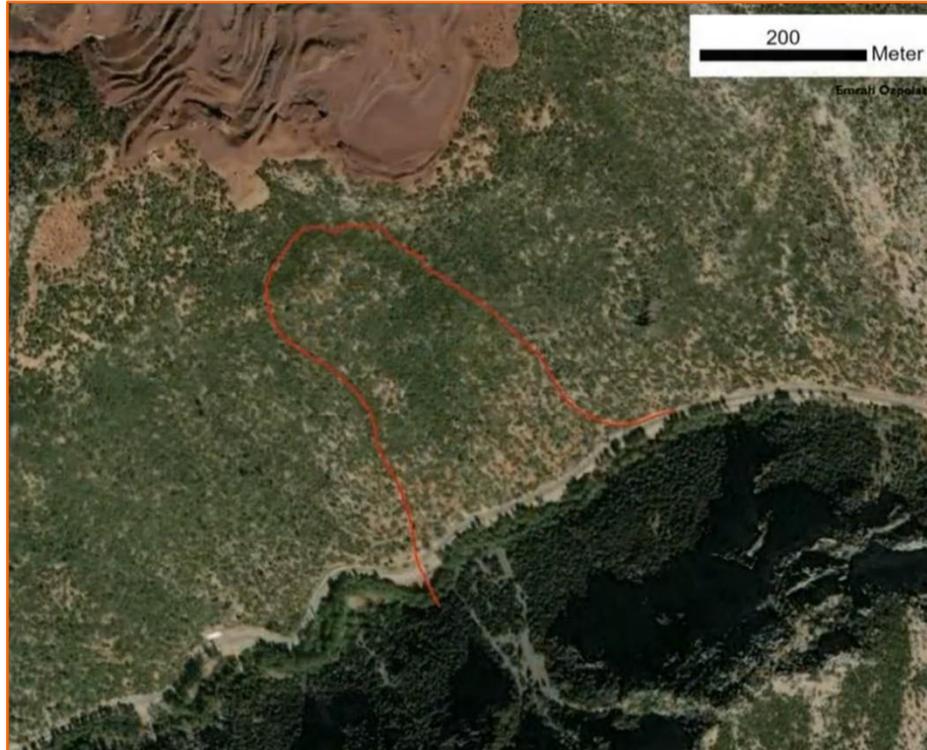
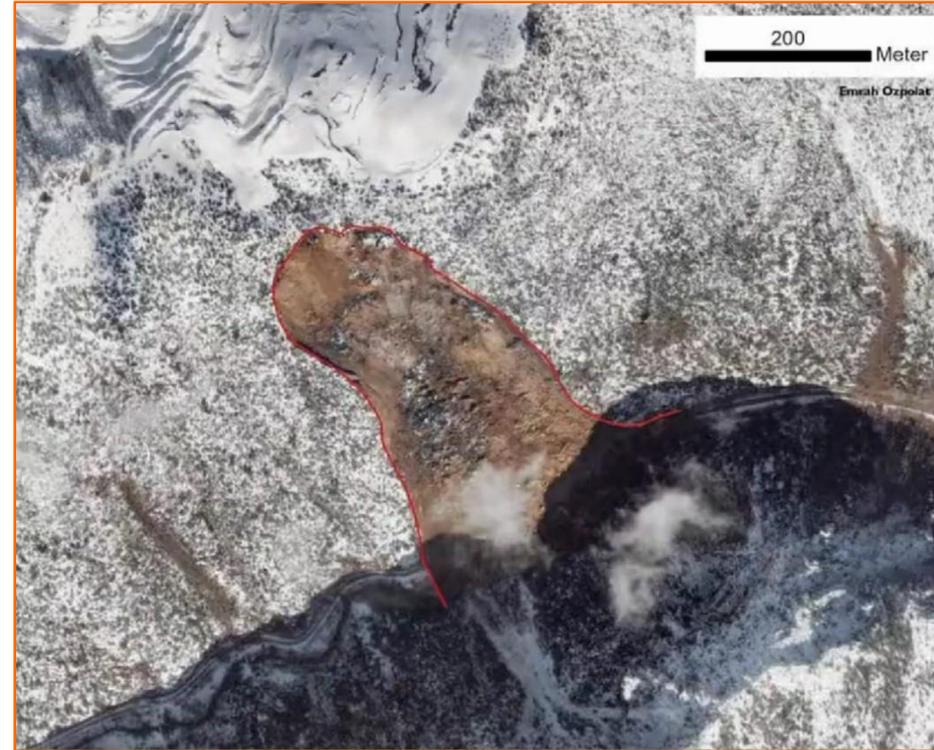
A large landslide, around 200 meters wide, discovered through satellite imagery not far from Islahiye, Gaziantep Province, as a result of the Mw=7.8 earthquake in Turkey.

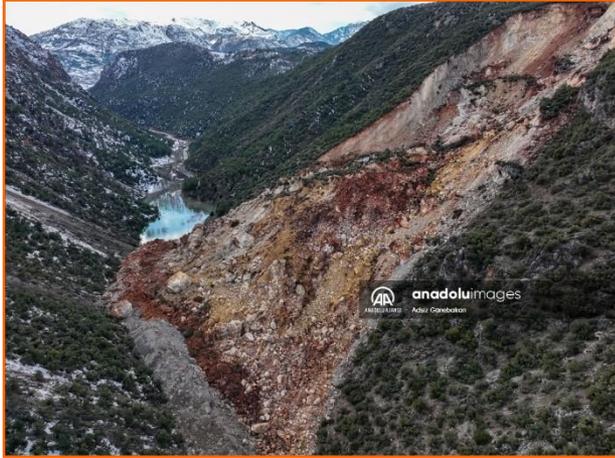
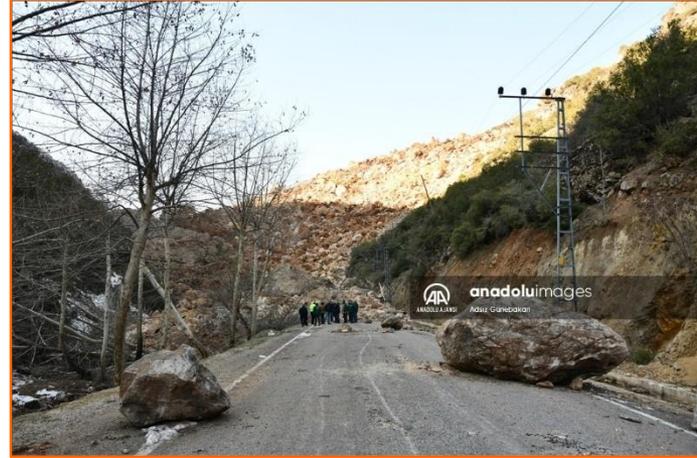
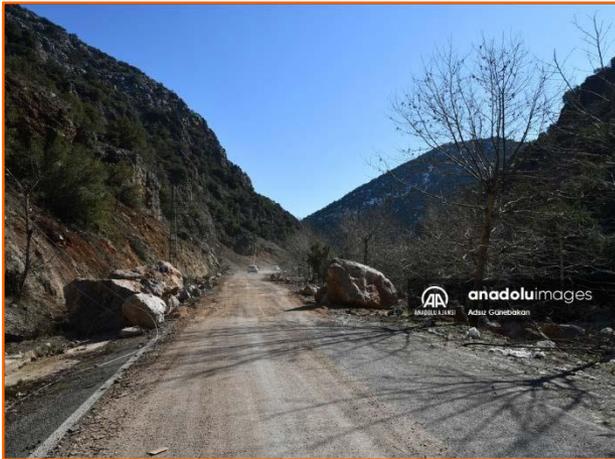
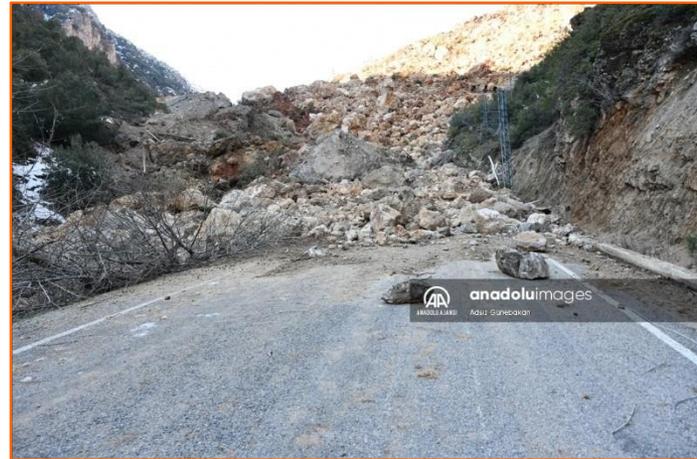
LANDSLIDES TRIGGERED BY THE 6 FEBRUARY 2023 EARTHQUAKES

The road between the rural Değirmencik and İdilli neighborhoods of Gaziantep's İslahiye district was closed due to the earthquake-induced landslide. The bed of Idilli Stream was filled with falling rocks and a pile of earth. Source: <https://www.aa.com.tr/tr/pg/foto-galeri/islahiyyede-depremin-ardindan-heyelanla-kapanan-yolda-inceleme-suruyor/0>.

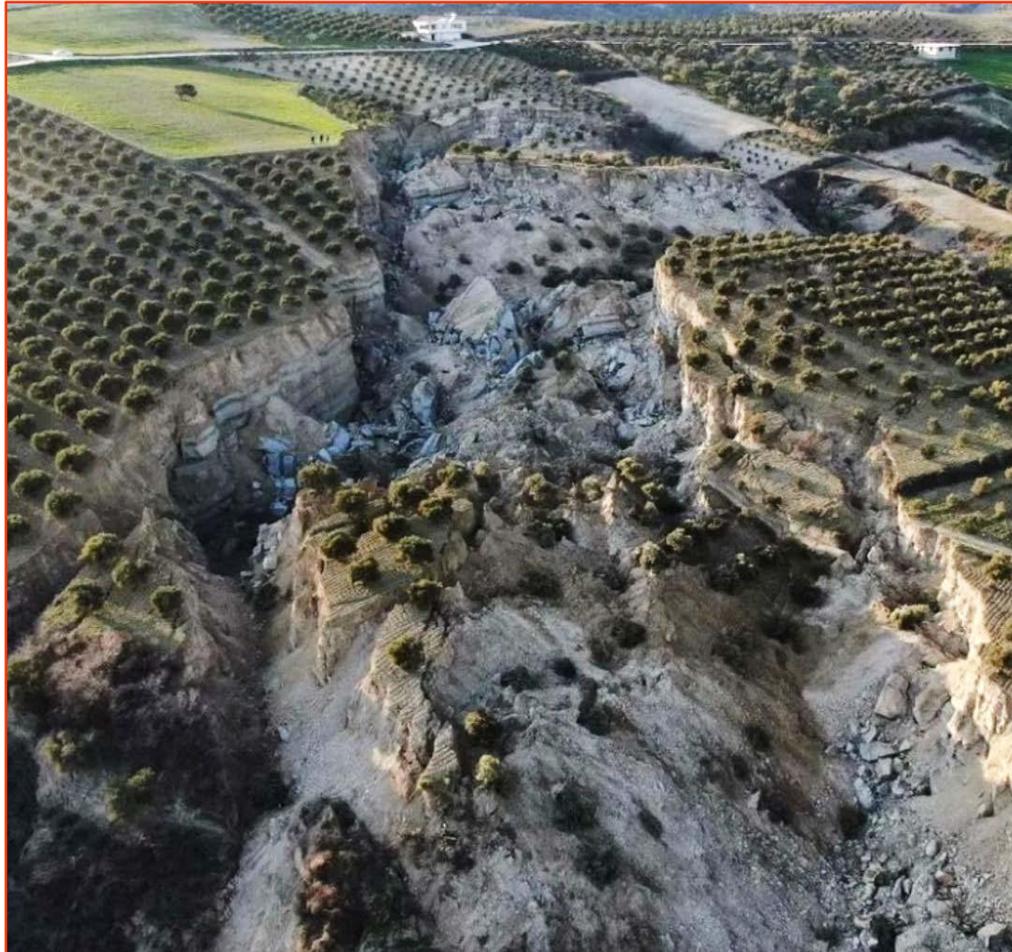
LANDSLIDES TRIGGERED BY THE 6 FEBRUARY 2023 EARTHQUAKES

A large rift was generated by the 6 February 2023 earthquake in the Altınözü district of Hatay and cut an olive field in half. It has width of 200 meters, length of 400 meters and depth of 50 meters. Villagers said that they heard an explosion and saw lights flashing over the site. The images presented in the following pages are derived from several internet sources.

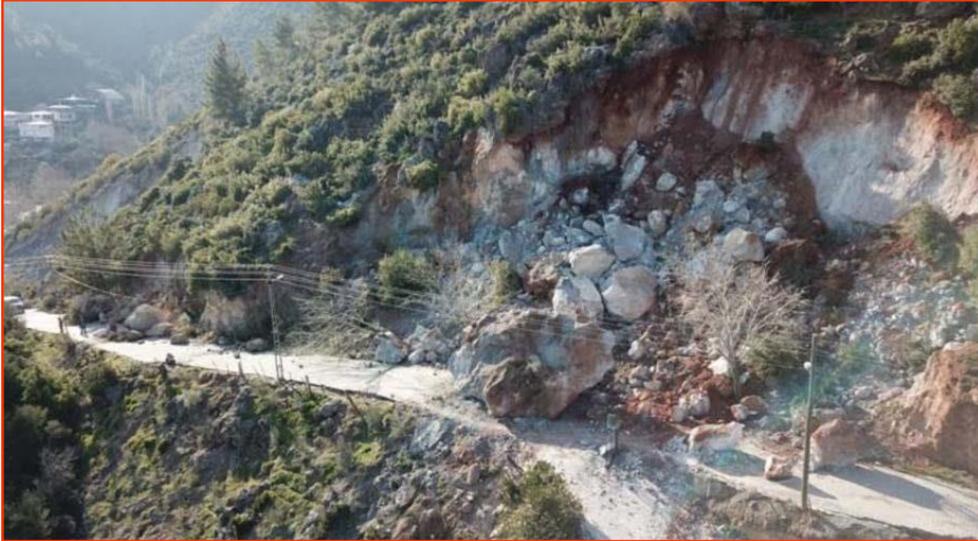
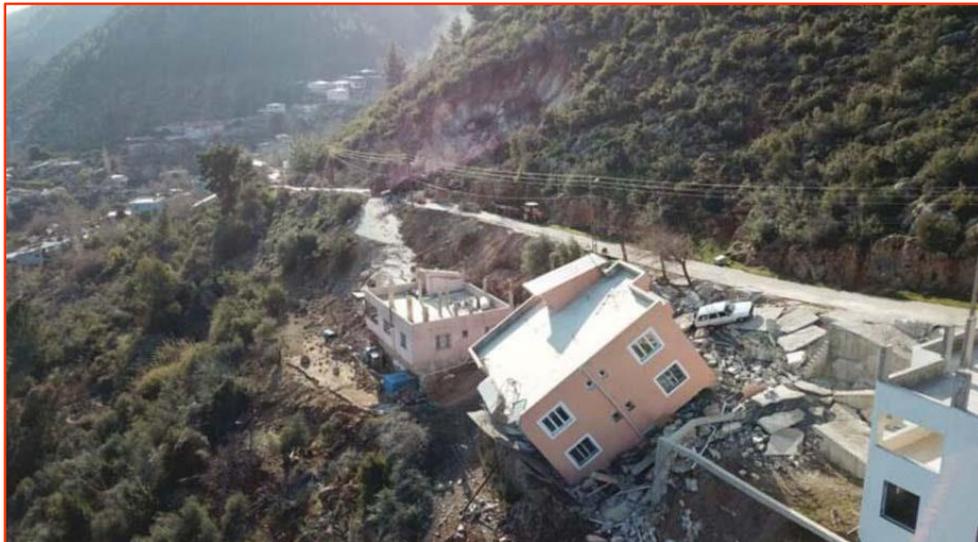
Rockfalls were generated by the earthquake along a hill adjacent to Bektasli village, causing damage to buildings and 49 fatalities. Boulders were detached from the mountain and then rolled and crushed one-story houses in the village resulting in total destruction.
