Turkiye Syria 6 February 2023 Earthquakes;

Reconnaissance Visit Report and Seismological Aspects

Mehdi Zaré

12 June 2023

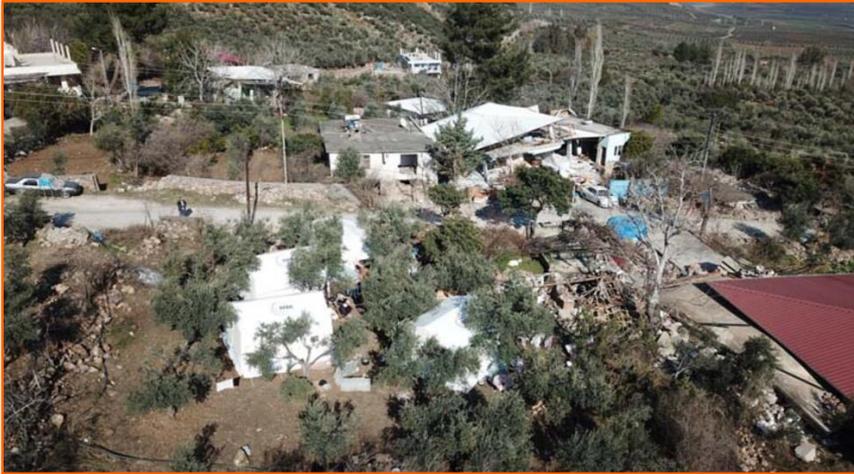
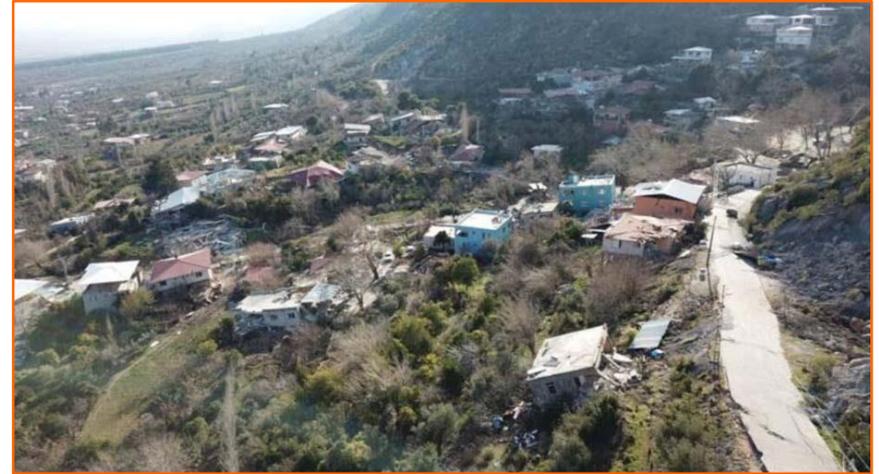
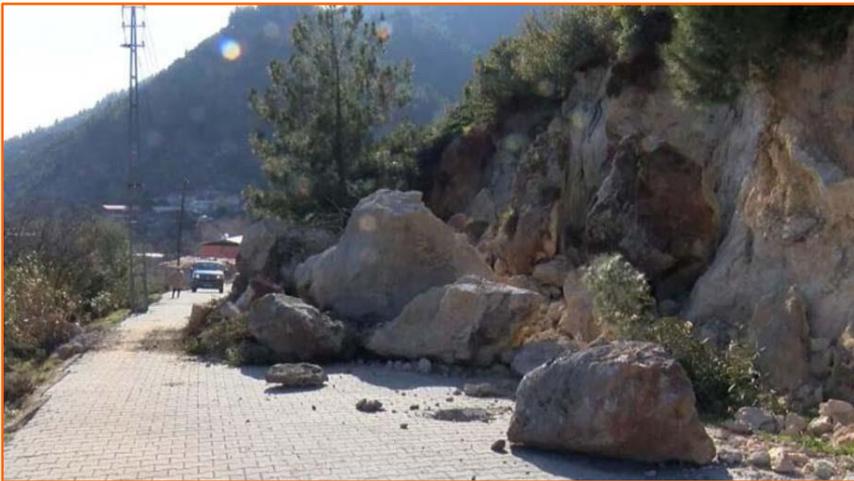
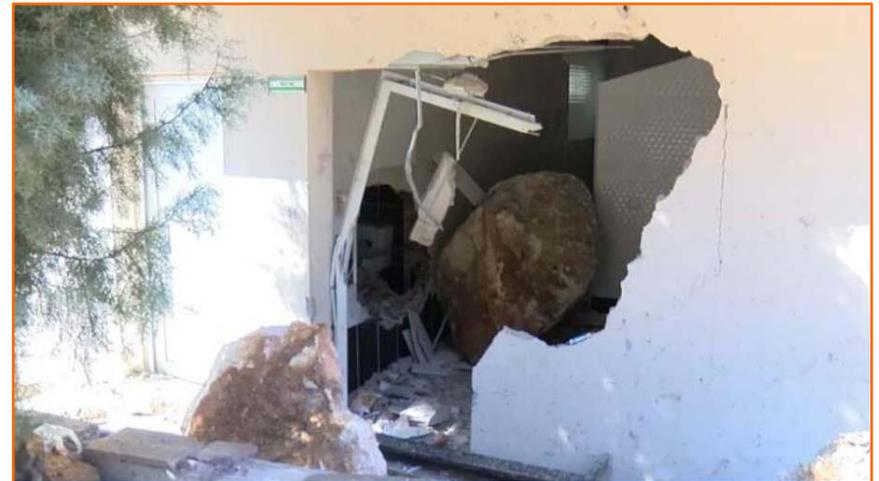
Rockfalls were generated by the earthquake along a hill adjacent to Bektasli village, causing damage to buildings and 49 fatalities. Boulders were detached from the mountain and then rolled and crushed one-story houses in the village resulting in total destruction.

In the Bektaşlı village of the Kırıkhan district of Hatay, the rocks that broke off the mountain due to the effect of the earthquake rolled and fell on the one-story houses. Source:

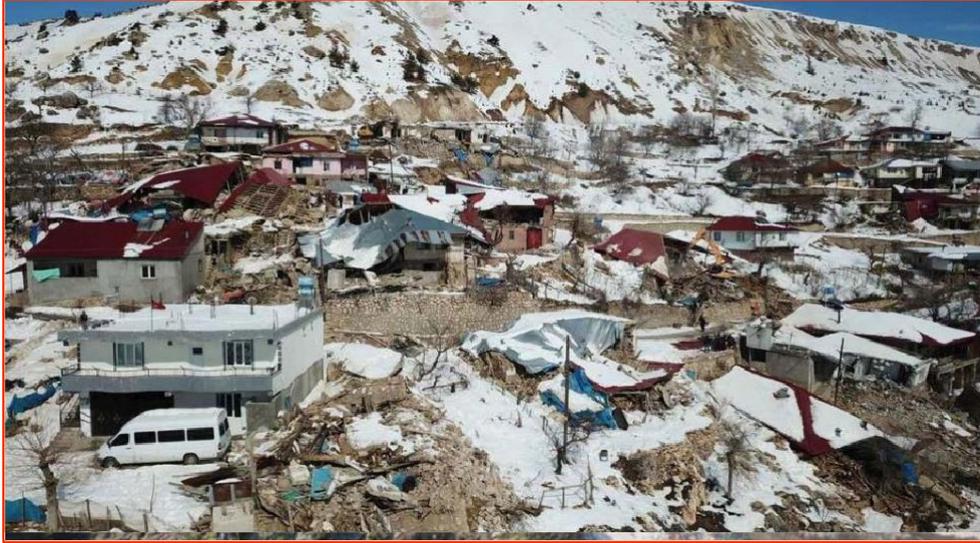
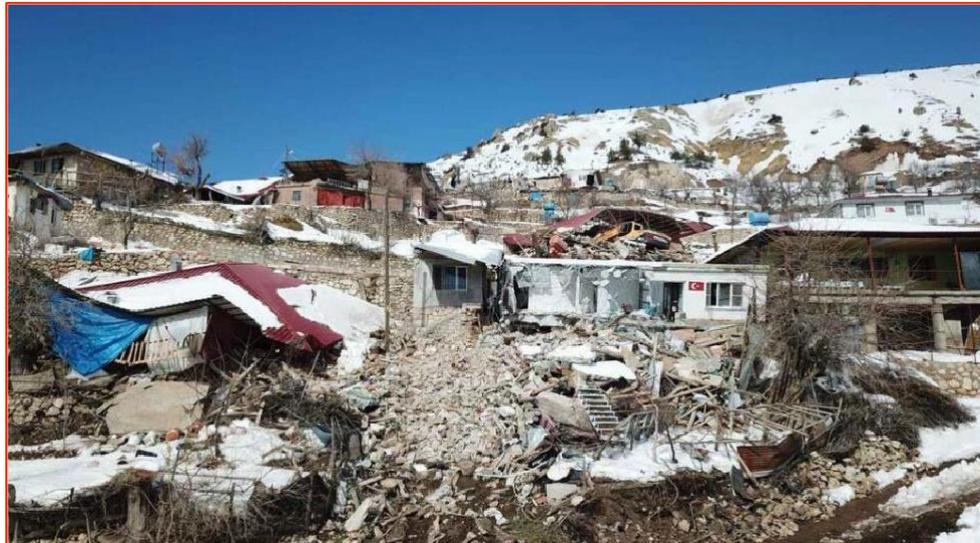
Büyüknacar village is located at the top of the Pazarcık district of Kahramanmaraş. About 84 percent of the houses in the village were destroyed by the 6 February 2023 earthquakes.

According to citizens, on the night of the earthquake the Sakı Baba mountain seemed to slide towards the village.

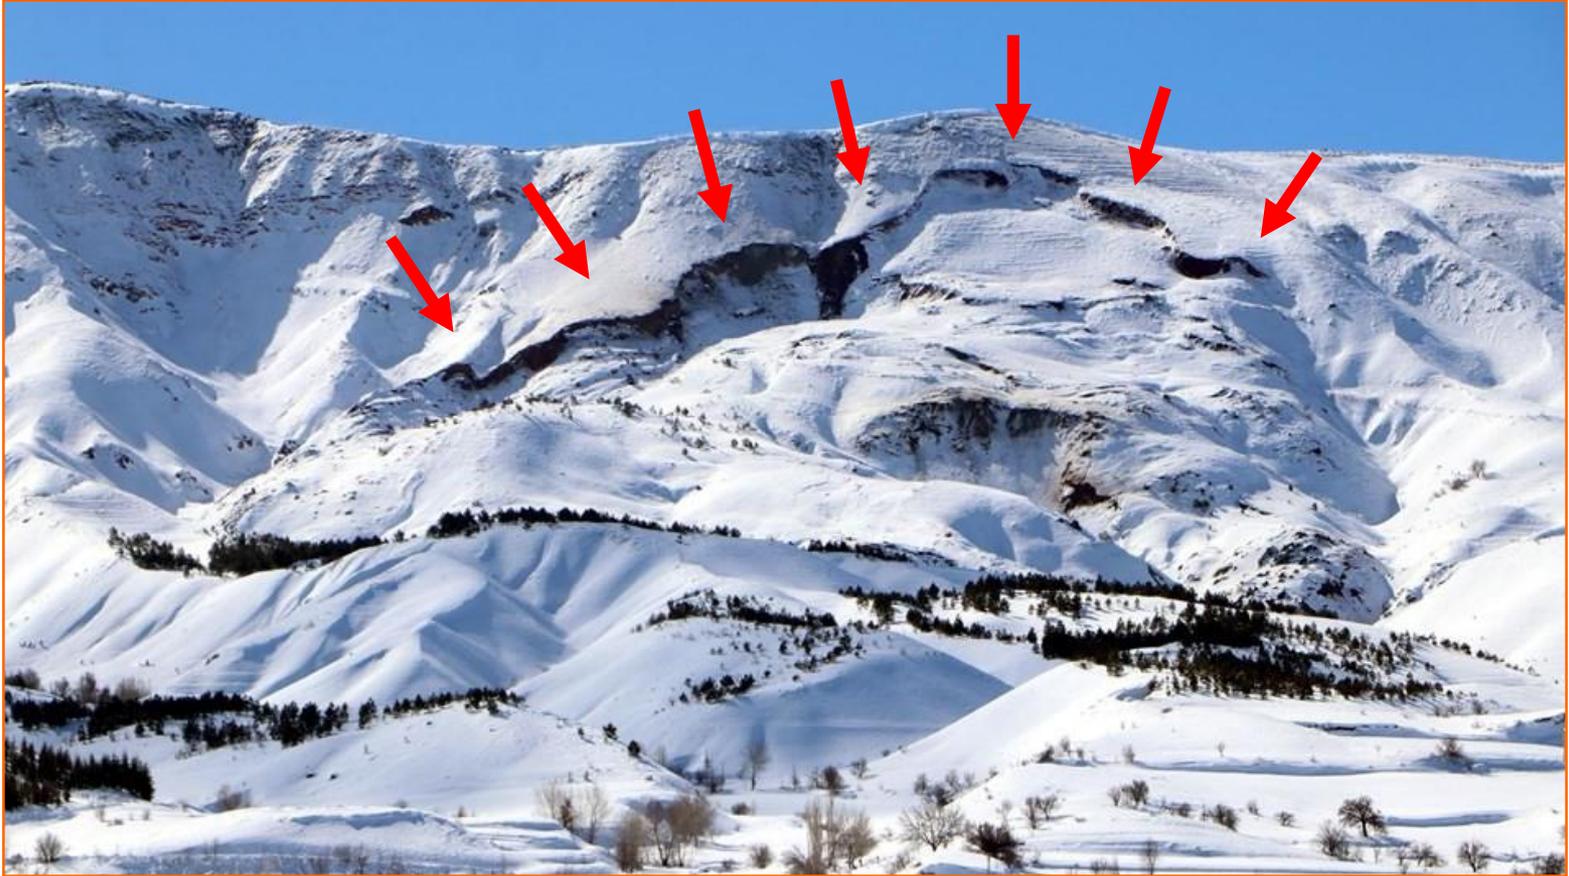
The Kızılf Mountain in the Kurucaova village of Doğanşehir district in Malatya province was also affected by the 6 February 2023 earthquakes. According to the villagers, the mountain split into two after the Mw=7.8 earthquake. Red arrows point the head scarp of the landslide. Source: <https://www.cnnturk.com/turkiye/11-ili-yikan-deprem-dogansehirdeki-dagi-ikiye-ayirdi>

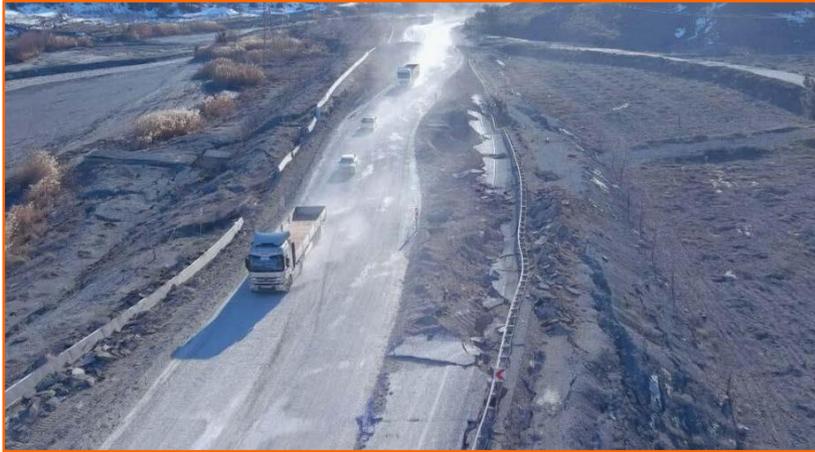
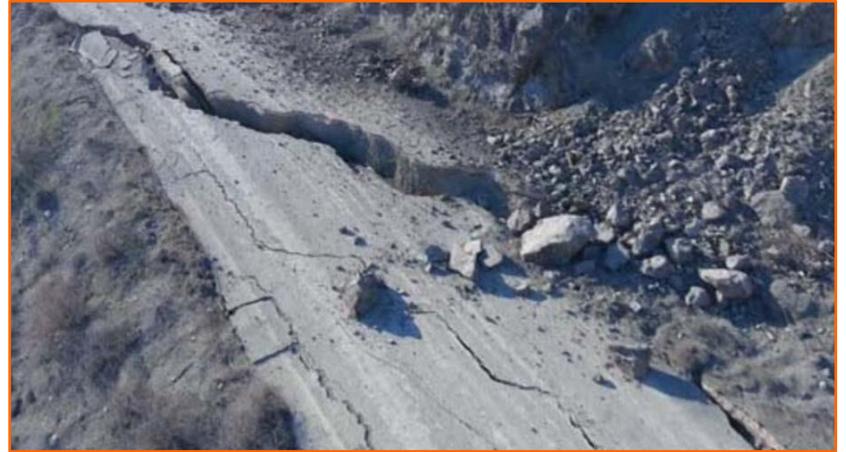
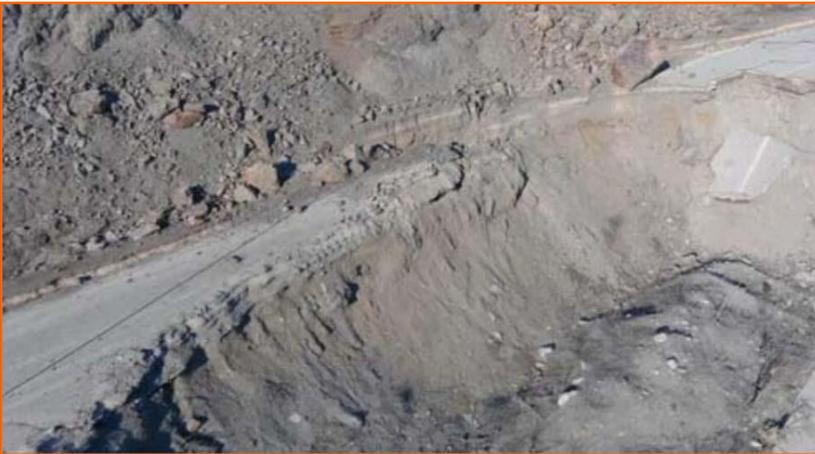
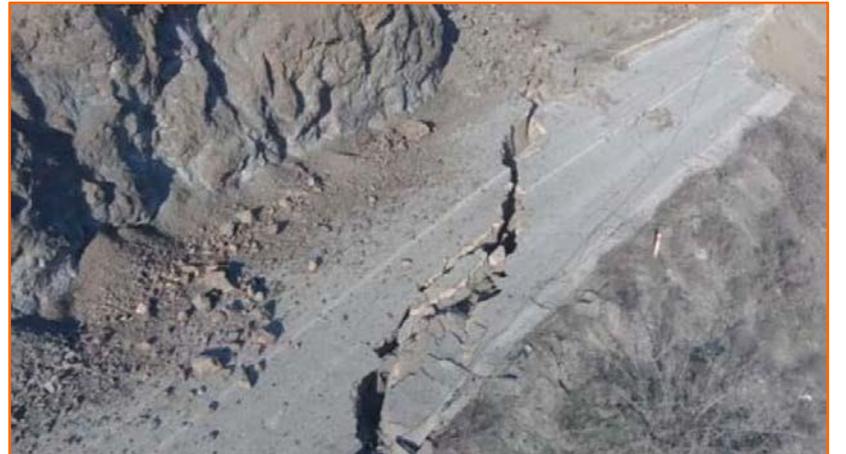
Part of the road leading from Kahramanmaraş to Malatya collapsed leaving only two of the four road lanes in place. In some places the landslide was 8 meters long. In addition, rockfalls were generated from adjacent slopes. Source: <https://www.cnnturk.com/turkiye/depremin-otoyollardaki-tahribati-hem-yarildi-hem-coktu?page=2>

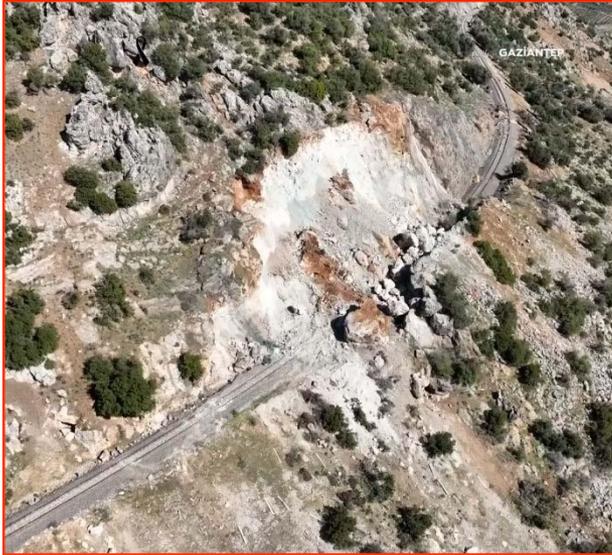
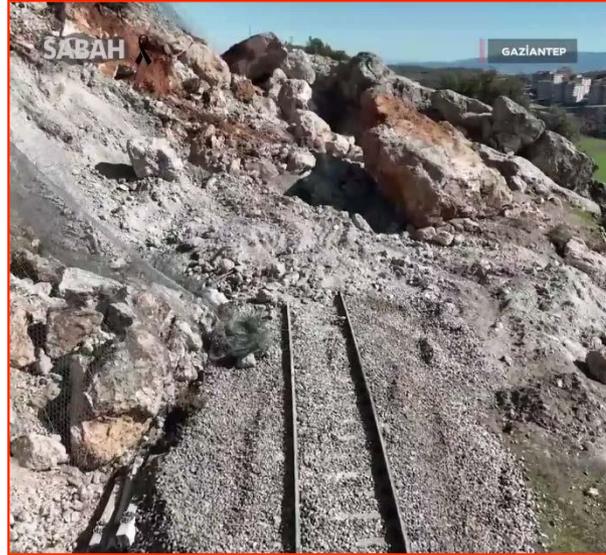
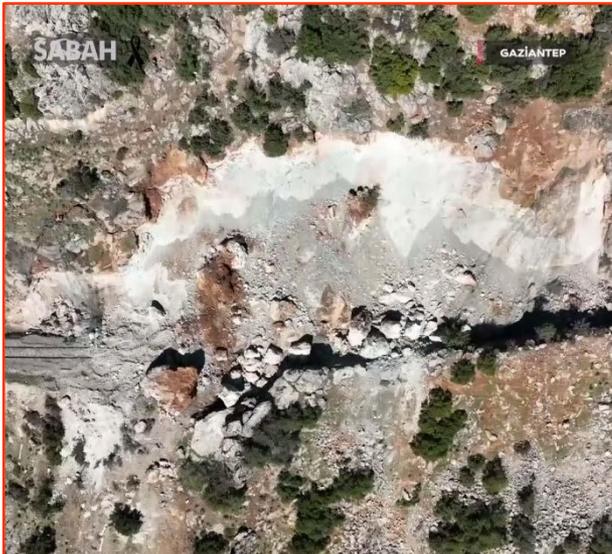
Rockfalls were triggered along slopes in Islahiye area, causing damage to the railroad. Landslide prevention measures were taken, however the nets failed due to the large volume of the mobilized material.

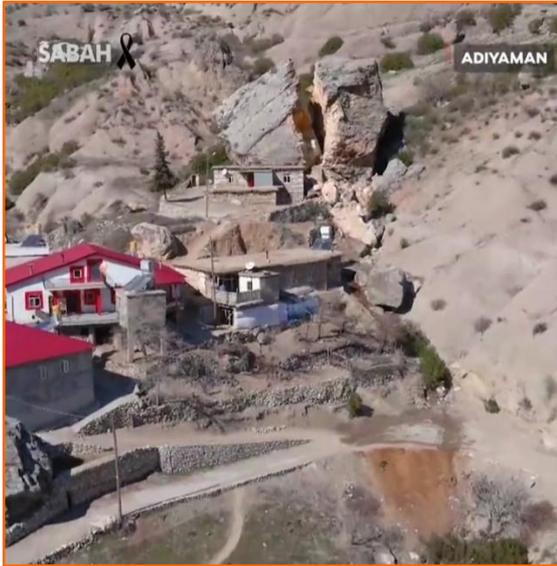
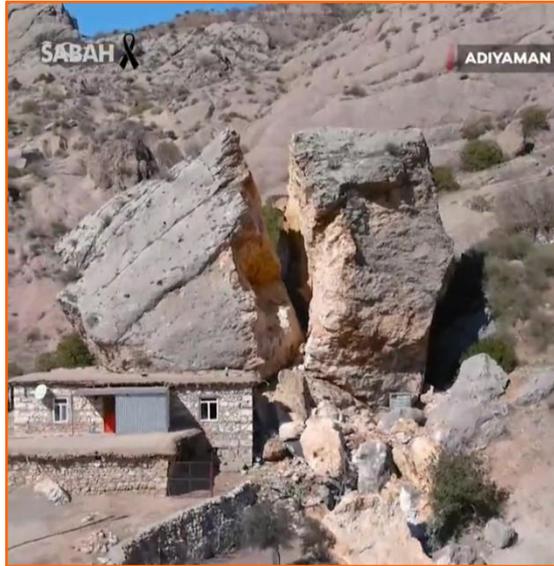
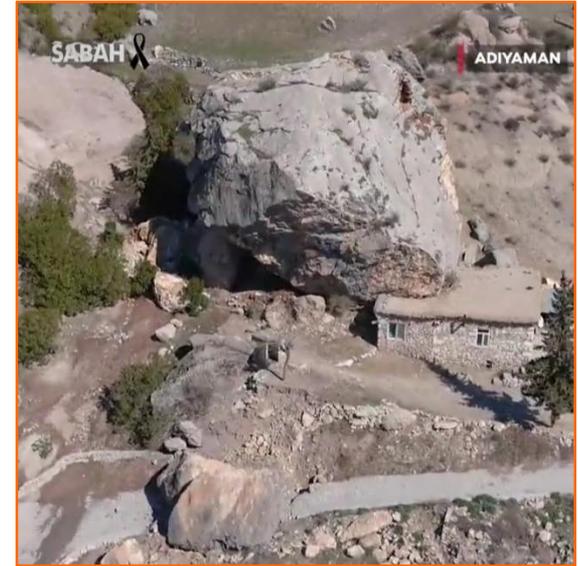
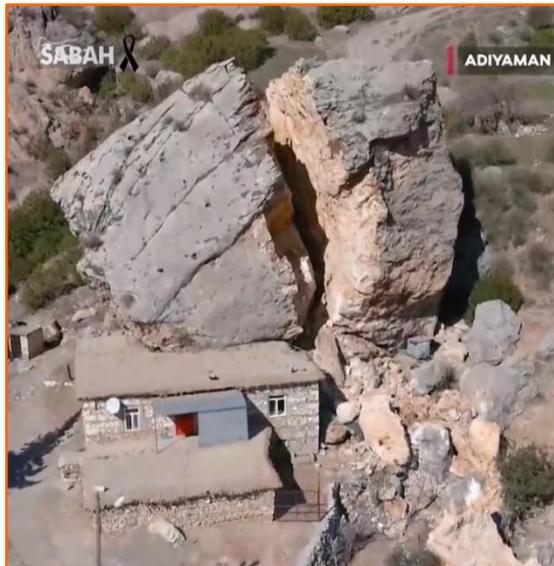
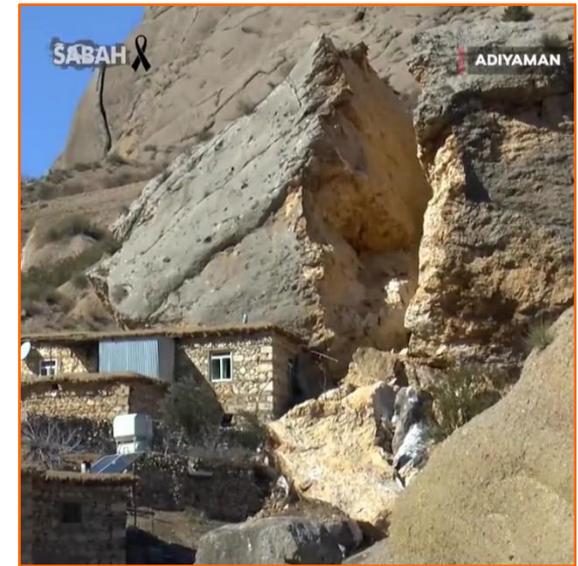
Huge boulders were detached from a slope and ended up in the village, crushing houses in the Eski Kahta (Adiyaman) area.

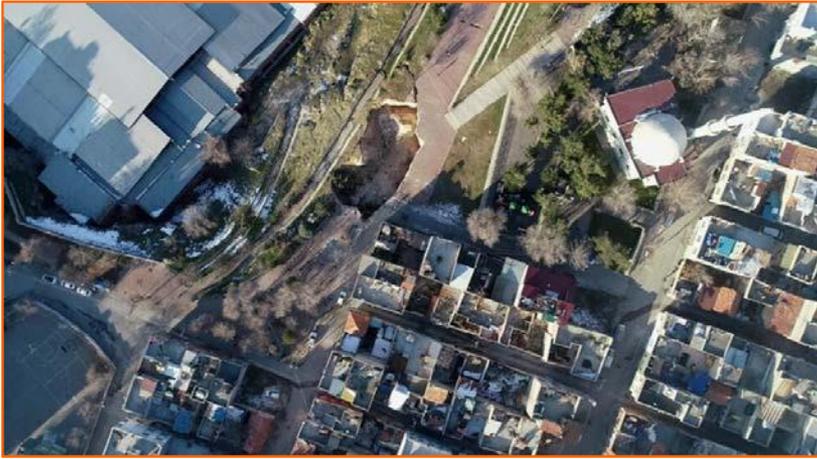
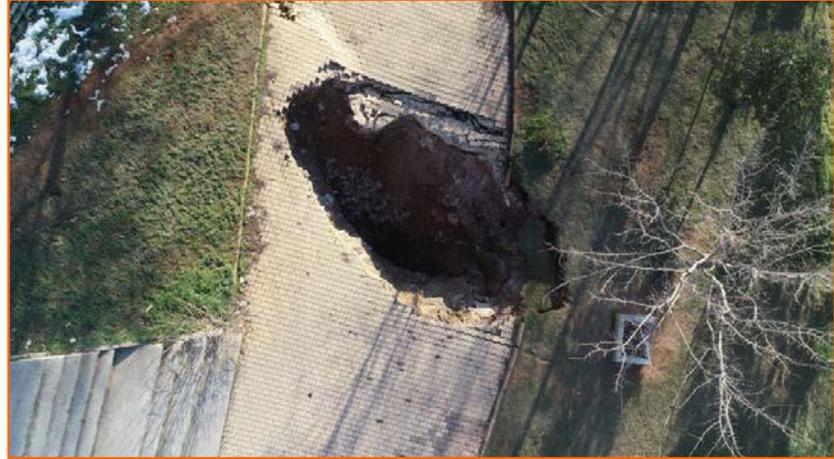
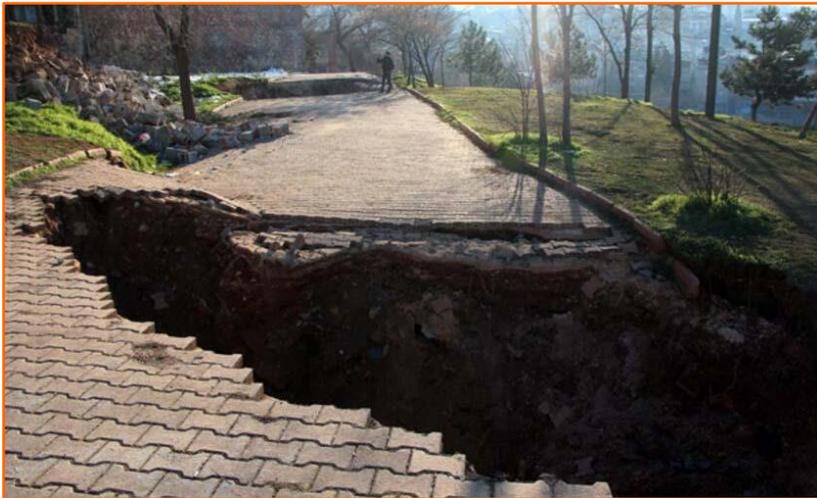
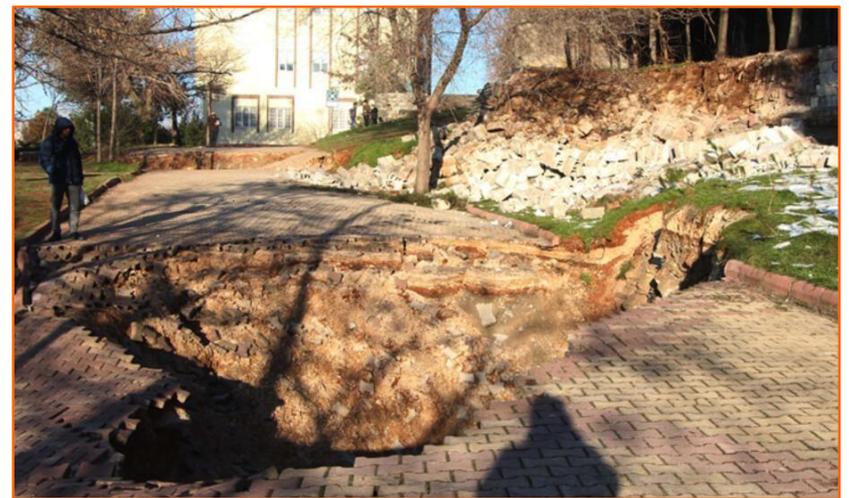
After two major earthquakes in Kahramanmaraş, 3 giant pits were formed in Yavuzlar Park in Gaziantep.

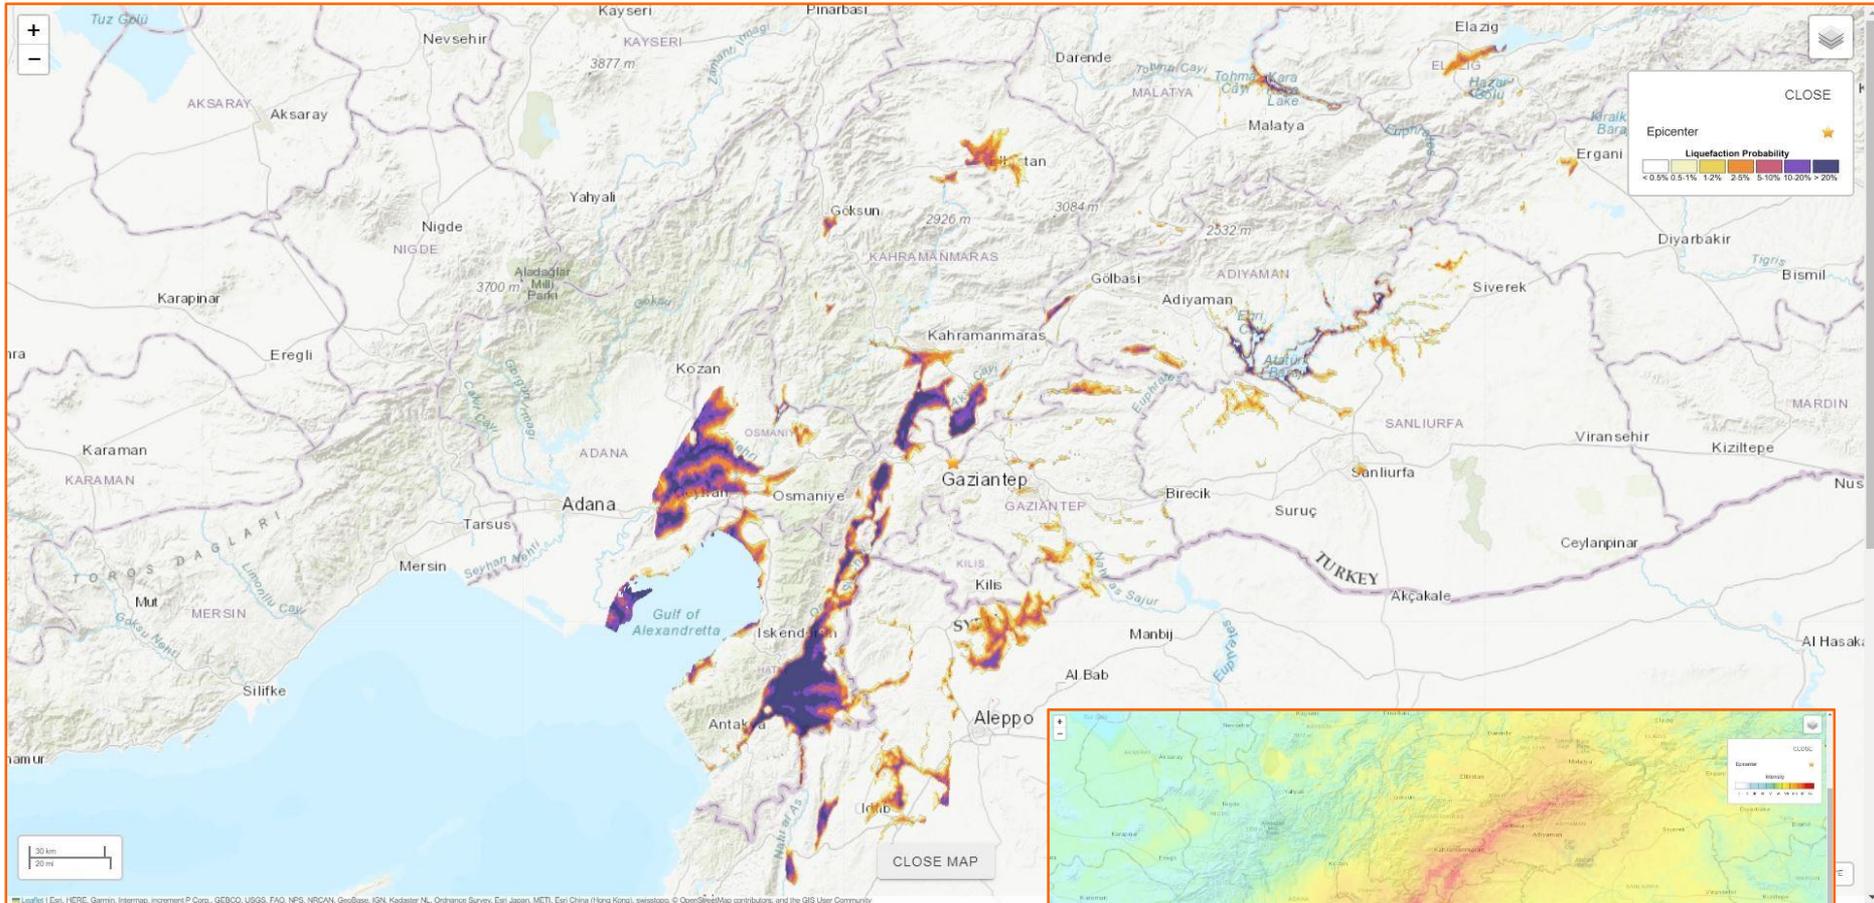
Map of liquefaction probability along the activated area of the East Anatolian Fault System. Larger probability is found in areas of maximum intensities and in lowlands composed of susceptible deposits.

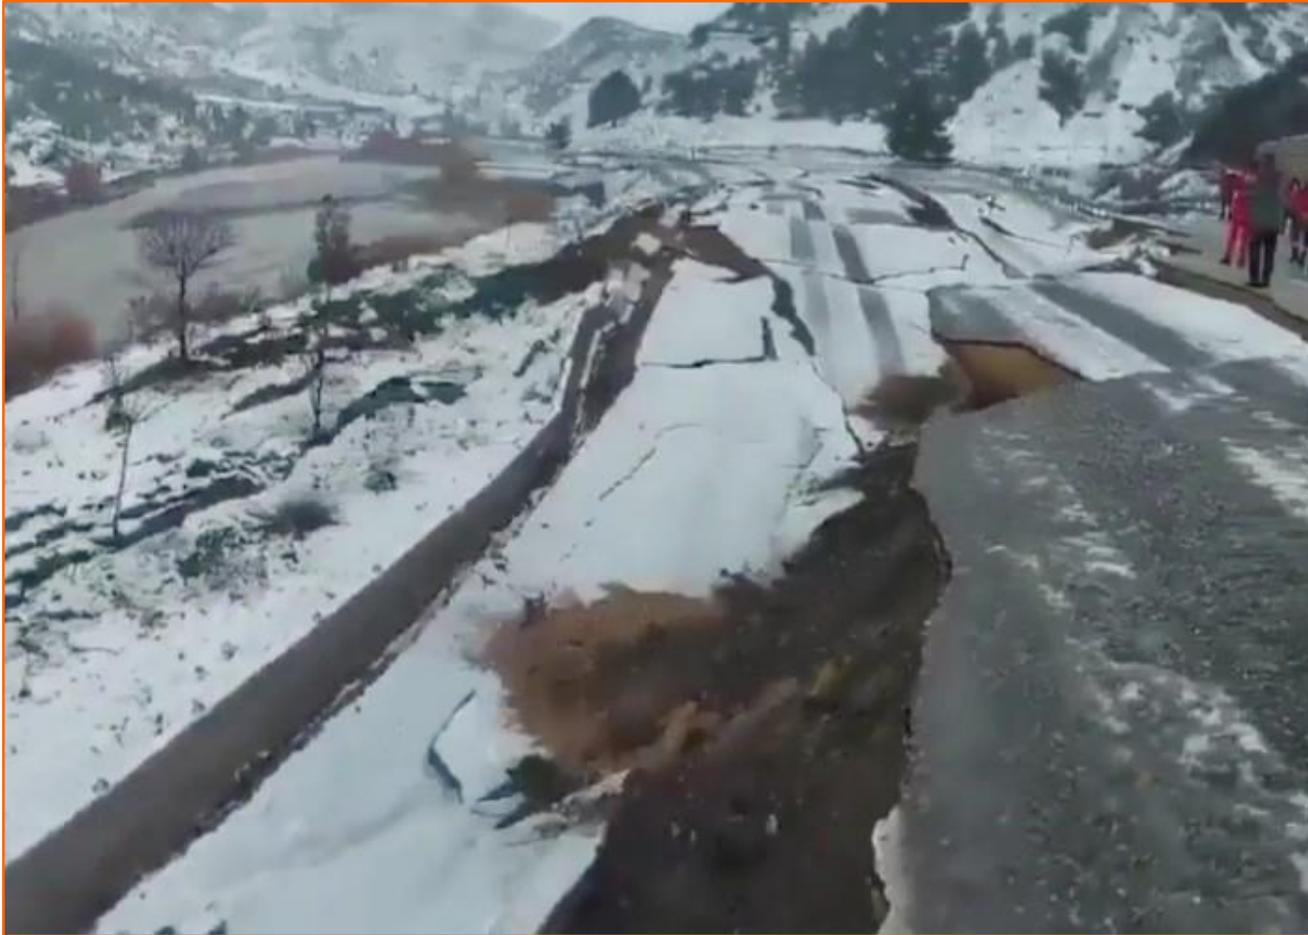
A lateral spreading failure on a river bank affected the road between Adana and Gaziantep.

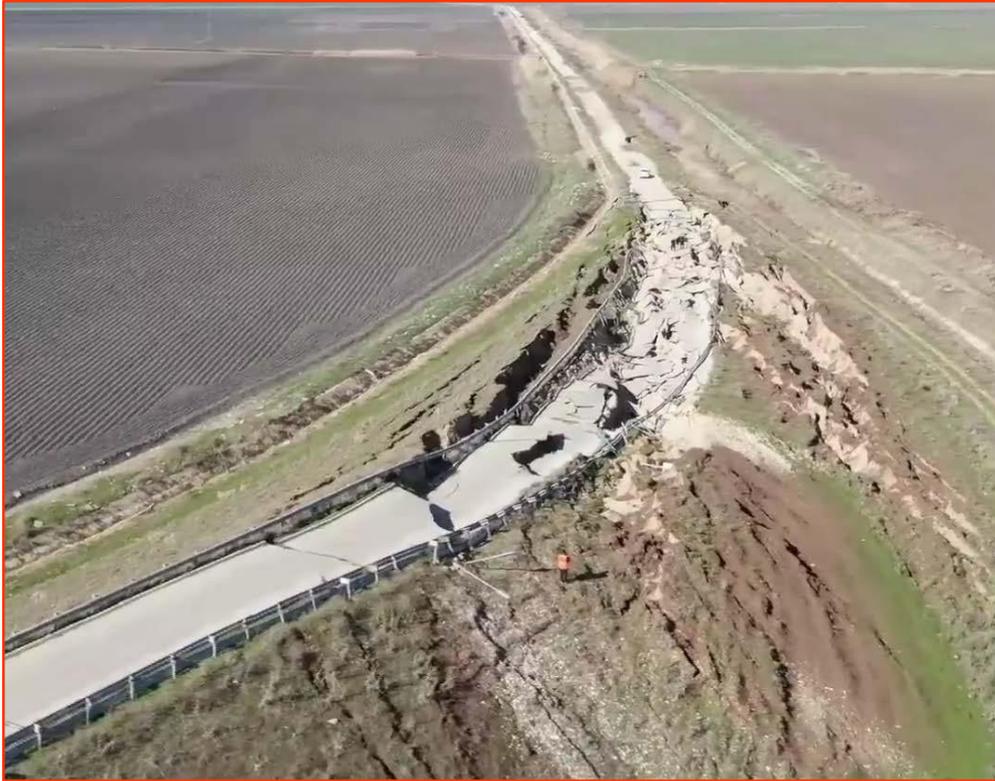
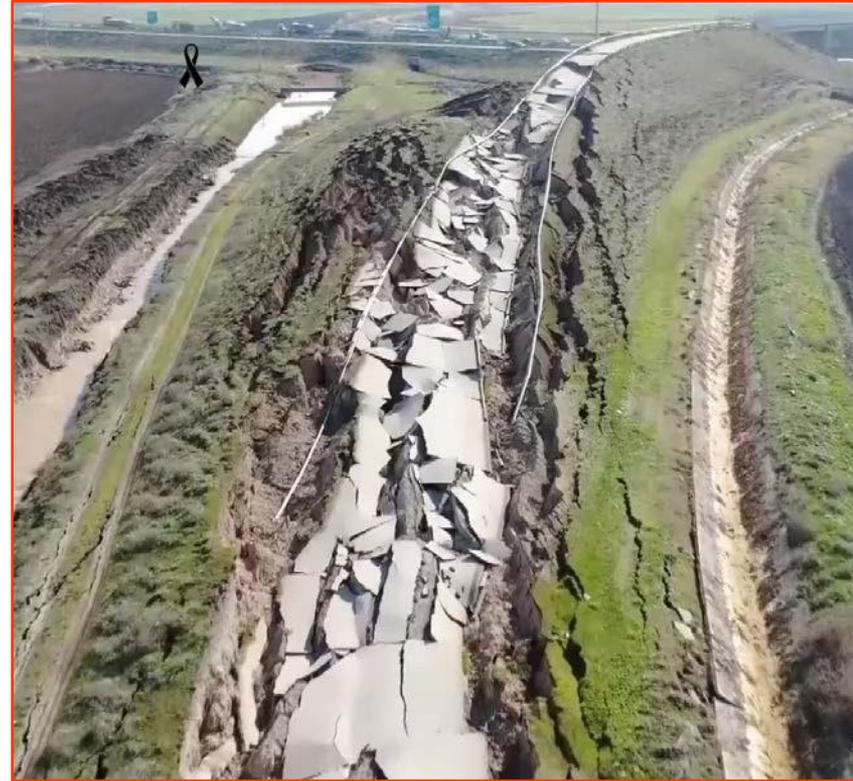
The collapse of the road to the village of Koseli, which passes over the Adiyaman-Sanlıurfa-Gaziantep Highway is attributed to earthquake-induced lateral spreading. The huge ground cracks are representative of the earthquake magnitude.

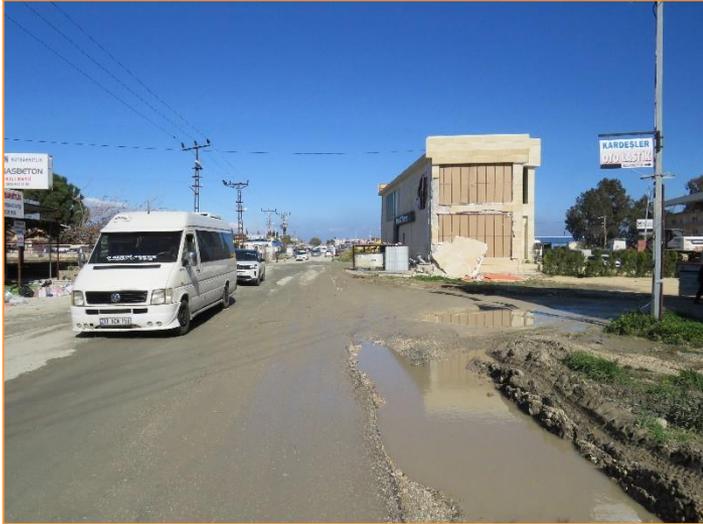
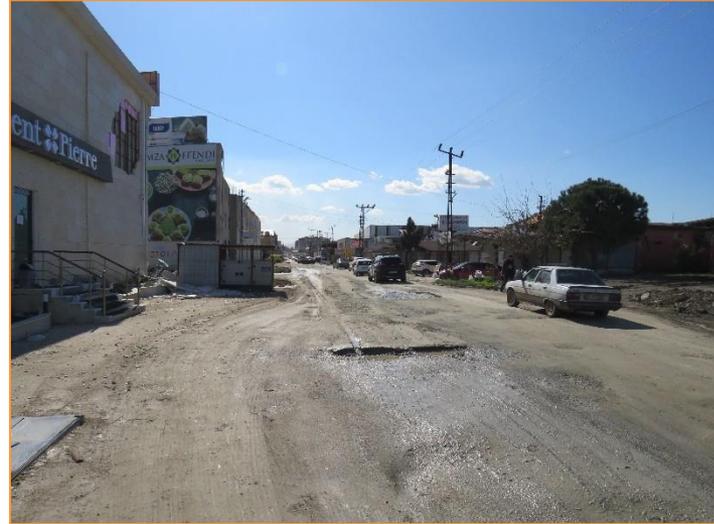
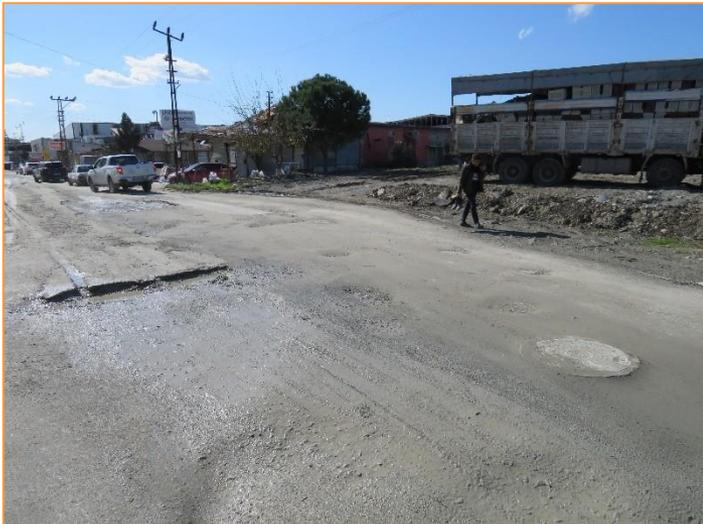
Liquefaction phenomena were triggered in several parts of the affected area. They comprised ejection of liquefied material from cracks, which covered large parts of the road and affected adjacent structures and infrastructures.

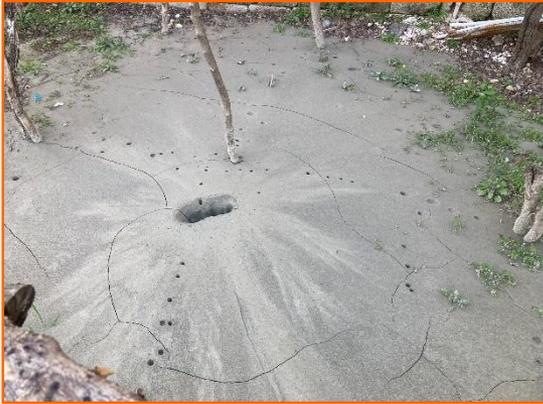
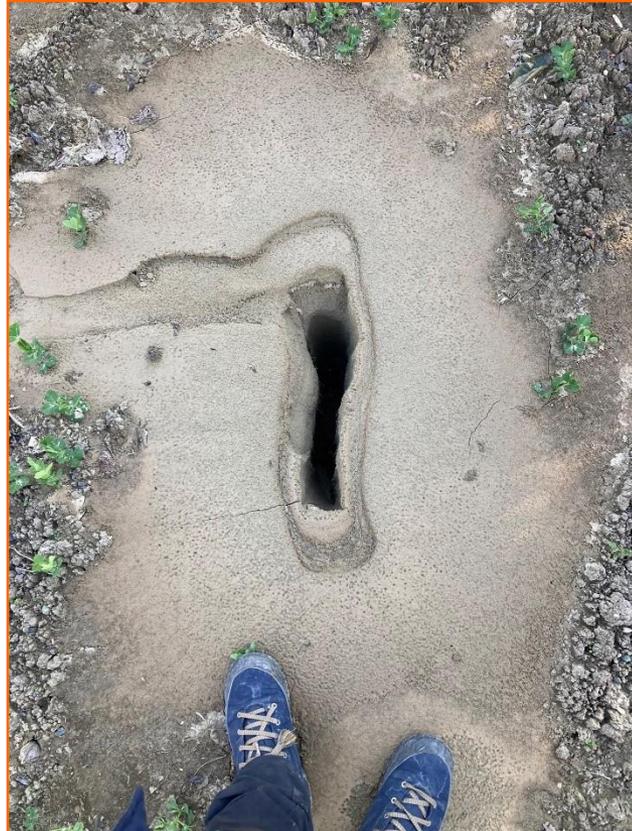
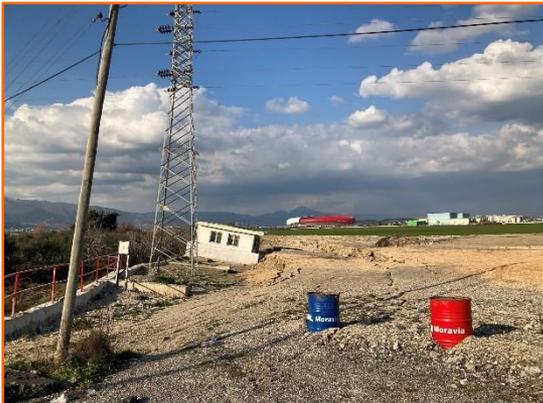
Earthquake-triggered liquefaction phenomena and subsidence reported from the northeastern end of the Hatay city center. Source: https://twitter.com/geodesist_a/status/1624410147853414400

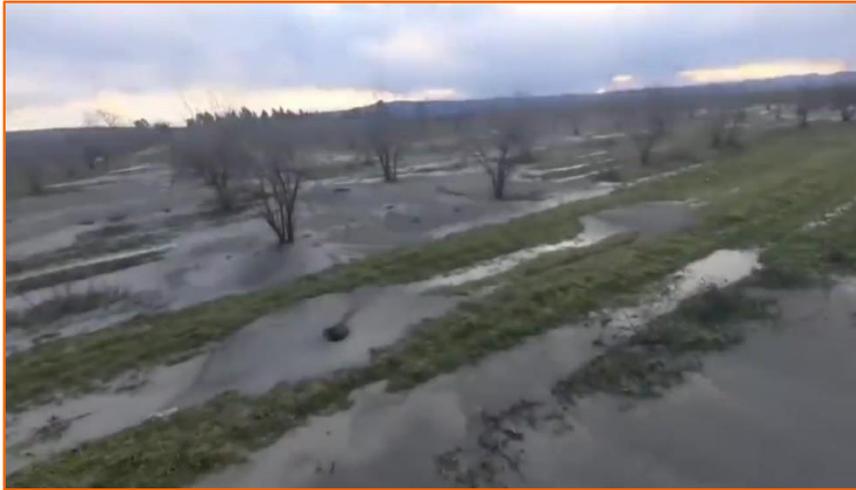
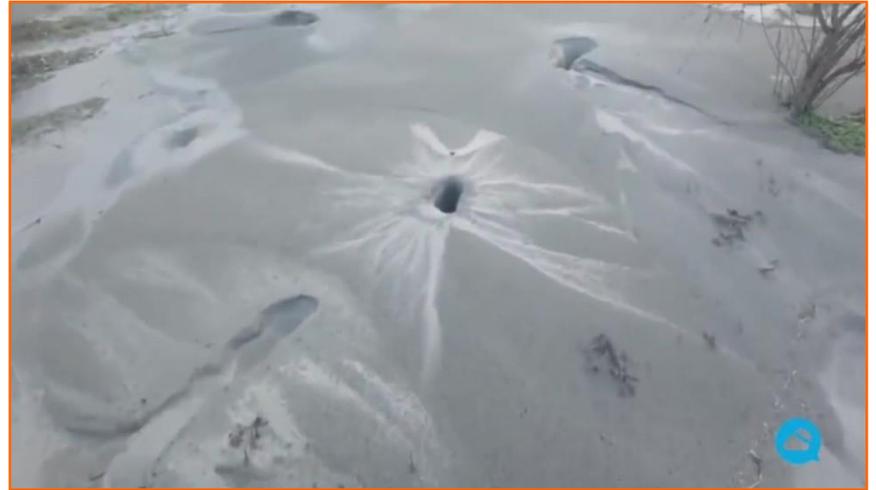
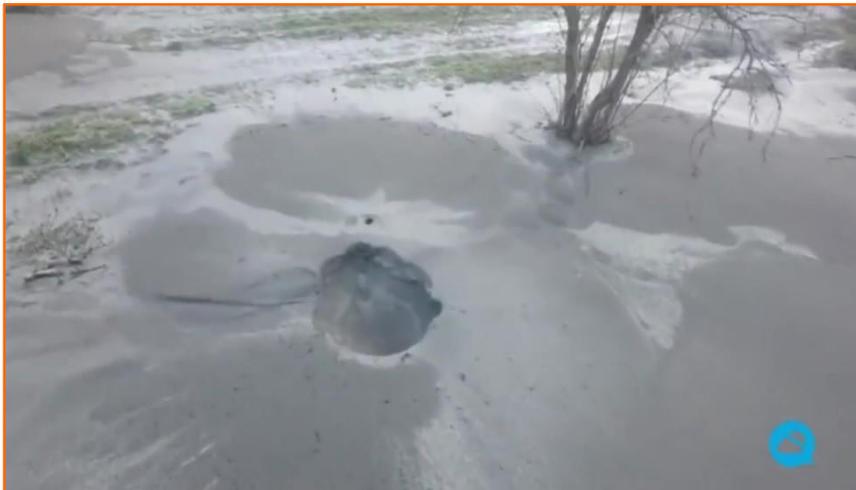
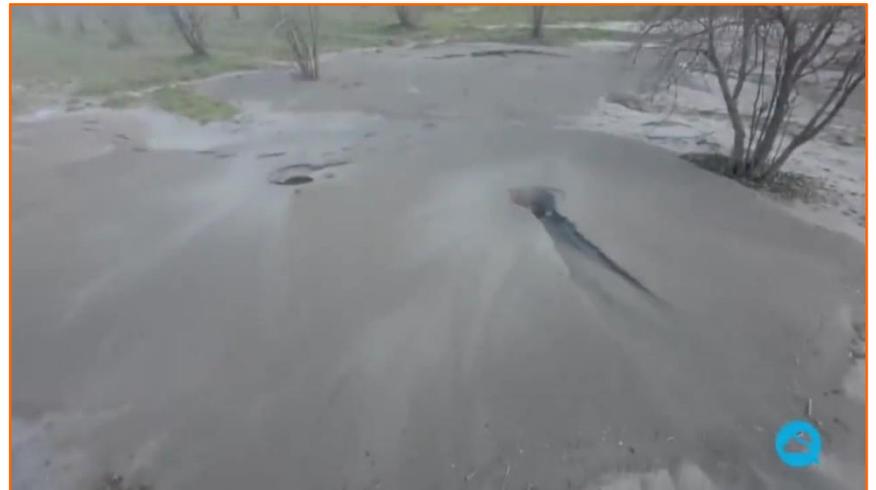
LIQUEFACTION PHENOMENA TRIGGERED BY THE 6 FEBRUARY 2023 EARTHQUAKES

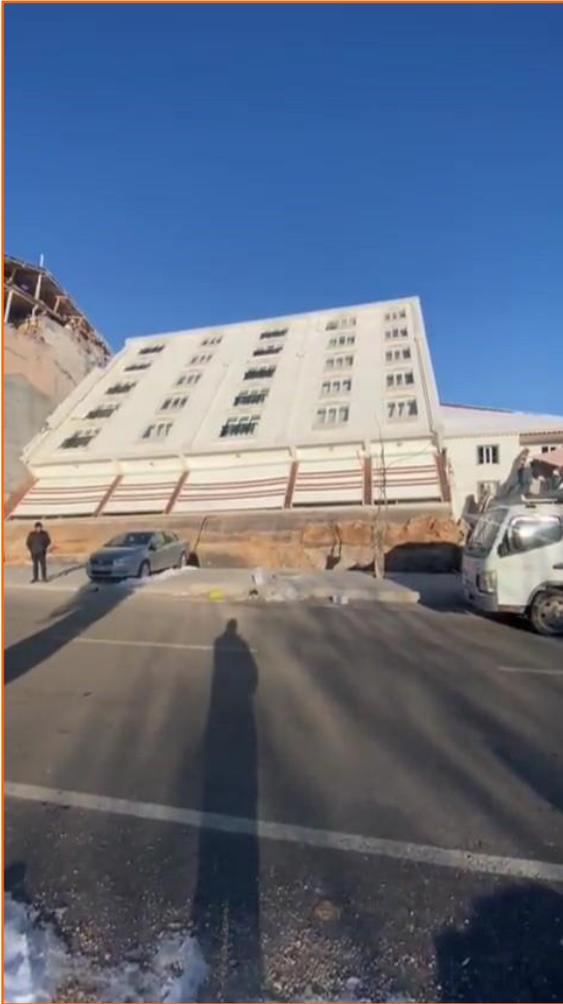
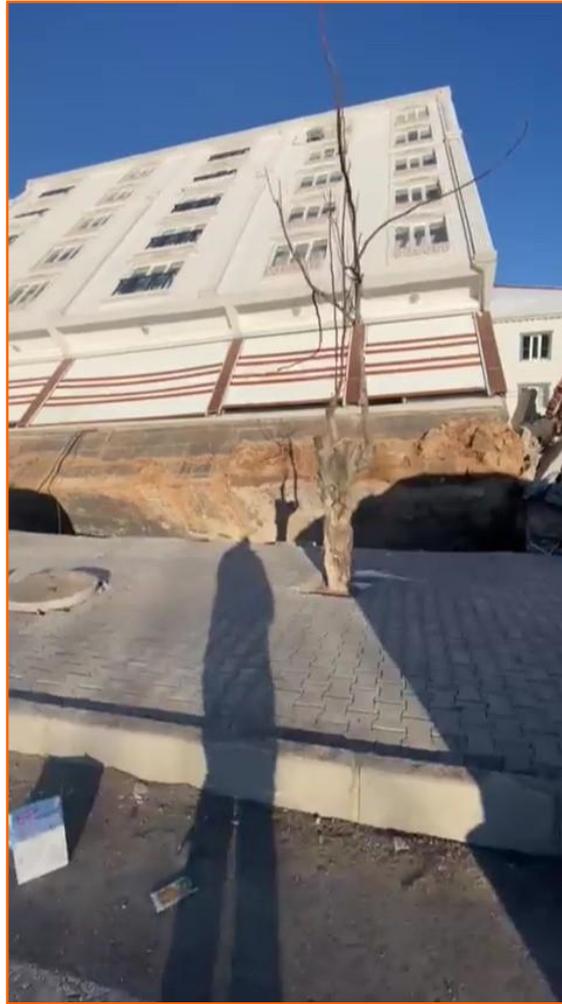
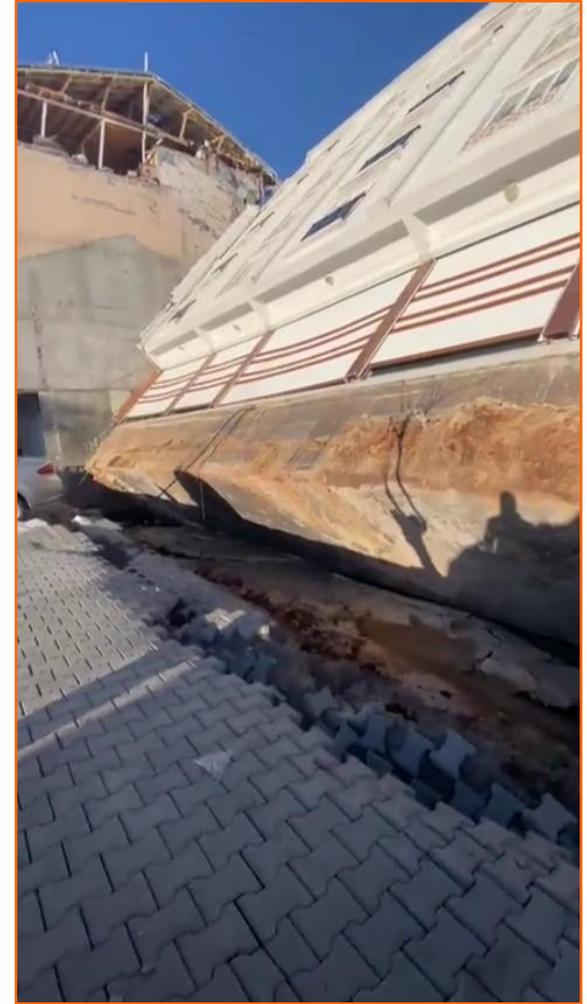
Liquefaction phenomena resulted in tilting of a building with no damage in the upper floors.

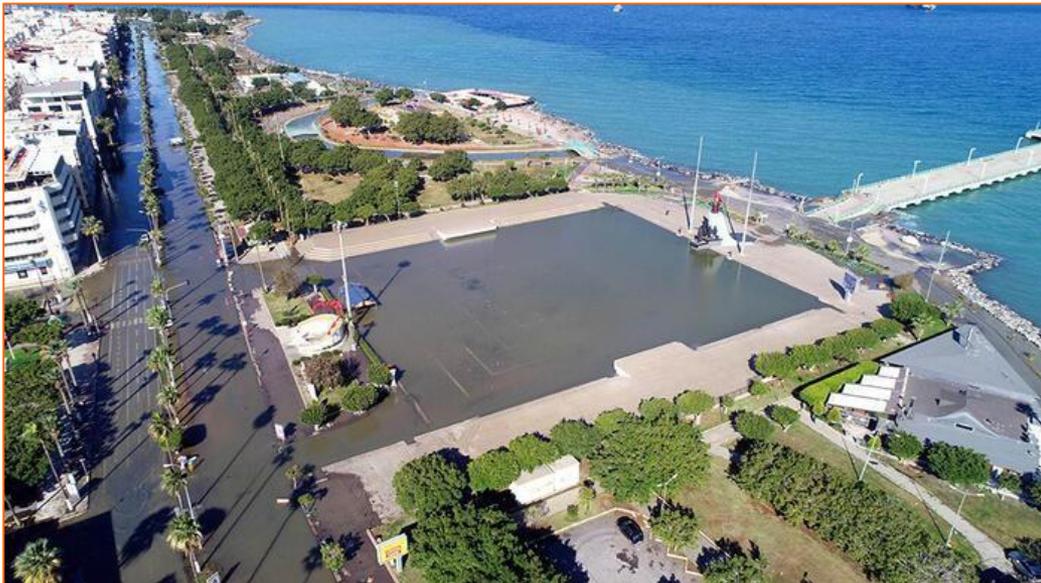
Shortly after the earthquake, the roads, buildings and infrastructures of the coastal part in the southern Hatay region were flooded. The water raised and inundated land.

The inundation is attributed to the earthquake-triggered widespread subsidence of several tens of centimeters and liquefaction-related phenomena in the coastal area composed of marine deposits. The liquefaction of the marine deposits as the result of the repeated and excessive earthquake ground shaking.

The coastal part of Iskenderun (Alexandretta) was flooded and evacuated due to the risk of both earthquake and rising water.

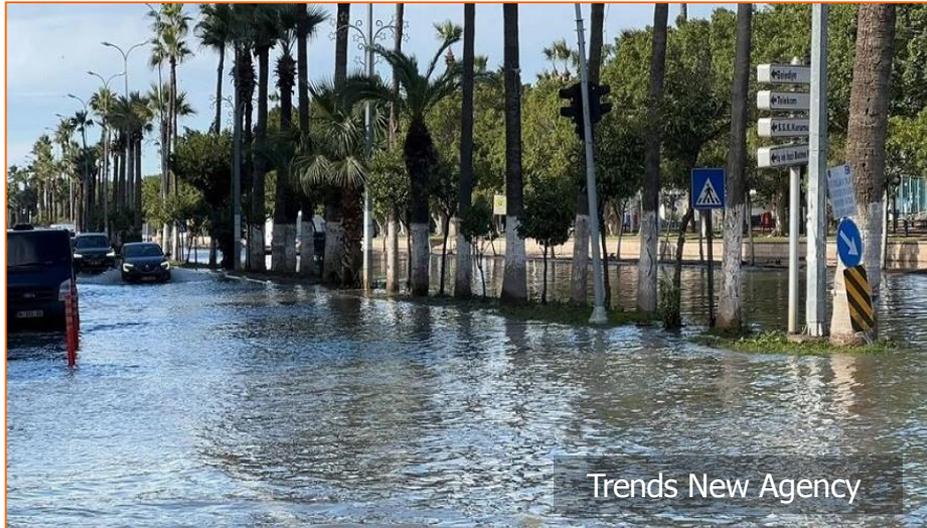
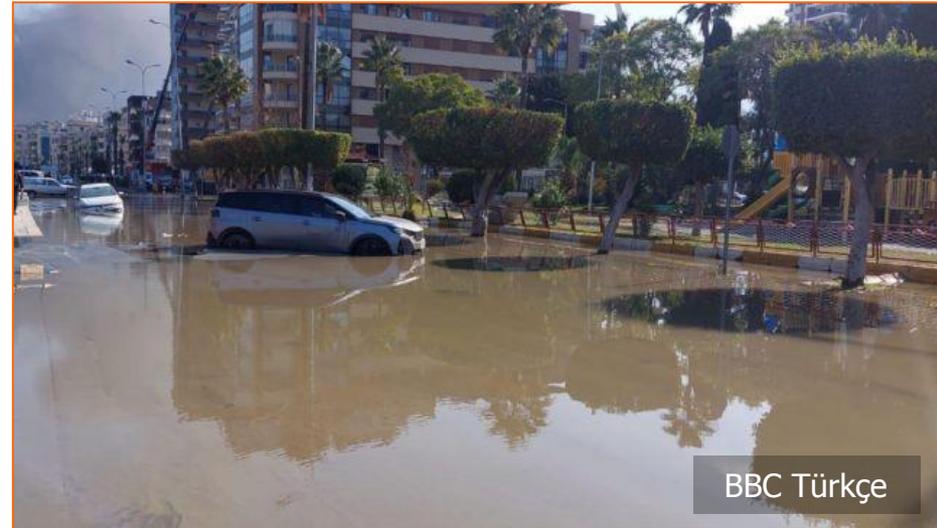
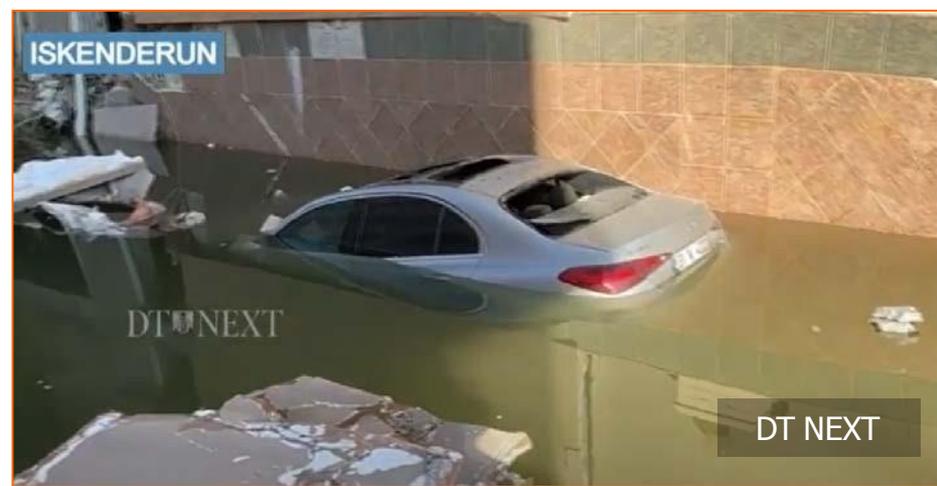
EARTHQUAKE ENVIRONMENTAL EFFECTS ON COASTAL ZONE ISKENDERUN (ALEXANDRETTA) FLOOD

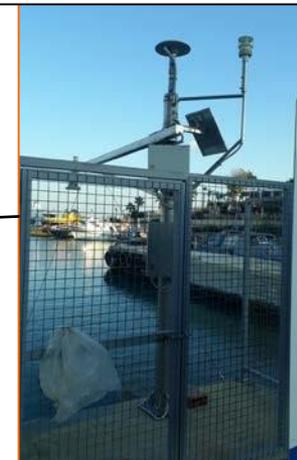
- The **Paralimni** station in the southeastern Cyprus coast recorded fluctuation **20 min** after the earthquake occurrence, with maximum fluctuation of 60 cm at 3:47 (+02:00 UTC, local time), **30 min** after the EQ.
- The sea level looks normal again after 2 hours, from the EQ time.
