Turkiye Syria 6 February 2023 Earthquakes;

Reconnaissance Visit Report and Seismological Aspects

Mehdi Zaré

12 June 2023

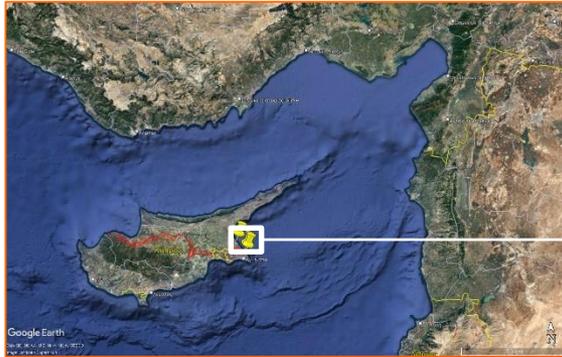
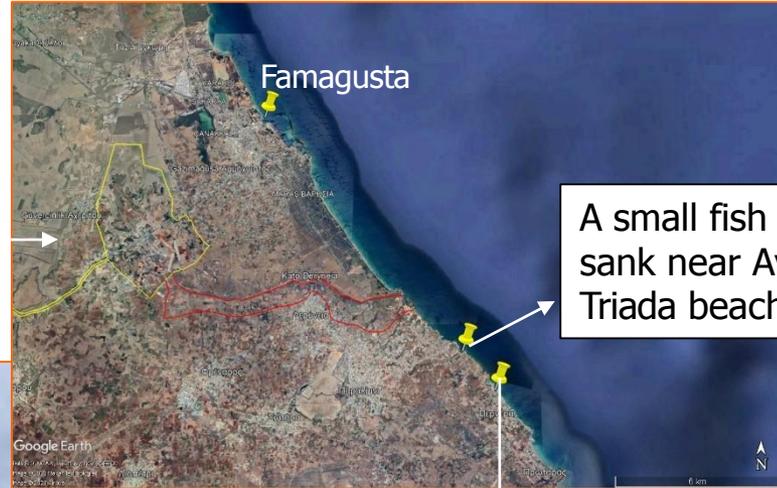
A small fish boat
sank near Ayia
Triada beach

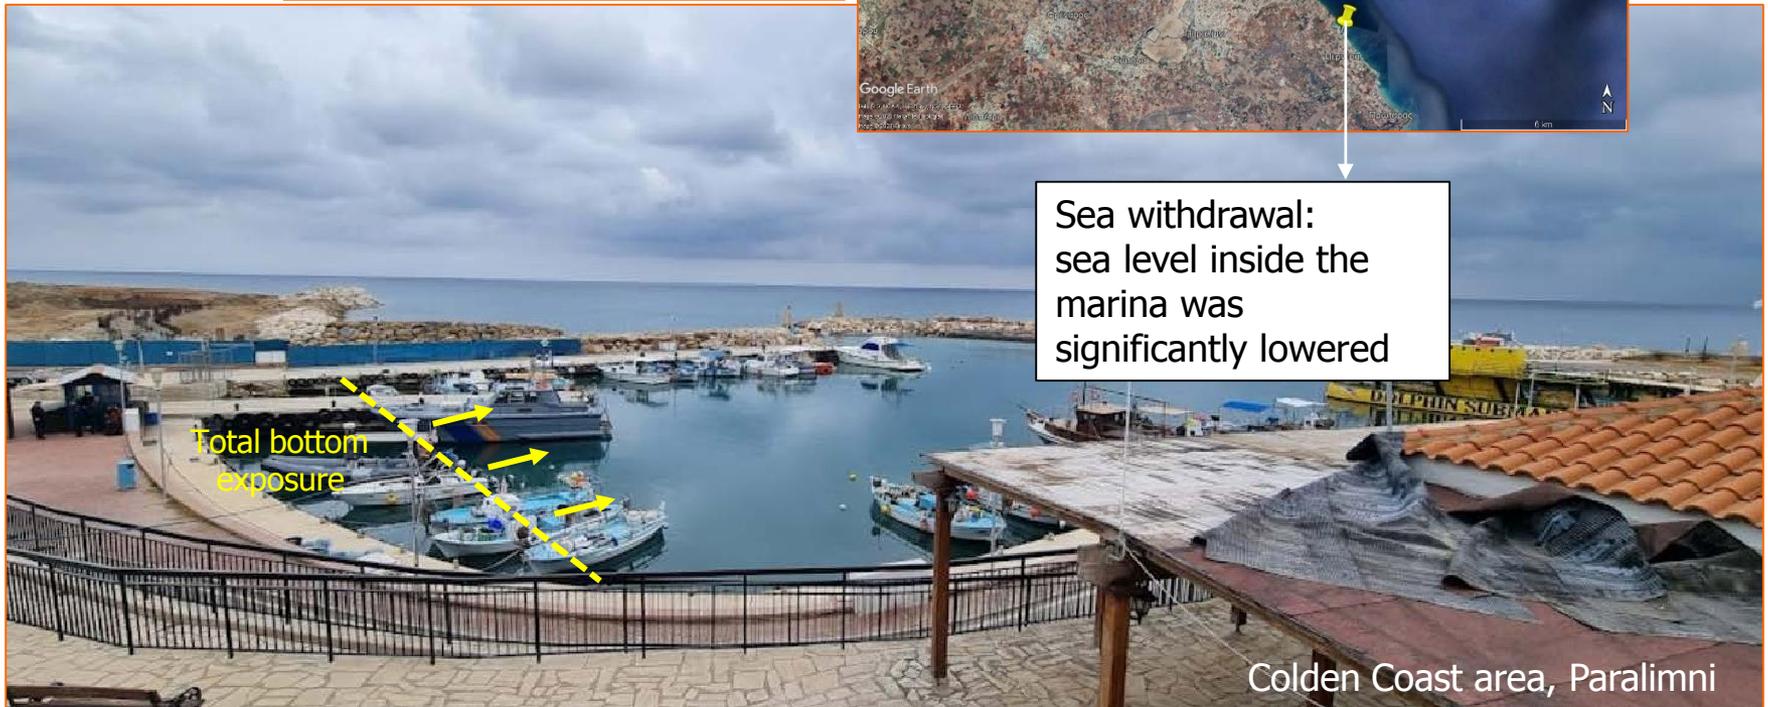
Sea withdrawal:
sea level inside the
marina was
significantly lowered

Total bottom
exposure

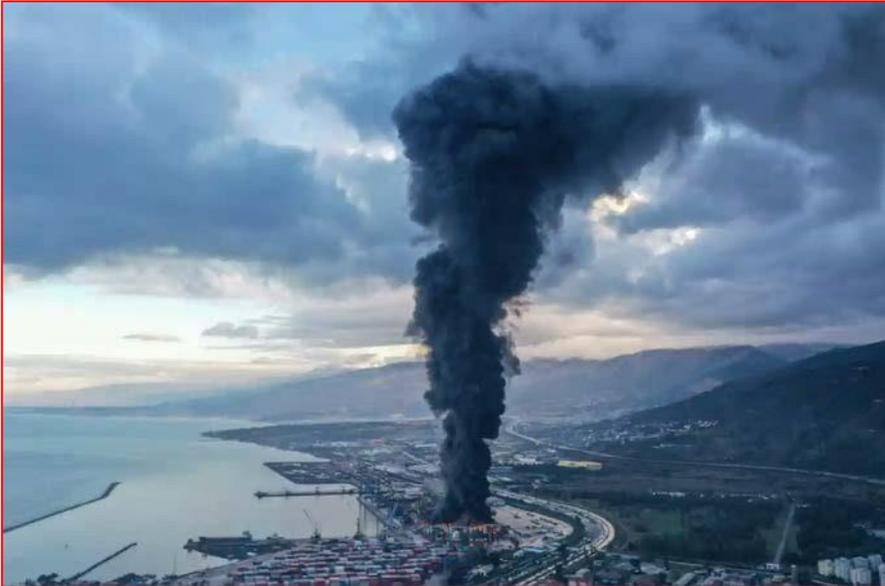
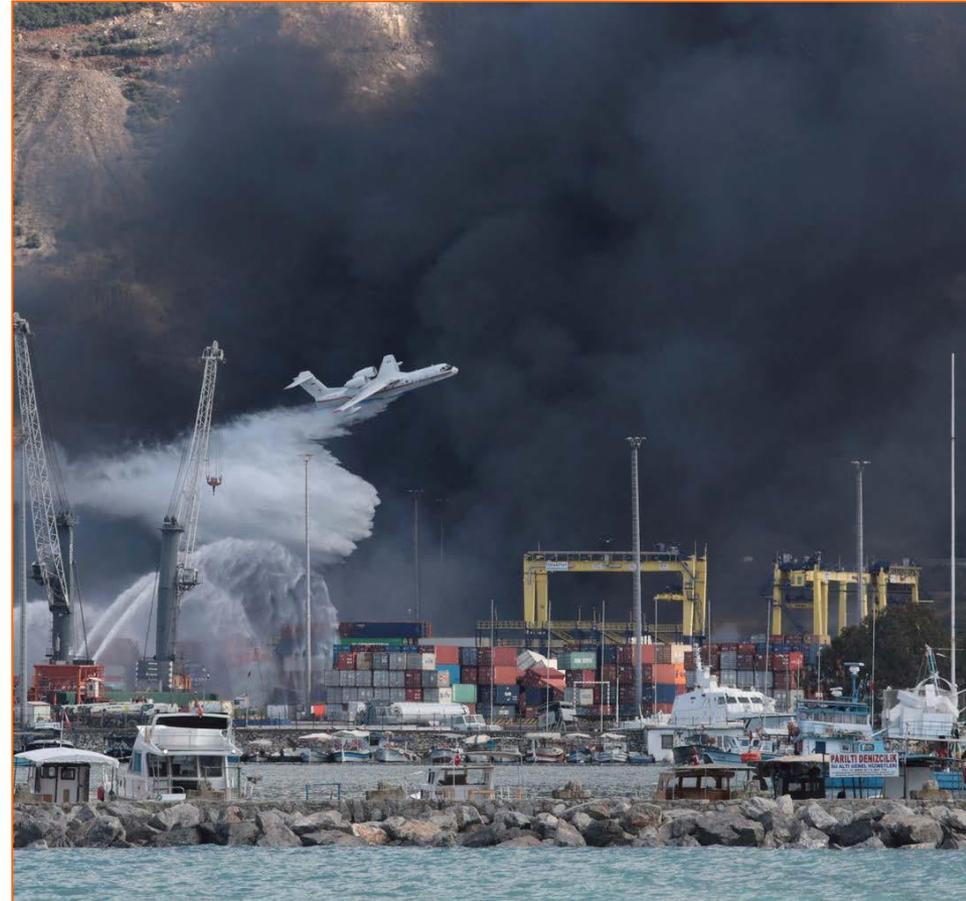
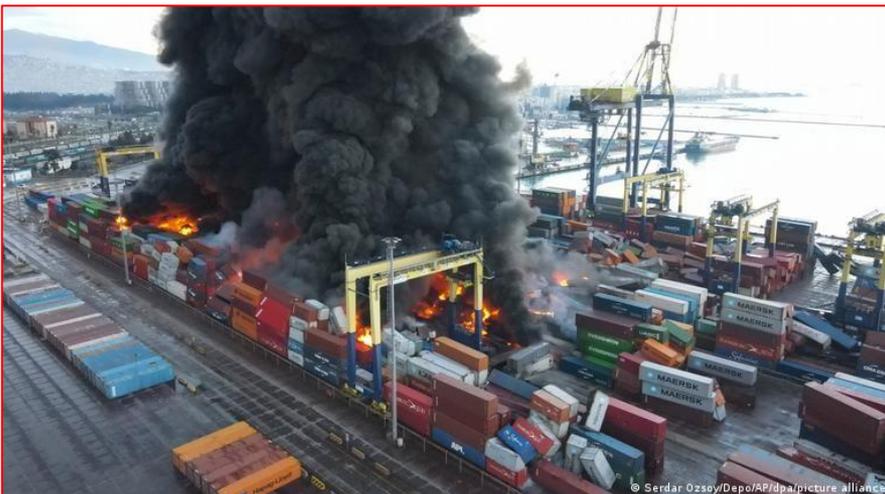
Coastal facilities at Iskenderun (Alexandretta) port collapsed and a big fire was started from the container storage area. All activities in the port were disrupted for four days.

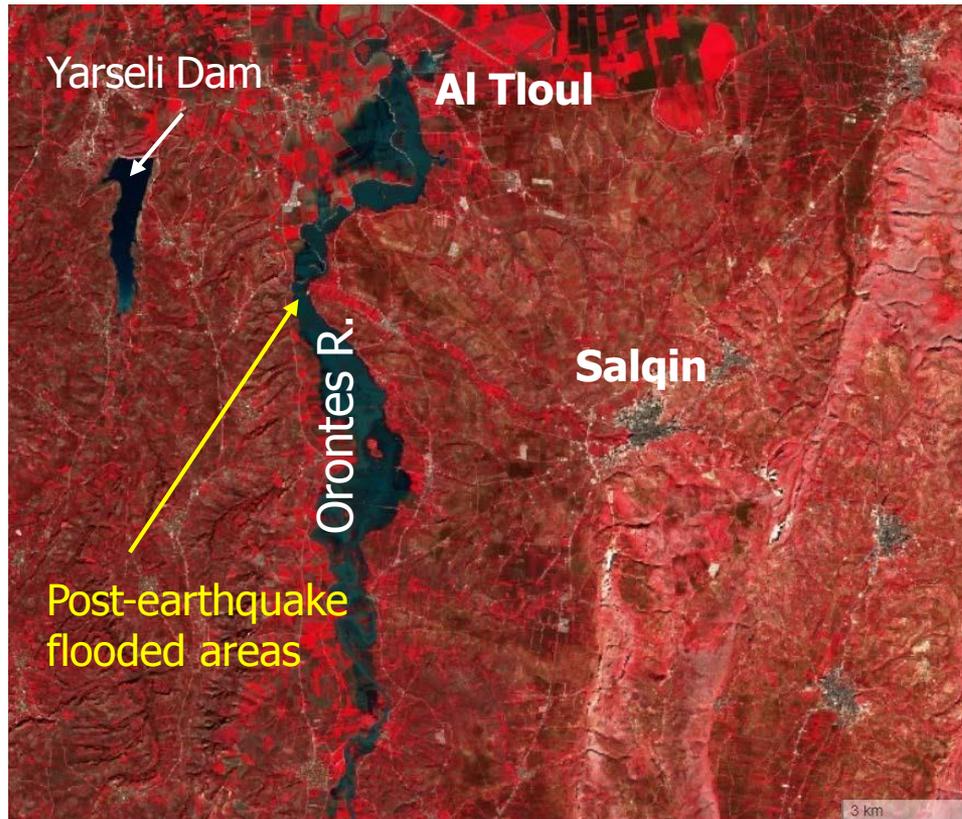
Map illustrating satellite-detected floodwaters along the Orontes (Al Assi) River on the Syria-Türkyie border close to the Al Tloul and Jakara towns. Sentinel-2 imagery acquired on 9 February 2023 show the floodplain of Orontes R. flooded after the earthquake. Within the analyzed area of 210 km² about 18 km² appears to be flooded. The floods were triggered by the opening of local dams and the damage induced to certain water-related infrastructures along the river by the the earthquake. The flood event led to the displacements of people from the village of Al-Tloul (Salqin Nahiyah Subdistrict, Harem District, Idlib Governorate) to nearby camps as several houses have been submerged by water, leading to 7,000 evacuated people and 1,000 flooded houses across the nearby villages of Hardana, Delbiya, Jakara, and Hamziyeh.

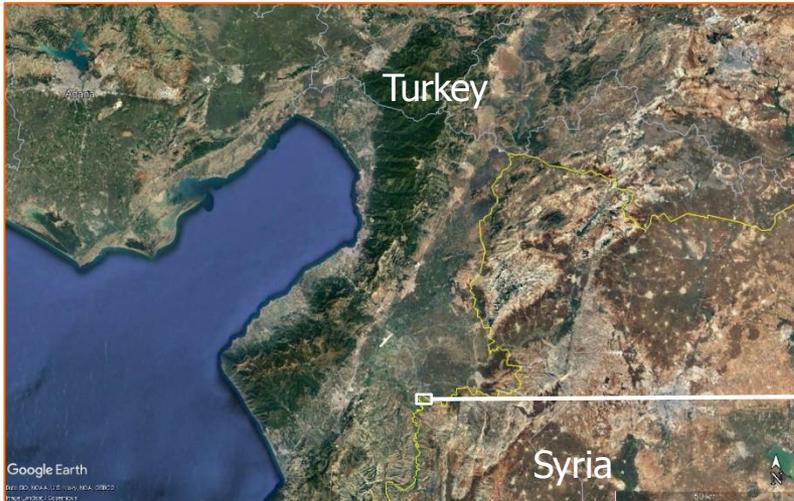
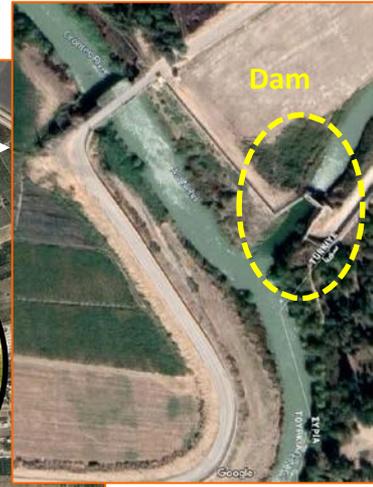
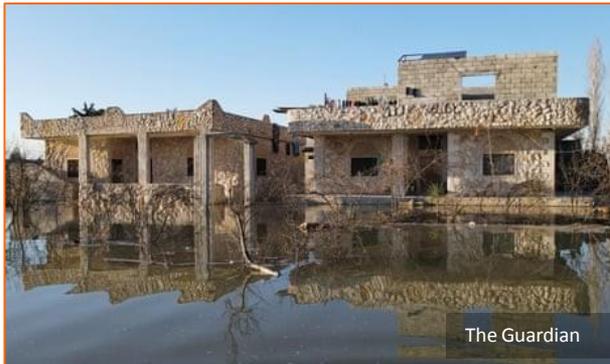
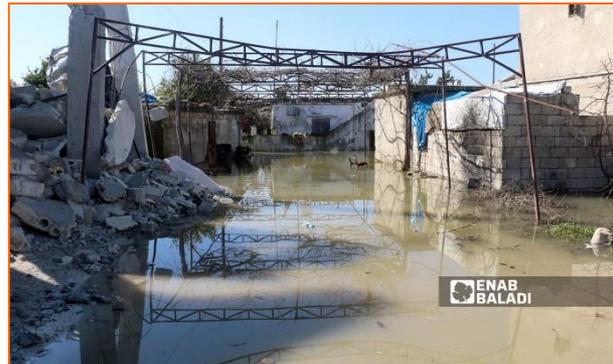
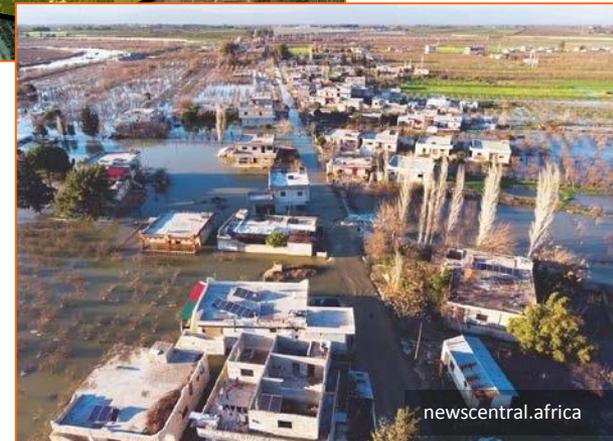
Flooding in the Syrian village of Al-Tloul, after a dam collapsed following the deadly earthquake

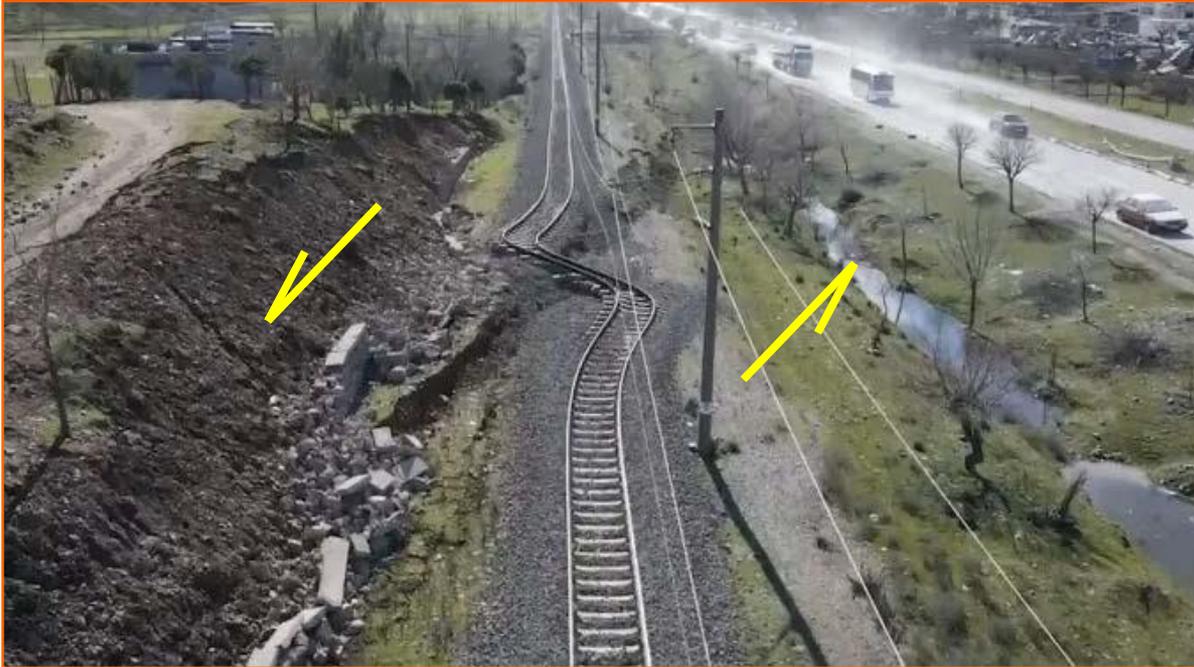
Railway tracks were heavily deformed due to the surface ruptures. They were restored few days after the occurrence of the earthquake.

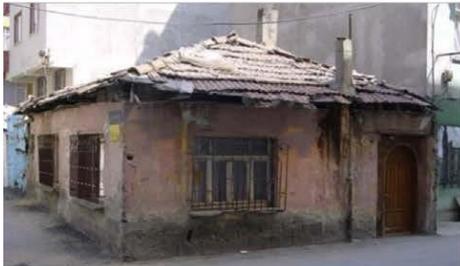
1st generation buildings (1960s)

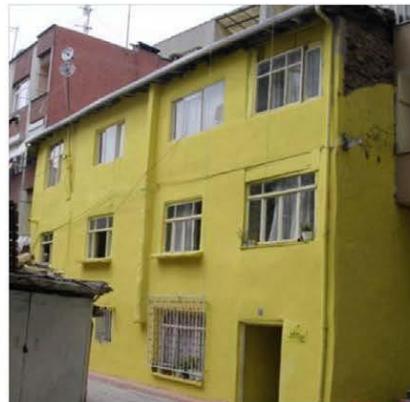
2nd generation buildings (1970s)

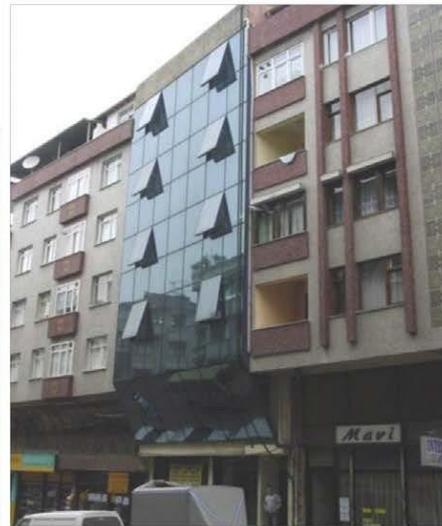
3rd generation buildings (1980s)

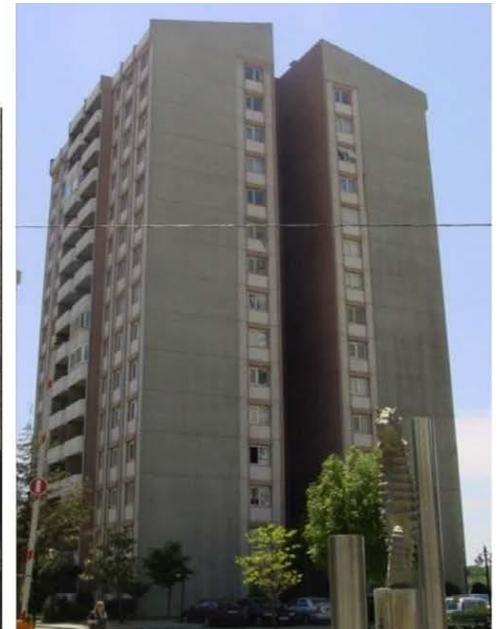
4th generation buildings (90s and later)

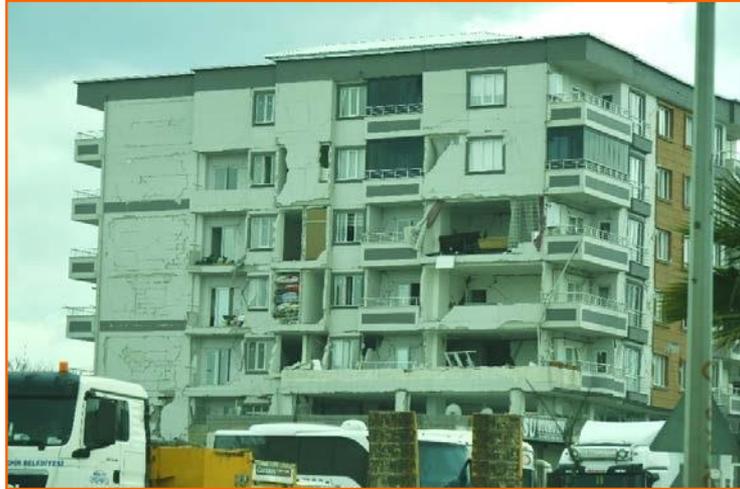
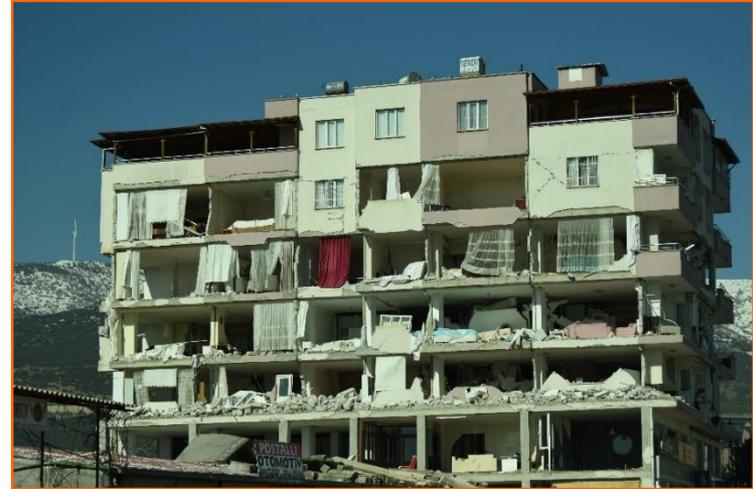
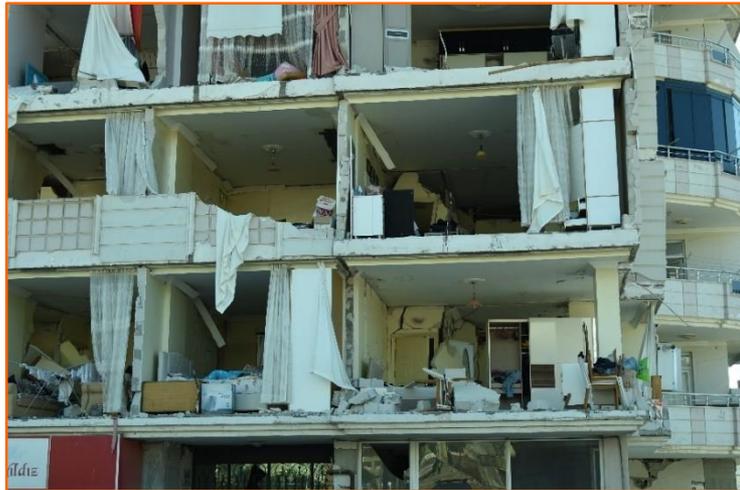
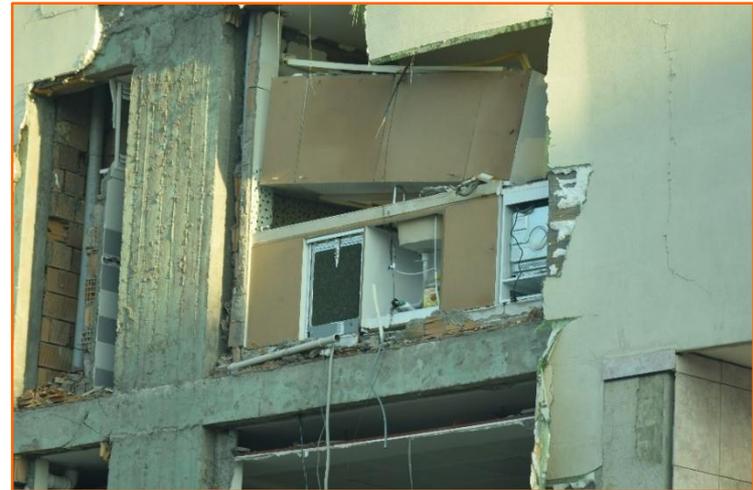
DAMAGE TO SECONDARY STRUCTURAL ELEMENTS WITH PARTIAL COLLAPSING

The load-bearing system of many buildings' has not suffered significant damage, in contrast to the external infill masonry, as well as some (internal) partition walls, which have -in some cases- completely collapsed.

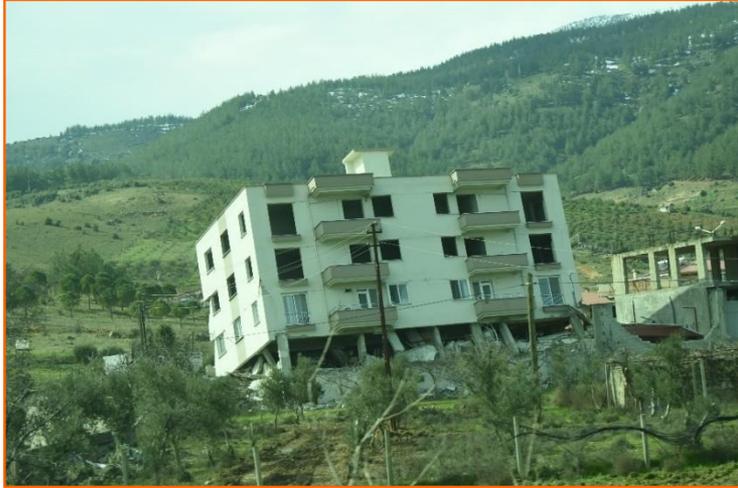
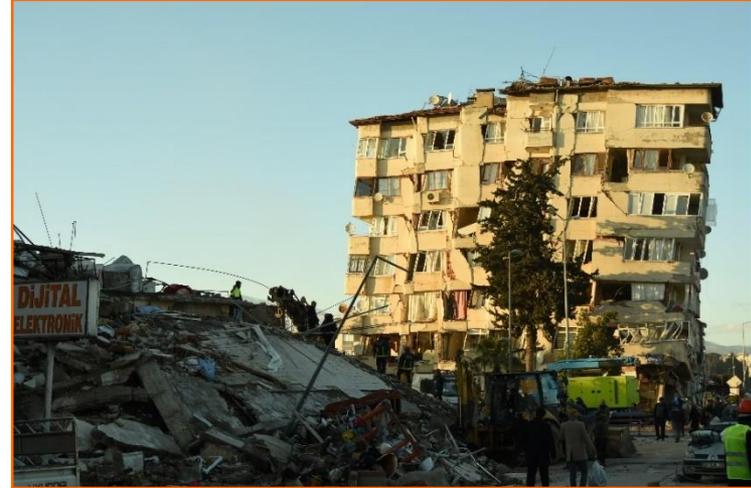
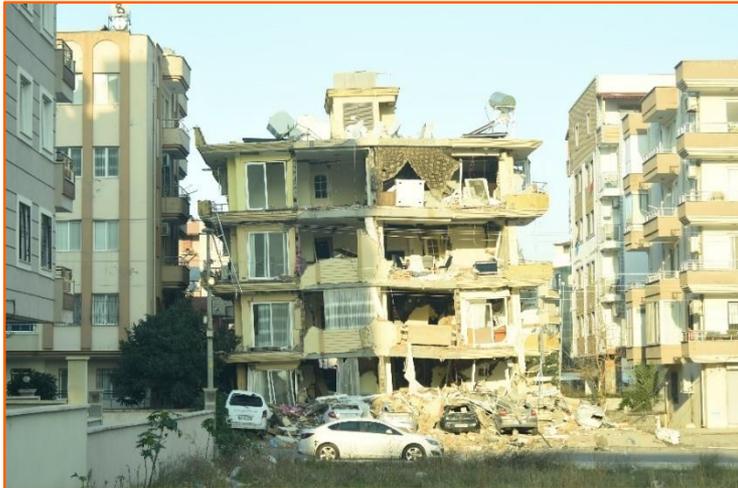
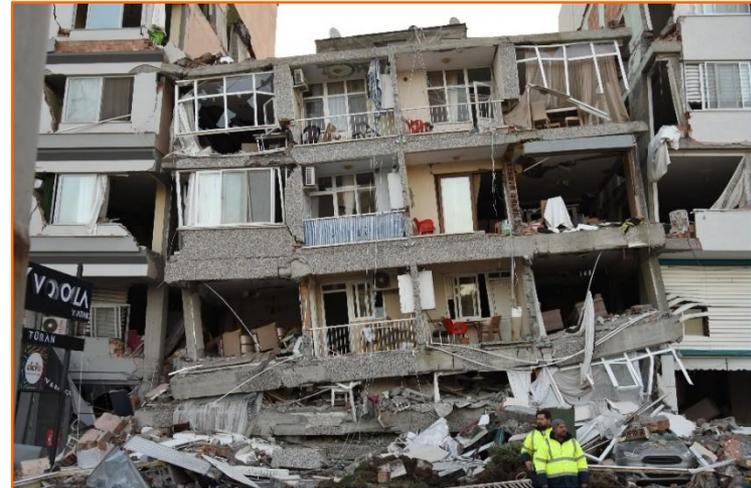
DAMAGE TO THE LOAD-BEARING SYSTEM WITHOUT TOTAL COLLAPSING

In several cases, although the structures have not completely collapsed, their load-bearing system has suffered significant damage that is considered beyond repair.

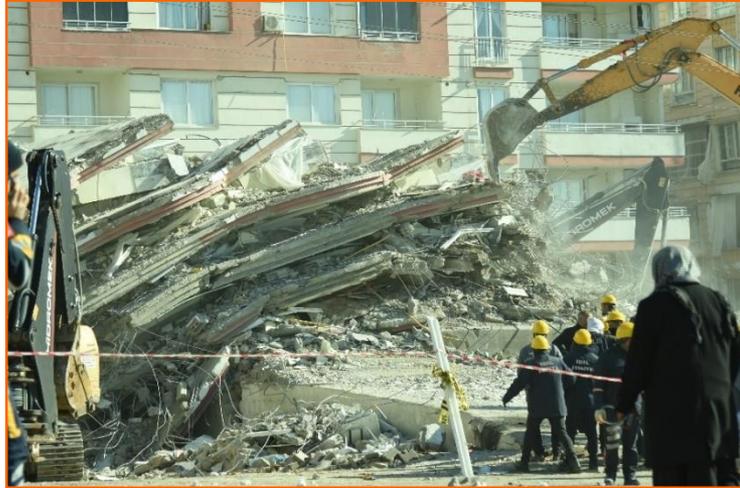
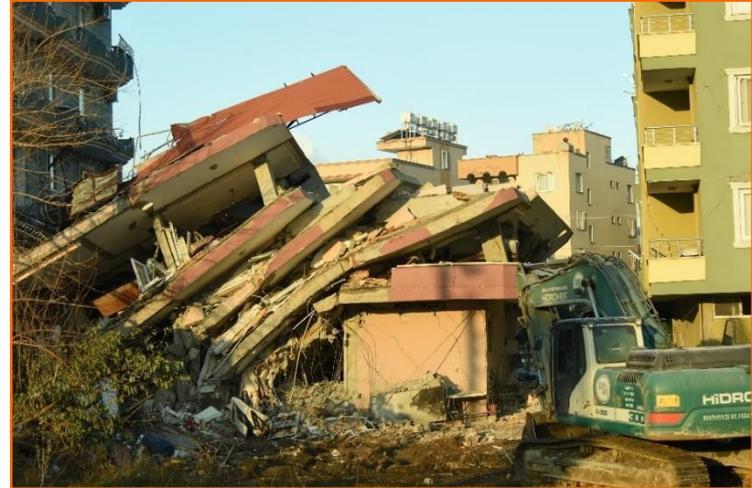
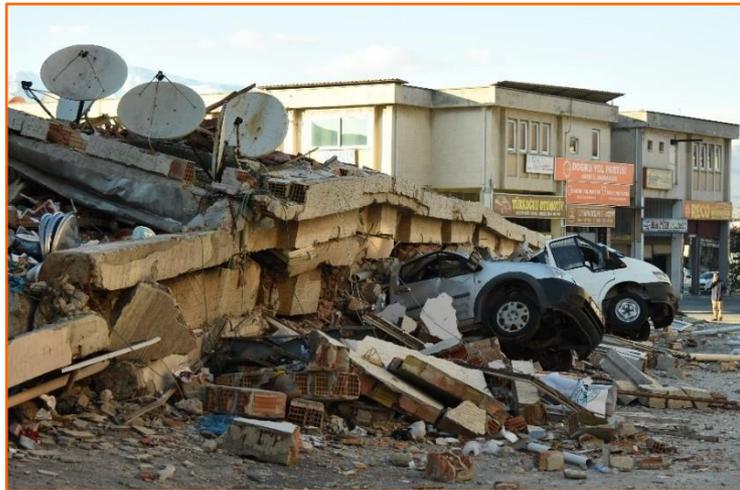
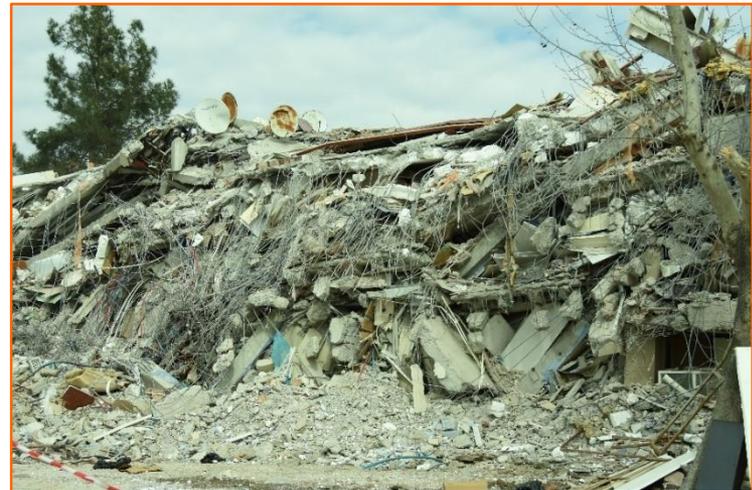
DAMAGE TO LOAD-BEARING SYSTEM WITH TOTAL COLLAPSING OF BUILDINGS

High-rise buildings have completely collapsed, while it is striking that the majority of collapses occurred within the outline of their floor plans. Inside these particular hills of rubble there are people trapped.

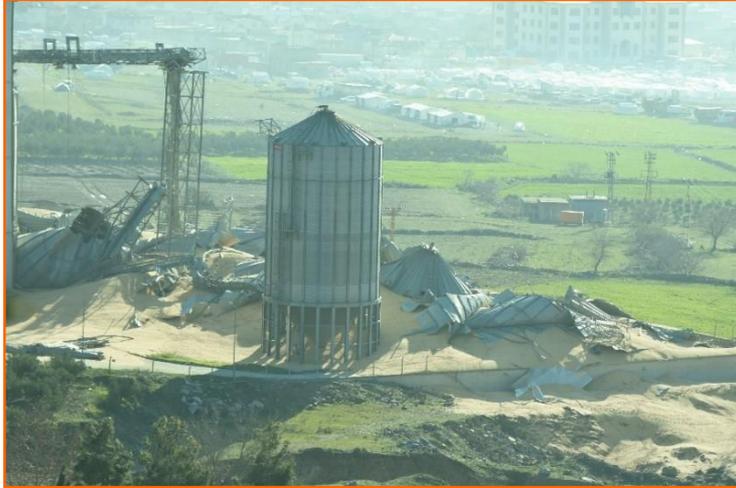
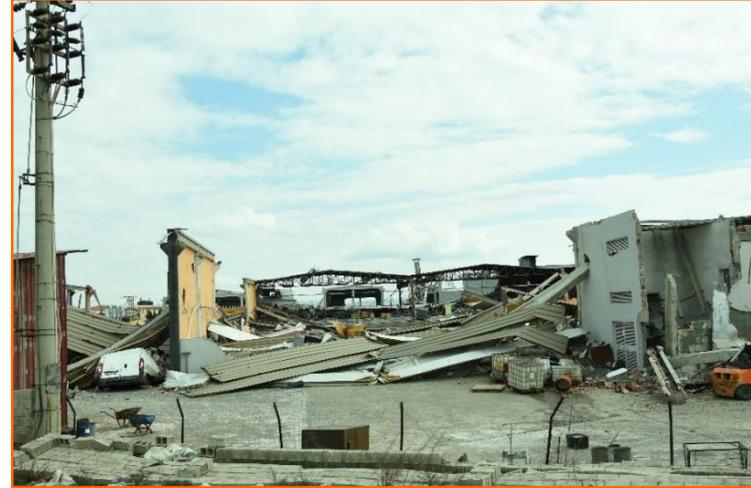
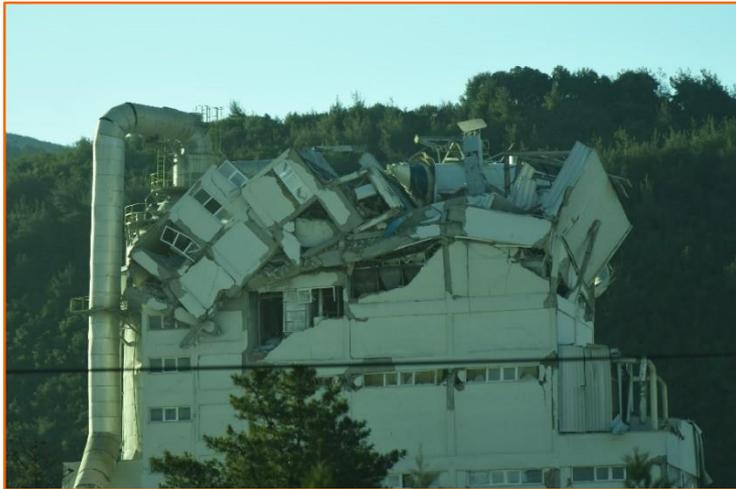
OTHER DAMAGE TO INDUSTRIAL BUILDINGS AND PLACES OF WORSHIP

Significant damage can be seen in industrial buildings, while in places of worship (mosques) damage of the same extent was not observed, except for the collapse of several minarets. Due to the time when the first seismic excitation occurred (04:17 local time), most of these spaces were vacant.

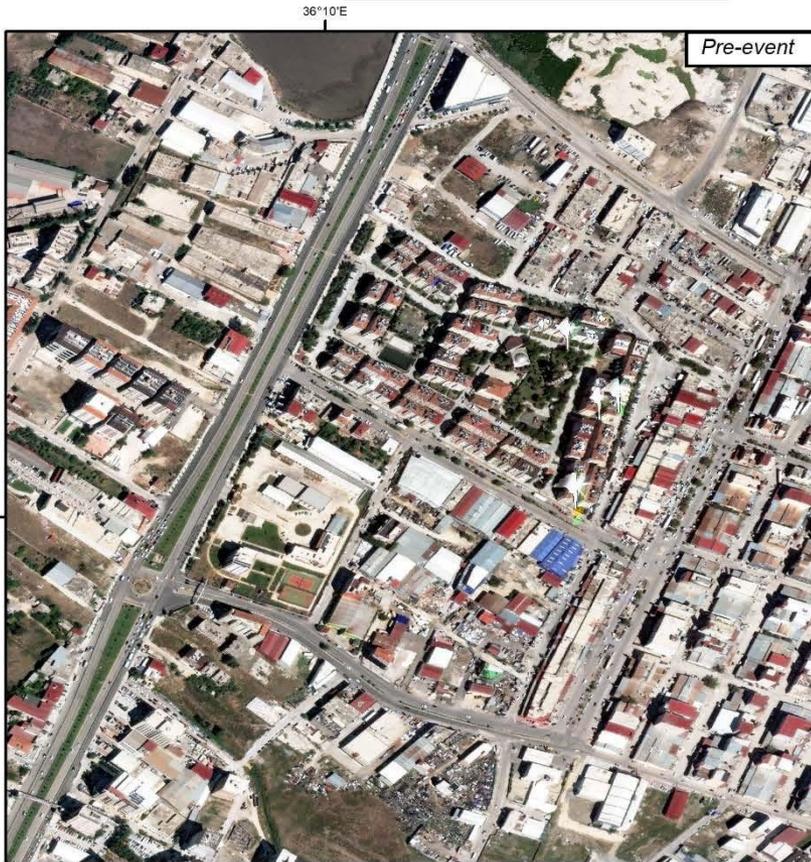
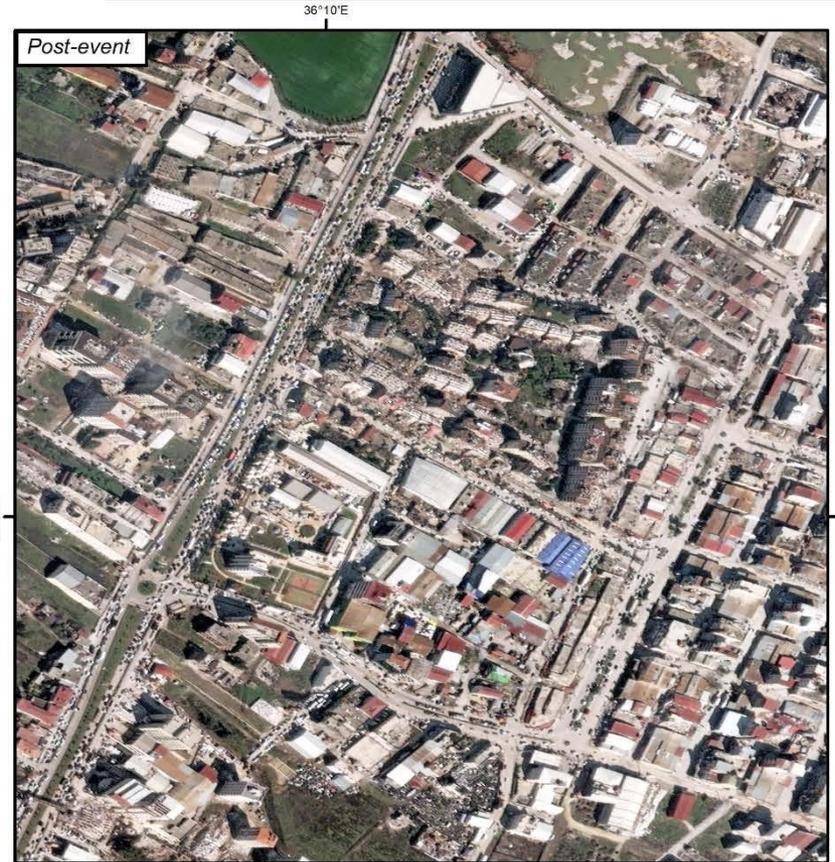
Earthquake dates: February 6, 2023
Magnitude: 7.8
Location: Antakya center
Remote Sensing data used: WorldView2
Spatial resolution: 0.3 meters
Pre Data Acquisition: 22.12.2022
Post Data Acquisition: 08.02.2023
Processing: Vassilakis, Konsolaki

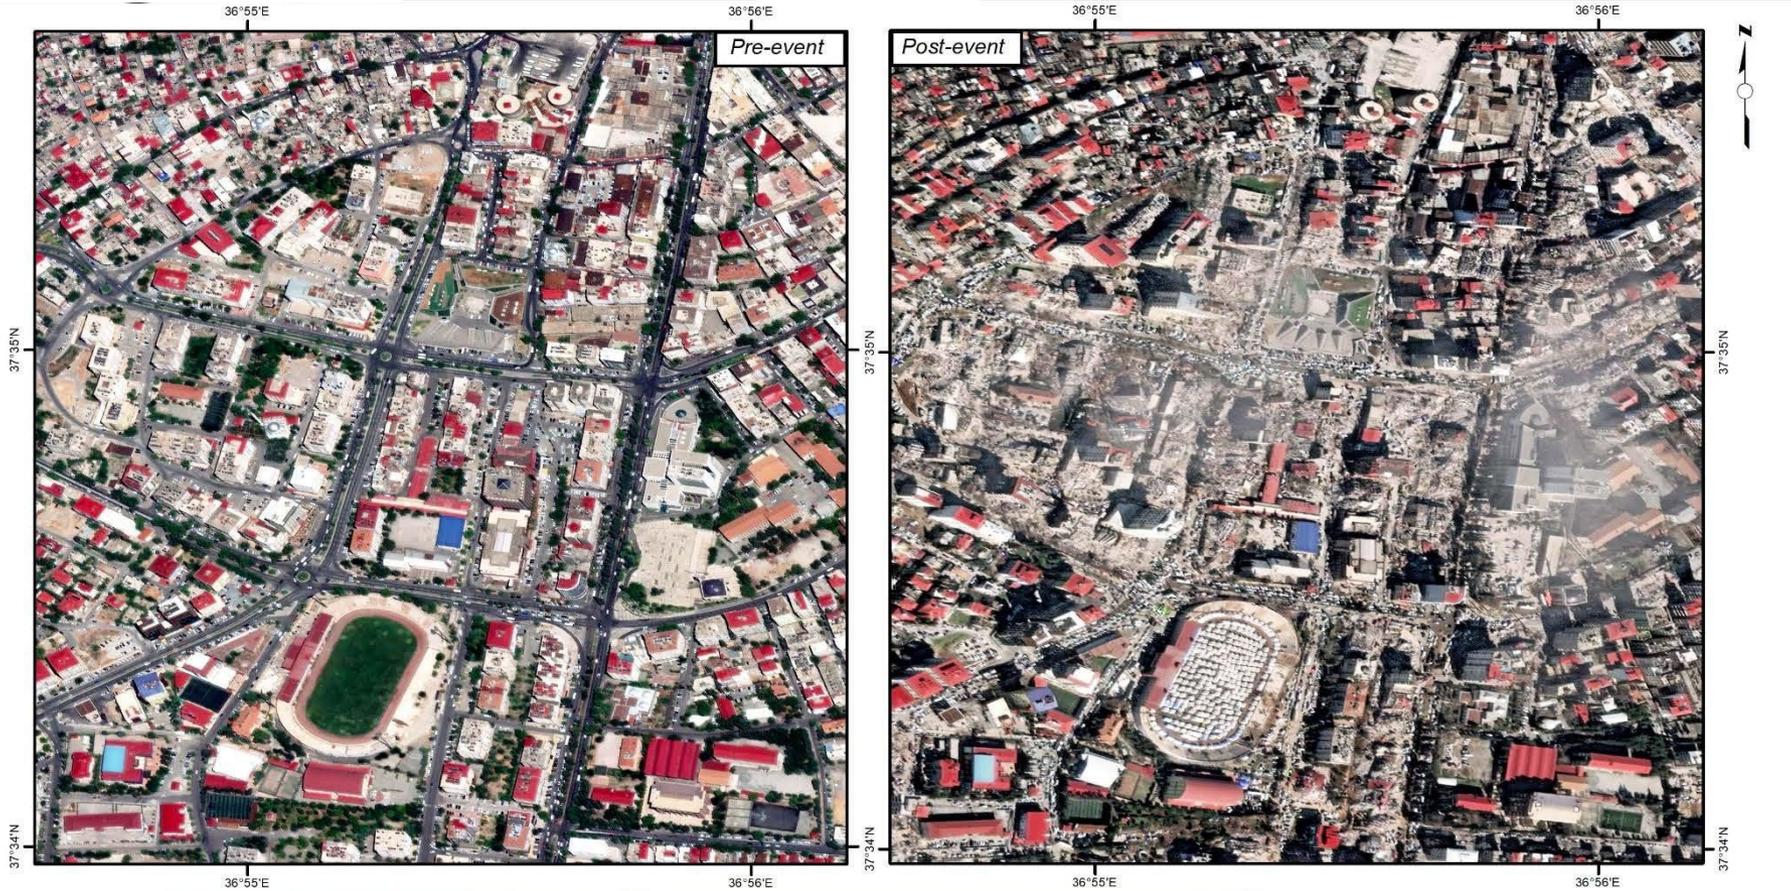
Earthquake dates: February 6, 2023
 Magnitude: 7.8
 Location: Kahramanmaraş
 Remote Sensing data used: WorldView2
 Spatial resolution: 0.3 meters
 Pre Data Acquisition: 26.07.2022
 Post Data Acquisition: 08.02.2023
 Processing: Vassilakis, Konsolaki

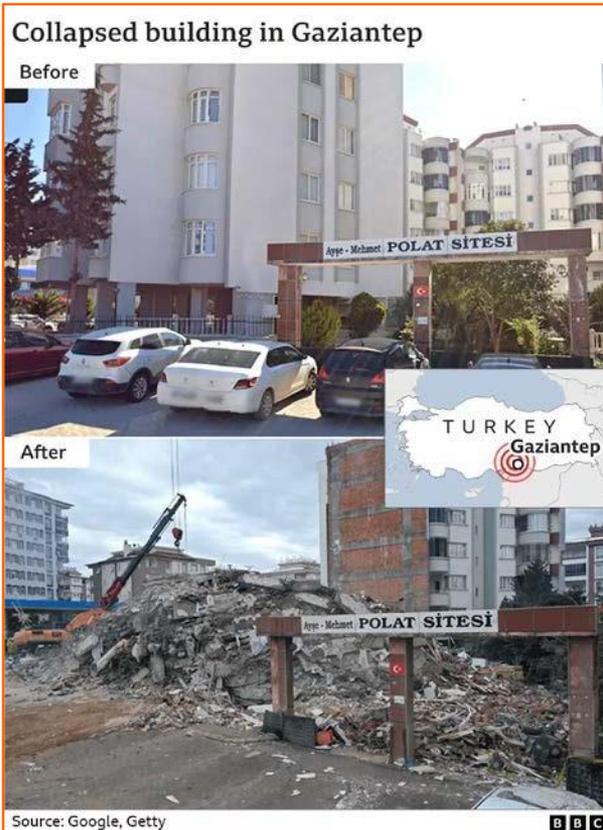
EARTHQUAKE BUILDING DAMAGE BEFORE AND AFTER THE 6 FEBRUARY DISASTER

All types of structures were affected by the 6 February 2023 earthquakes in Turkey and Syria. Residential buildings and monumental buildings including mosques suffered very heavy structural damage including total collapse. Source: <https://www.bbc.com/news/world-europe-64544998>

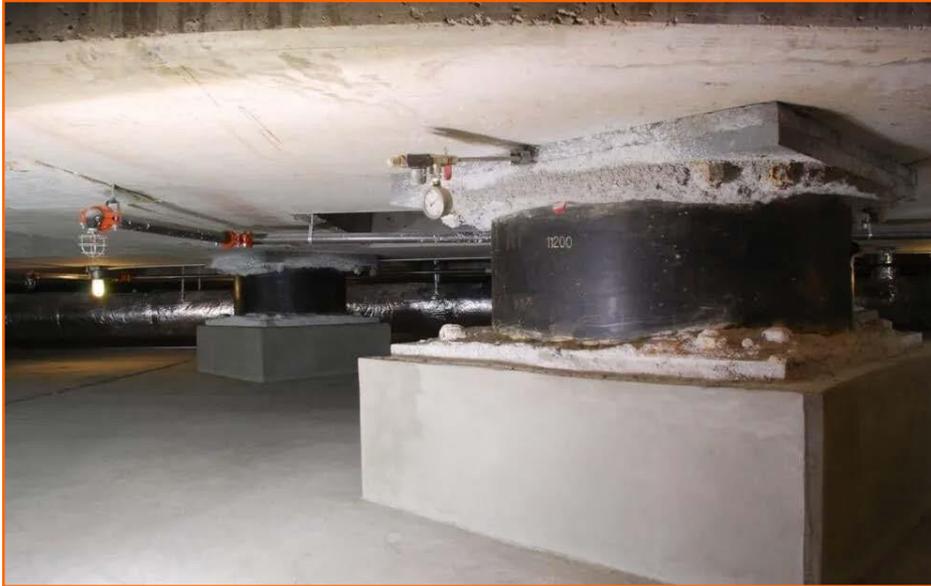
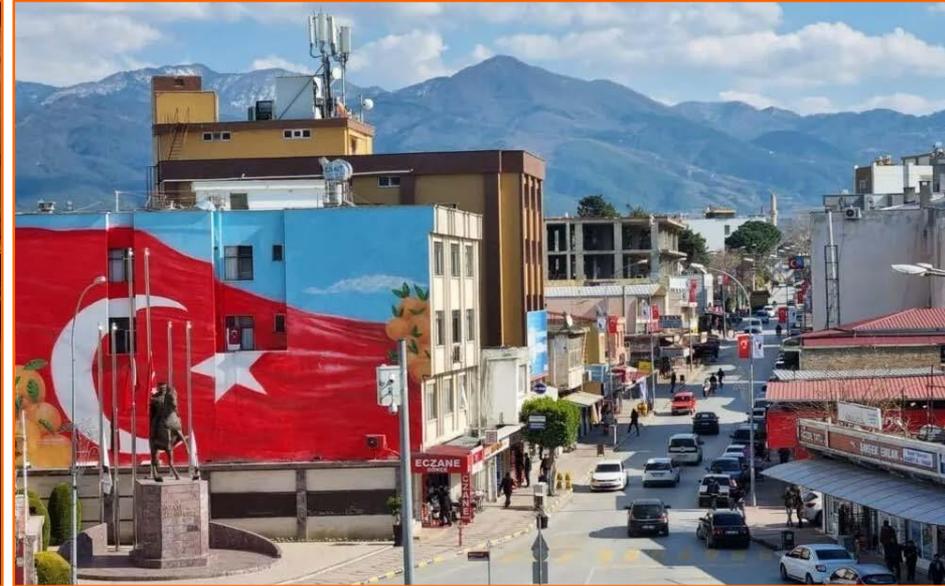
▲ In both devastating earthquakes, Elbistan State Hospital in the epicenter district of the second major quake, Hatay Dörtyol State Hospital, Malatya Battalgazi State Hospital and Maternity and Children's Hospital in Malatya did not suffer even the slightest damage. This fact is attributed to the seismic isolation devices placed in their columns
