Reconnaissance Report of July 16, 2007 Niigata-Ken Chuetsu-Oki, Japan, Earthquake

M.R. Ghayamghamian¹, Tetsuo Tobita², Susumu Iai², and Gi-Cheon Kang²

ABSTRACT: *The damage survey of the Niigata-ken Chuetsu-Oki, Japan earthquake ($M_{JMA} = 6.8$) of July 16, 2007 was conducted by the reconnaissance team of Disaster Prevention Research Institute (DPRI), Kyoto university. The area with dimension of 24 km x 19 km is investigated by the reconnaissance team. This paper reports the seismological aspects and observed geotechnical and structural damage during the damage survey in the area. The landslides, liquefaction and ground settlements were the most important geotechnical features that caused serious damage to the lifelines and buildings. Especially, landslides caused major damage to the railways and roads. The building damage survey was conducted around Kashiwazaki city hall where the K-net strong motion station was located. The damage to the buildings was classified as D2 or D3 within 100m around the city hall. Meanwhile, the collapsed wooden houses (D6 Grade) were mostly concentrated in Higashi Honmachi street situated in 280 m south of city hall. Most of the wooden house, concre

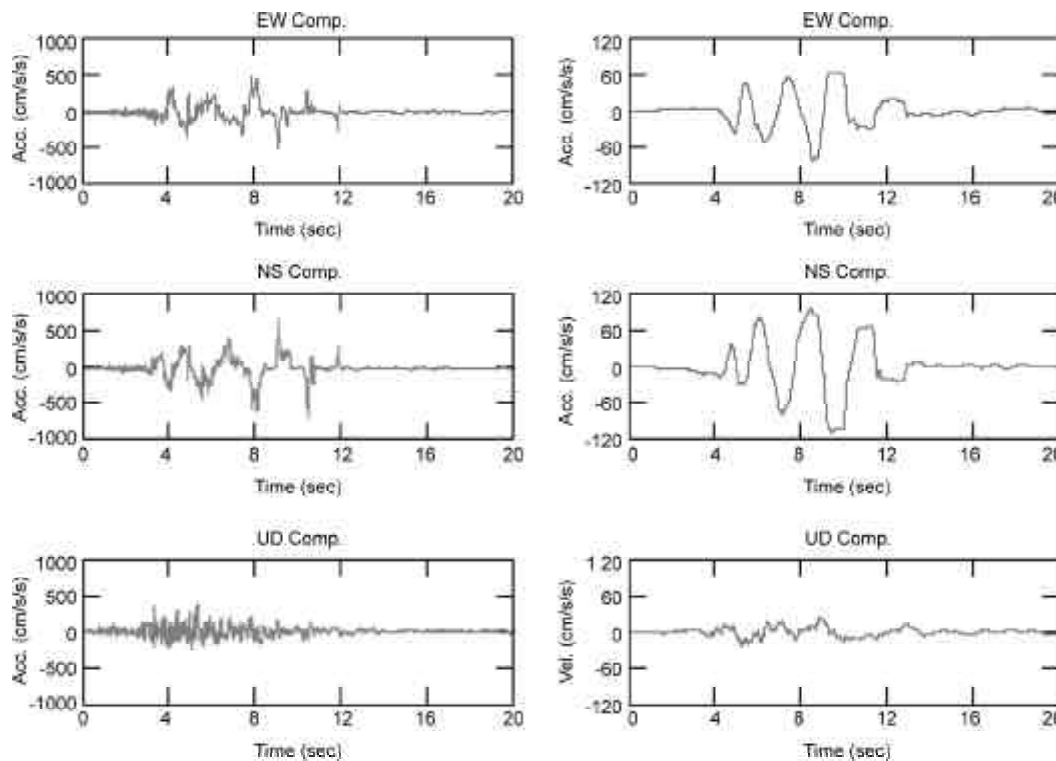
Figure 7. Strong motions recorded in Kashiwazaki K-net station and calculated velocity time histories (high passed filter of 0.08 Hz).

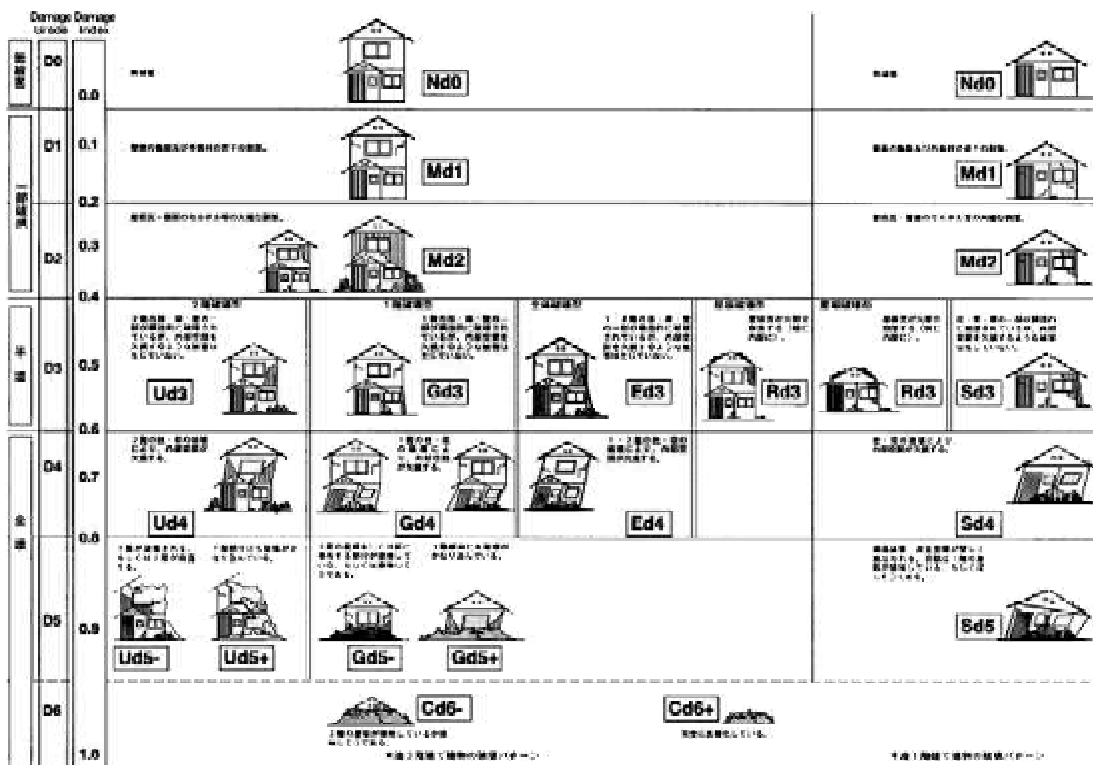
We also measured the direction of collapsed buildings in the area. The damage grade of buildings was evaluated using Okada and Takai [2] classification of wooden houses, as shown in Figure (15) [2]. In this classification, building damage is categorized into 7 grades from D0 (no damage) to D6 (very heavy

Figure 15. Damage grade and classification for wooden houses in Okada and Takai [2].

structural damage or collapsed). Most of the building damage is classified as *D1* and *D2* near the Kashiwazaki city hall. However, many wooden houses with Grade 5 and 6 damage were observed along the Higashi Hon Machi street (regions 2 and 3). Figure (16) shows typical collapse of wooden houses together with their collapse direction observed in this street. The Highashi Hon Machi street was almost directed along *EW* direction with a lenient slop in its south side. Besides this observation, the scares damage along the other streets was found that is mostly categorized as a *D2* or *D3* types. The place that damage *D6* was observed is shown in the map in Figure (14). Although it was not possible to visit all the damaged buildings, the ntensity based on collapsed buildings seems to be lower than the one announced based on instrumental *JMA* seismic intensity (6+ comparable to *IX* in *MMI* scale).
