# Experimental Study on Seismic Behavior of Conventional Concrete Bridge Bents

*This paper presents the results of an experimental study conducted to assess the seismic response of the commonly used multicolumn bridge bents constructed in Iran. Observing the real performance of the bent, capturing undesirable failure modes, and verifying current code requirements are the main goals of this study. A 30% scaled specimen was designed, constructed and tested under simulated earthquake loads. The results indicate that the joint failure and slippage of longitudinal column reinforcement within the joints are the predominant failure modes under lateral cyclic loading. Such failure modes adversely affect the energy-absorbing capacity by a significantly pinched hysteresis response. Slippage of the column's longitudinal bar is the main contributing factor for the pinched hysteresis response. Based on the test results, AASHTO requirements for development length of the column's longitudinal bars inside the cap-beam is unnecessarily long, and it can be reduced considering the confinement effects of transverse reinforcement. Test results also indicate that the displacement capacity of bridge ben

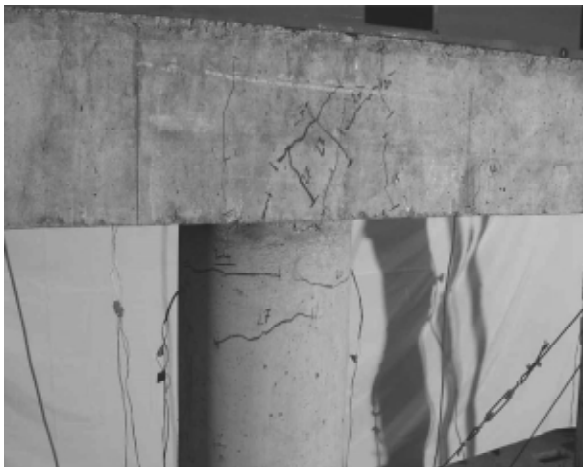
a) Performance Level (I)

**Figure 4.** Crack pattern and damage observation at selected performance levels.

**Performance level I:** The bent behaved elastically with no significant degradation in the lateral strength at low displacement. Hairline flexural cracking initiated at stirrups' locations in the cap-beam at 0.88% drift ratio and then began to incline slightly in the next cycles. These cracks appeared at the bottom of the cap-beam near the exterior columns.

Vertical hairline cracks were observed in the joint area at 1.1% drift ratio, and flexural cracks were observed in the columns at 1.4% drift ratio. However, upon unloading, the cracks were closed and did not need repair. By increasing the displacement, hence loading magnitude, diagonal cracks appeared in the joints at 1.6% drift ratio and propagated quickly. Figure (4a) shows the crack pattern and damage at the performance level (I).

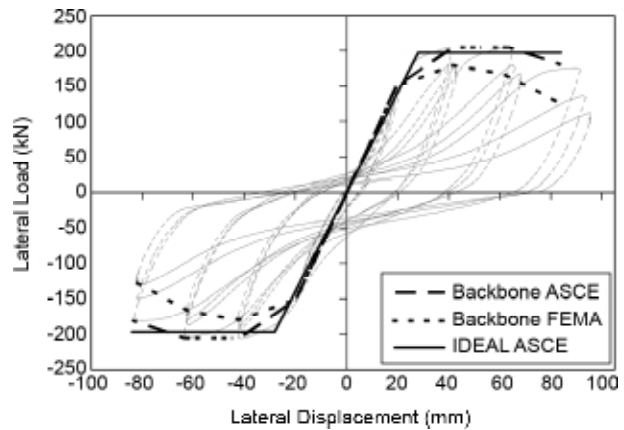
**Figure 6.** Comparison of proposed FEMA-356 and ASCE-41 backbone curves and derivation of ideal elastoplastic curve based on ASCE-41 backbone.

The backbone curve was defined in *FEMA 356* [23] through the intersection of the first cycle for the  $i^{\text{th}}$  deformation step and second cycle at the  $(i-1)^{\text{th}}$  deformation step. This type of backbone relations exaggerated the rate of the strength degradation, and it can result in an over-estimation of the earthquake deformation demands [25], especially where large in-cycle strength loss occurs. In the update to *ASCE/SEI 41* [26] Concrete Provisions, Elwood et al [27] proposed that the backbone curves should be drawn through each point of peak displacement during the first cycle of each

increment of deformation. Both types of backbone curves were derived from the hysteresis response and are shown in Figure (6).
